# CASE HISTORY SPOTLIGHT

## Cortec® Case History #581: Fighting Corrosion on Gas Station Fuel Sumps

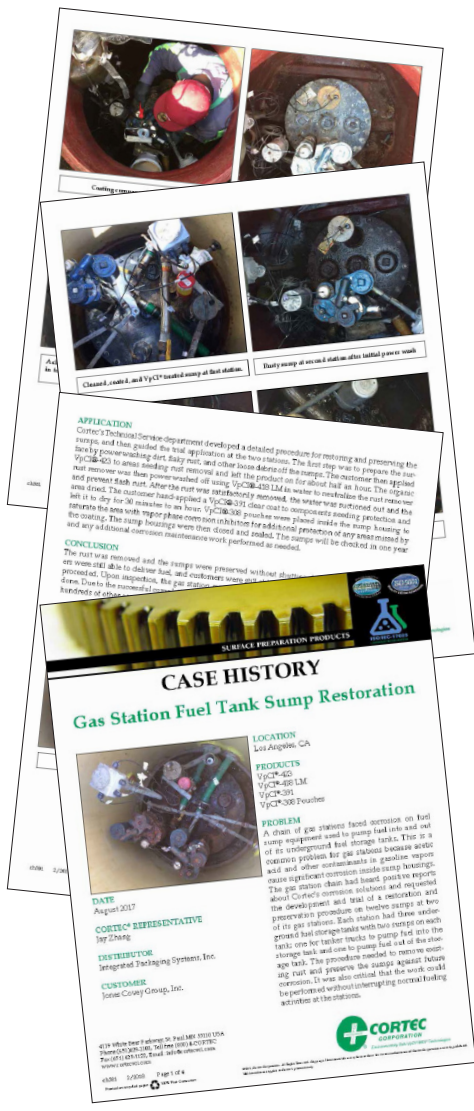
Corrosion in fuel sump housings is a common problem for gas stations due to acetic acid and other contaminants in gasoline vapors. One gas station chain chose to address the problem by trying a Cortec® restoration and preservation procedure on twelve sumps at two stations in Los Angeles. Each gas station had three underground storage tanks with two sumps on each tank.

The first step for each sump was to remove debris, dirt, and loose rust by power washing. After cleaning, the team applied biobased VpCI®-423 to areas needing rust removal, let the gel sit for a half hour, and rinsed it off using VpCI®-418 LM. Then they dried the sump out and applied VpCI®-391 clear coat to metal surfaces needing protection. Workers attached VpCI®-308 pouches inside the housings for additional protection of any areas that might have been missed by the coating. The sumps were then closed and sealed.
