CASE HISTORY SPOTLIGHT

Case History #618: Corrosion Protection of Guy-Wire Clamps

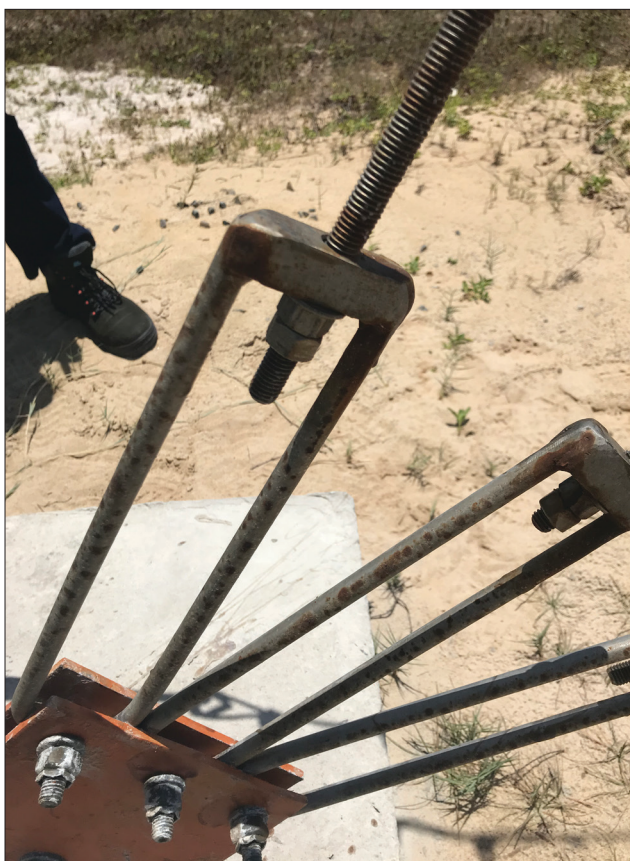
A corrosive environment of strong wind and blowing sand near the ocean led to corrosion on guy-wire clamps anchoring a cell tower in Brazil. The solution was to brush off loose rust, clean the clamps with VpCI®-418, and coat them with VpCI®-368, a wax-like, removable coating. This will be an important step to mitigate future corrosion in such a severe environment and thus prolong the service life of the critical components that keep the cell tower standing safely.
