Case History Spotlight #619: Clamp and Powerline Protection

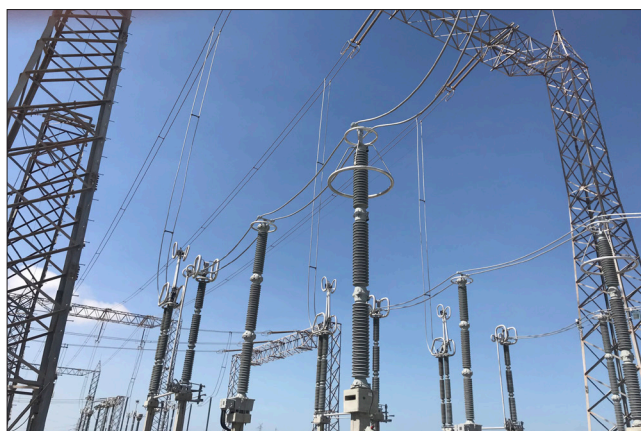
Not long after installation, clamps and surrounding areas on powerlines at a wind power transfer station corroded badly due to the severe environment of strong wind and blowing sand near the ocean.

Power was turned off to do restoration work. After taking the clamps down and mechanically removing most of the corrosion, workers cleaned the clamps in [VpCI®-415](#), dried them, and sprayed [ElectriCorr™ VpCI®-239](#) inside most of them. They reinstalled the clamps and applied a [VpCI®-396](#) primer coat to the clamps and sections of wire on both sides. The clamps were top-coated with [VpCI®-384](#).

Around the substation, workers applied [VpCI®-368](#) removable coating to moving parts and applied [MCI®-2020](#) to concrete support structures. [MCI®-2005](#) was added to a large sand containment wall on the wind farm.
