CASE HISTORY SPOTLIGHT

Case History #62: Concrete Cooling Tower Restoration

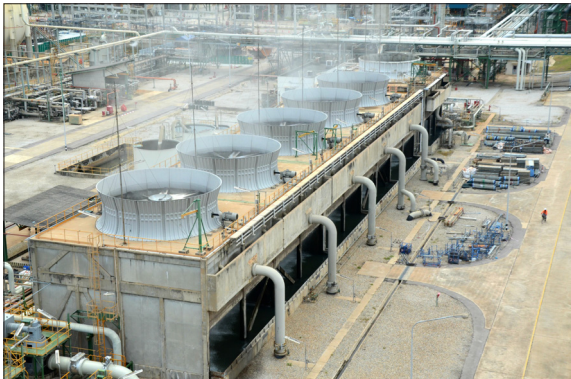
Cooling towers at a processing facility had severe damage from corrosion. It was wondered whether structural integrity could be maintained while avoiding the cost of total replacement. Loose concrete was removed with jet blasting, and [VpCI®-423](#) was used to remove heavy rust on rebar. [MCI®-2023](#) was applied immediately to protect cleaned rebar. [MCI®-2038](#) and [MCI®-2039](#) were then used to repair concrete and restore structural integrity. Structurally sound areas that did not require concrete repair were treated with [MCI®-2020](#) surface applied corrosion inhibitor designed to migrate and protect the steel beneath the concrete. Using this process, the contractor was able to restore the structure's integrity and aesthetics at a substantial cost savings to the owner.
