MIGRATORY CORROSION INHIBITOR (MCI®) PRODUCTS FOR CONCRETE

Case History Spotlight #678: Swedish Water Tower Repair

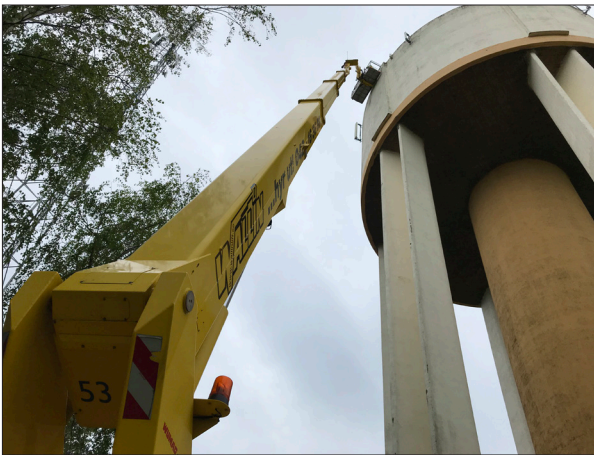
The water tower in Höganäs County, Sweden, was built in 1978 with a 50-year service life design. By 2020, chlorides and carbonation had caused reinforcement corrosion, and pieces of concrete were breaking apart and falling off. Although bearing capacity was not yet affected, some damage that could potentially cause problems was found on tension cable fastenings. Large areas still had high levels of chlorides, and there was the danger that concrete damage could progress rapidly. The municipality wanted to repair the structure and extend its service life by at least 20 years.

The chosen repair method involved removing all paint by sandblasting. They water jetted local damage and repaired it with a corrosion inhibiting repair mortar. Next, they treated all concrete surfaces (3,000 m² [3588 yd²]) with Cortec® [MCI®-2020 V/O](#). The last step was to repaint the water tower.
