CASE HISTORY SPOTLIGHT

Case History #769: Stopping Underbody Rust on Collector's Car

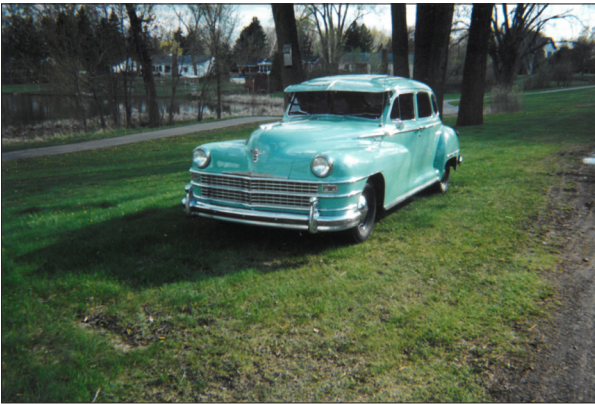
In 2008, the owner of a 1947 Chrysler Windsor decided to passivate the rusty front underbody and interior floor of his collector's car. He chose to try [Cortec® Coatings](#) based on a good experience working with Cortec® products in the Cortec® sample department.

The owner was impressed with the coatings, especially since he did not have to worry about using flammable products or enduring unpleasant fumes while working in his garage with the heater on and the door closed. When doing brake work almost 14 years later, he was impressed to find that these areas were still clean, solid, and rust-free, with no "rust creep" coming out of the nuts and bolts.

He started his winter restoration by scraping all the grease and grime off the front wheel drums, shock absorbers, and undercarriage. He applied just enough [CorrVerter® Rust Converter Primer](#) to stop the rust and followed this with a topcoat of [VpCI®-386 Black](#) when the CorrVerter® cured. He used the same two coatings on the rusty floor inside the car.
