# Case History #788: Preservation of Gas Turbine Engine Core

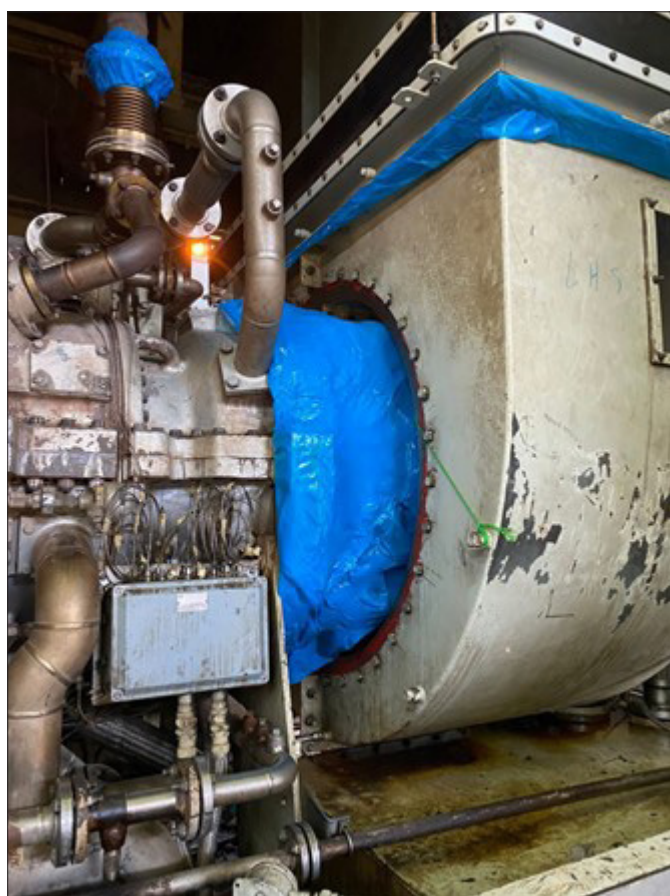
A Gas Turbine Compressor Train-C (GTC) needed two years of preservation. The engine core needed to be isolated first. This was done by fitting [VpCI®-126 HP UV Shrink Film](#) to various openings such as the engine air inlet, vents, and exhaust joints. [VpCI®-308 Pouches](#) were placed inside the engine bell mouth and the engine core was fogged with [VpCI®-337](#). The variable guide vane was cleaned and preserved before wrapping it in VpCI®-126 HP UV Shrink Film. A key benefit of this method was that the customer was able to preserve the engine core without having to remove it and place it in a nitrogen-purged canister.
