MIGRATORY CORROSION INHIBITOR (MCI®) PRODUCTS FOR CONCRETE

CASE HISTORY SPOTLIGHT

Case History #364: Preserving Float Tanks at Round Butte Reservoir

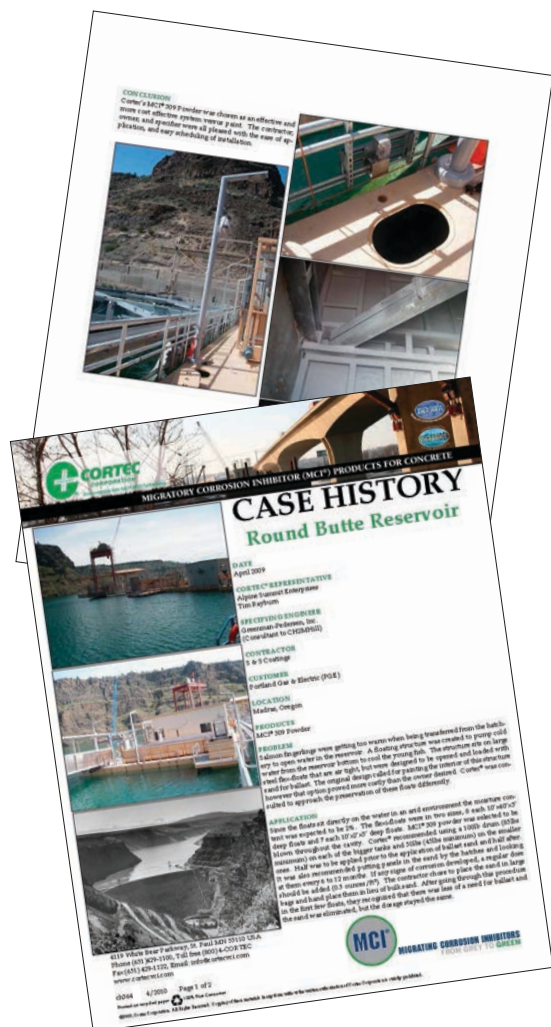
When introducing salmon fingerlings from the hatchery into the Round Butte Reservoir, the customer found the water to be too warm for the young fish. To solve the problem, a floating station was designed to pump cold water from the bottom of the reservoir to cool the salmon. The pump station was supported on airtight steel flex-floats that could be loaded with sand for ballast. Moisture content was expected to be 2% inside the tanks. The original plan was to preserve the interiors of the floats by painting them, but this proved to be too expensive, and the customer consulted Cortec® for a different option.

Cortec® was able to offer MCI®-309 powder as an alternative and recommended blowing half of the dose inside the tanks before ballasting the floats with sandbags and the other half of the dose after ballasting. It was also recommended that panels be placed in the float cavities to monitor for corrosion every six to 12 months in case additional MCI®-309 were needed. The workers soon realized that the sand was not necessary, but they kept adding MCI®-309 at the same dose. While MCI®-309 had originally been chosen because it was a cost-effective alternative to paint, the contractor, owner, and specifier also ended up being happy with how easy it was to apply.
