# Enhancing Durability of Stone Cladding Corrosion Restoration and Repair

By Julie Holmquist

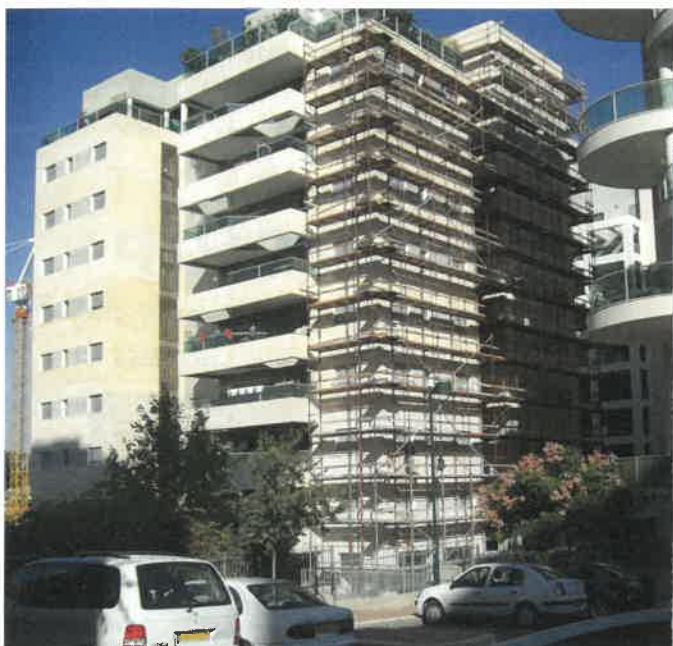
Fig. 1: Stav Street residential building during repairs (image courtesy of Glimmer Industrial Consultation)

The restoration of approximately 270,000 sf (25,000 m<sup>2</sup>) of surface area was completed in 2011 at a total cost of over \$2 million USD. Once the cracked and loose cladding tiles were removed, corrosion stains and corroded anchors were drilled out of the walls and filled with repair mortar. New screws were used to re-anchor the tiles, and pieces cut from the original cracked tiles were used to cap the holes to minimize change in surface appearance. To inhibit further corrosion, holes were also drilled intermittently throughout the cladding to allow the injection of the corrosion inhibiting gel, designed to release corrosion inhibiting vapors that would work their way through concrete pores and voids behind the tiles to deter corrosion on cladding anchors and reinforcement (Fig. 1, 2, and 3).

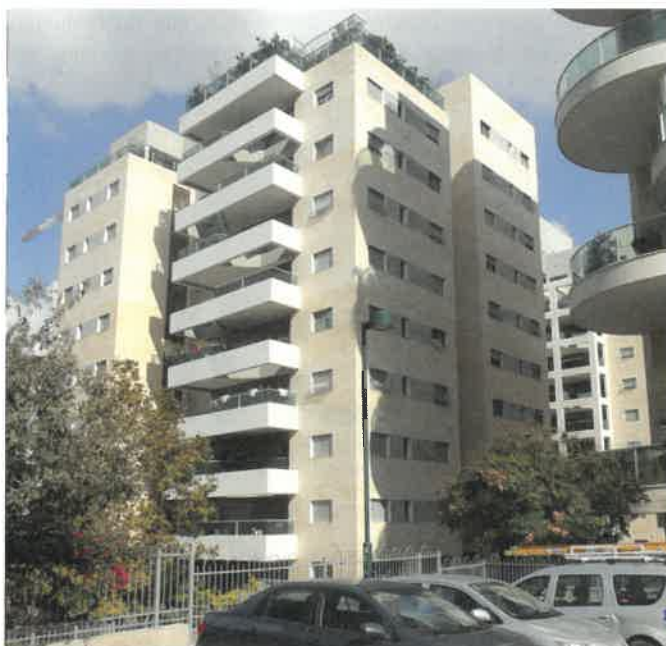
Fig. 2: Stav Street residential building after repairs completed (image courtesy of Glimmer Industrial Consultation)

Six months after gel injection, testing was performed that confirmed the presence of inhibitor in the concrete. A visual inspection at five years found no new corrosion stains. As of the last review in November 2017, a year after the 5-year inspection, the building repairs were still in good condition, as opposed to an adjacent building where additional work had been required to remove new corrosion stains.

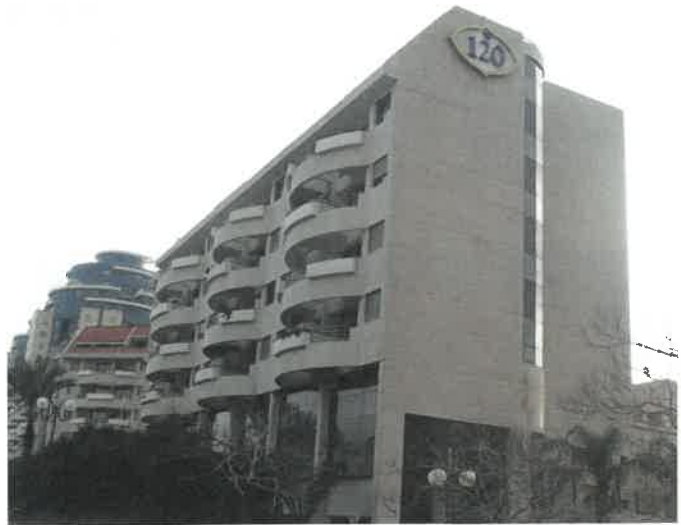
The Ad-120 Retirement Center (Fig. 4) was completed in the year 2000. Similar to the Stav Street situation, problems with the stone cladding started to appear only four years after construction. Large voids developed behind the cladding, and corrosion damage on cladding hooks and reinforcement resulted in cladding tiles that cracked, detached, and began to fall off the building. A comprehensive rehabilitation program was developed between 2006 and 2012, and repairs took place in 2013-

Fig. 4: General view of Ad-120 retirement center (image courtesy of Glimmer Industrial Consultation)

In addition to using stainless steel for the new anchoring system, an important part of the rehabilitation was to deter future corrosion through the use of two forms of migrating corrosion inhibitors. Where void spaces behind the stone tiles needed additional concrete cover, repair mortar admixed with migrating corrosion inhibitors was injected. A gel containing migrating corrosion inhibitors was also injected at periodic spacings along the grout lines to provide protection to cladding anchors and metal reinforcement underlying the surface (Fig. 5 and 6). Holes were capped with cementitious mortar, and grout lines were renewed. A visual survey several years later found no new corrosion damage.

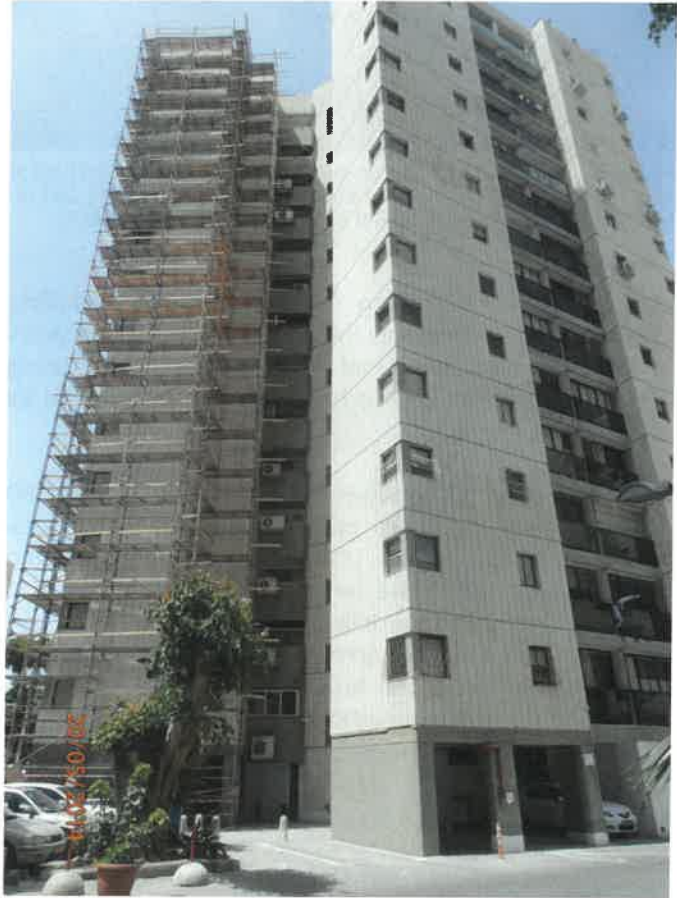
A residential building (Fig. 7) in Givatayim, Israel, had stone cladding tiles that began to detach and fall off in 2004, about 15 years after construction. Following an initial re-anchoring repair that did not incorporate migrating corrosion inhibitors, tiles continued to fall off and delamination of exposed concrete occurred. Corrosion was identified on both concrete reinforcement and cladding anchors. Corroding rebar was causing expansion beneath the tiles, making them unstable (Fig. 8). Despite the expensive repair completed in 2004, the building was in need of a second repair program in 2014, only 25 years after construction.

Fig. 7: Ben-Gurion Street residential building during repairs (image courtesy of Glimmer Industrial Consultation)

This time in 2014, the repair included migrating and vapor corrosion inhibitors to mitigate corrosion on rebar and cladding anchors. As performed at the Ad-120 Retirement Center, migrating corrosion inhibitors were admixed into repair mortars for repair of delaminated concrete. To minimize cosmetic damage to the building, holes were

drilled into the grout lines so that tablets containing vapor corrosion inhibitors could be inserted. Similar to migrating inhibitors, these corrosion inhibitors vaporize and diffuse throughout void spaces (e.g., concrete pores) to provide corrosion protection to embedded metals. The holes were capped and grout lines renewed, leaving the

tablets to gradually release corrosion inhibiting vapor for future protection. A migrating corrosion inhibitor surface treatment was applied for additional protection to exposed concrete surfaces on the ground floor, where wet-dry cycles and fertilizer and pesticide application made the environment especially harsh. The repair covered
