New White Paper Presents “The Cortec® Solution” for Corrosion Under Insulation

Corrosion Under Insulation – The Cortec® Solution

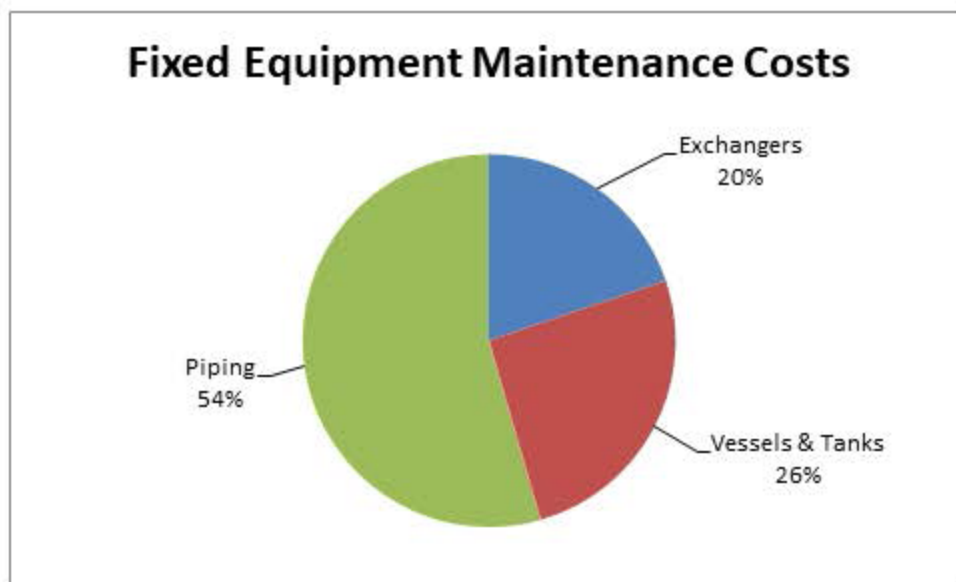
Temperature and containment sources influence the CUI rate, with wet insulation being the root cause of the problem. Maintenance costs are significant both in terms of materials and resources. Approximately 35 cents of every general maintenance dollar goes to costs for fixed equipment, such as vessels and piping. Of fixed equipment costs, about 55% is spent on piping (about 20 cents of every maintenance dollar), with CUI making up 40-60% of piping cost (or 10 cents of every maintenance dollar) (see chart below). ^[1]

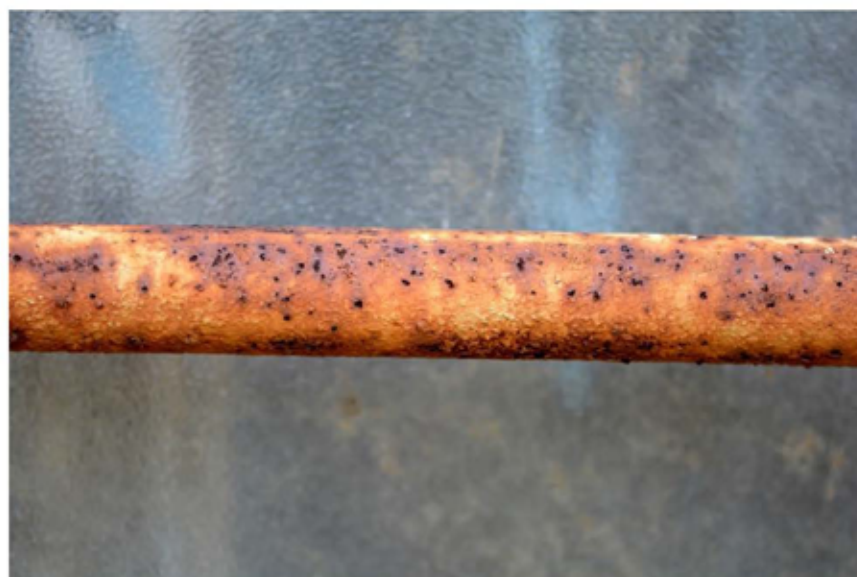
Corrosion on a pipe leads to pipe failure. It is even more difficult to detect when covered by insulation.

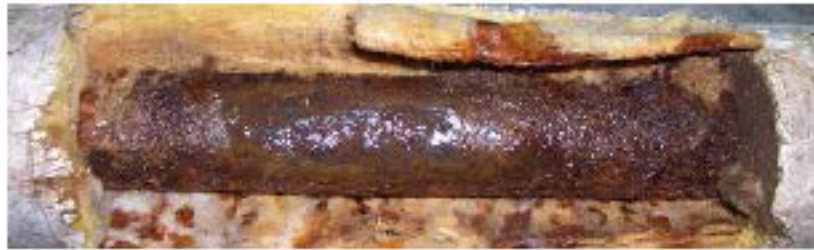
An example of the deteriorated condition of an existing pipe with CUI.

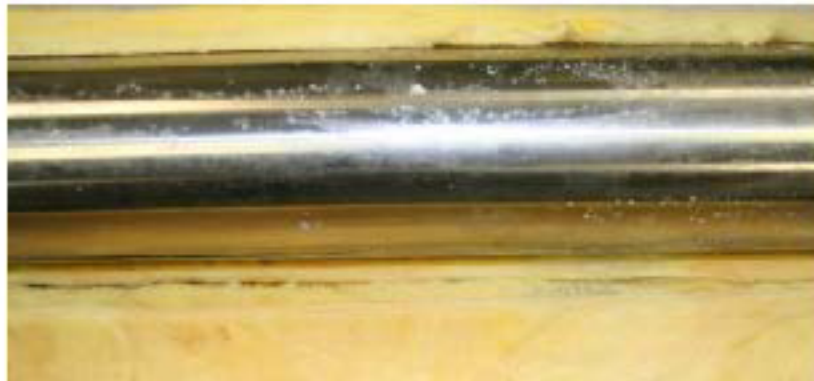
Pipe protected with VpCl®-619.

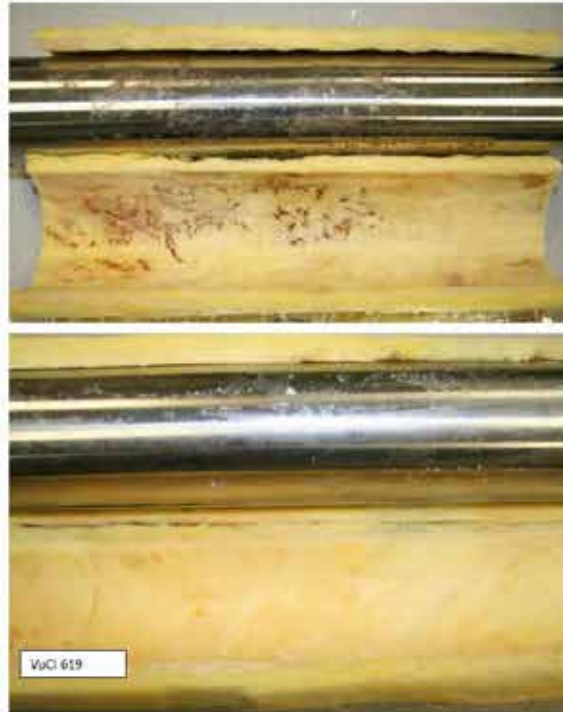
Insulated pipes after 240 hours of CUI condition testing at 176 °F (80 °C). Control sample insulation revealed localized corrosion and red rust. No corrosion attack was found on the sample treated with VpCI®-619.

The pipe treated with VpCI®-619 remained protected at 176 °F (80 °C) after 240 hours of testing, while the control pipe had localized corrosion. CUI simulation tests of a treated pipe at 350 °F (177 °C) after 192 hours and four salt injections also showed no corrosion, and an inhibitor deposit was detected on the surface. A companion corrosion test showed the effectiveness of VpCI®-619 to protect a steel pipe segment tested in a 200 ppm chloride solution at boiling temperature and reduce corrosion by a factor of 15.

The other part of the test involved insulated piping that was subjected to cyclic corrosion testing for 240 hours. The purpose was to see if VpCl®-619 inhibitor impregnated into the thermal insulation would protect the pipe. The insulation of the control pipe remained untreated. Both the control and treated sample were injected with a 200 ppm sodium chloride solution every 48 hours, and the samples were inspected every 5 days. After 240 hours, the untreated pipe showed localized corrosion, but the surface of the VpCl®-619 treated pipe remained well-protected. Consistent with inhibitor chemistry, a

Molybdenum rich protective film was detected on the surface of the VpCI®-619 protected pipe.

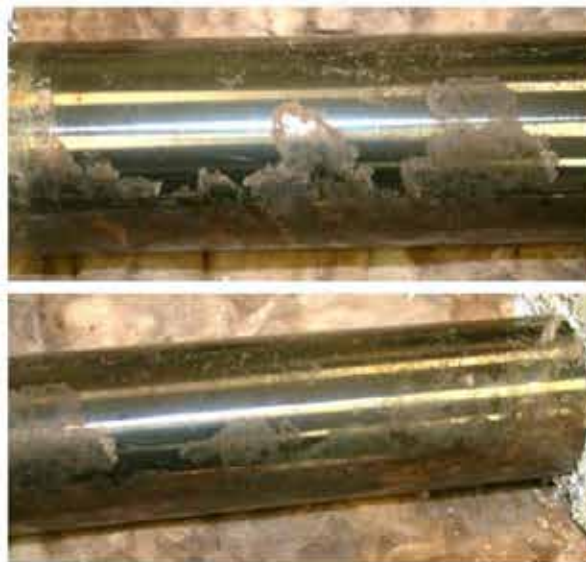
After four cycles (192 hours) of salt injection and CUI tests at 350 °F (177 °C), VpCI®-619 coated pipe surfaces were discolored but not corroded. Discoloration was attributed to Mo-rich deposits of inhibitor compound.
