HE AND CPT OF ASTM A470 IN VCI 337 ED ECOLINE 3690

The buildup of damage due to localized corrosion, pitting, stress, corrosion cracking and corrosion fatigue, in low pressure steam turbine blades, discs and rotors is a primary cause of most of turbine failures. Localized corrosion inhibitors can be used to protect steam turbines from the subsequent environment during shutdown and routine maintenance.

Inhibition effectiveness of VCI 337 and Ecoline 3690 products was confirmed with electrochemical corrosion techniques in different concentrations of inhibitor and Stress corrosion cracking/ Crevice corrosion tests in Anodic potential range.

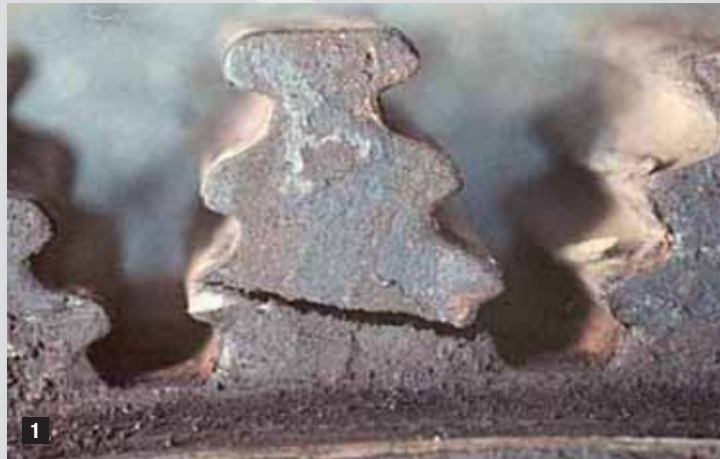
1
Typical Locations of Disc Rim Cracking.
 Localizzazione tipica della cricatura del cerchione.

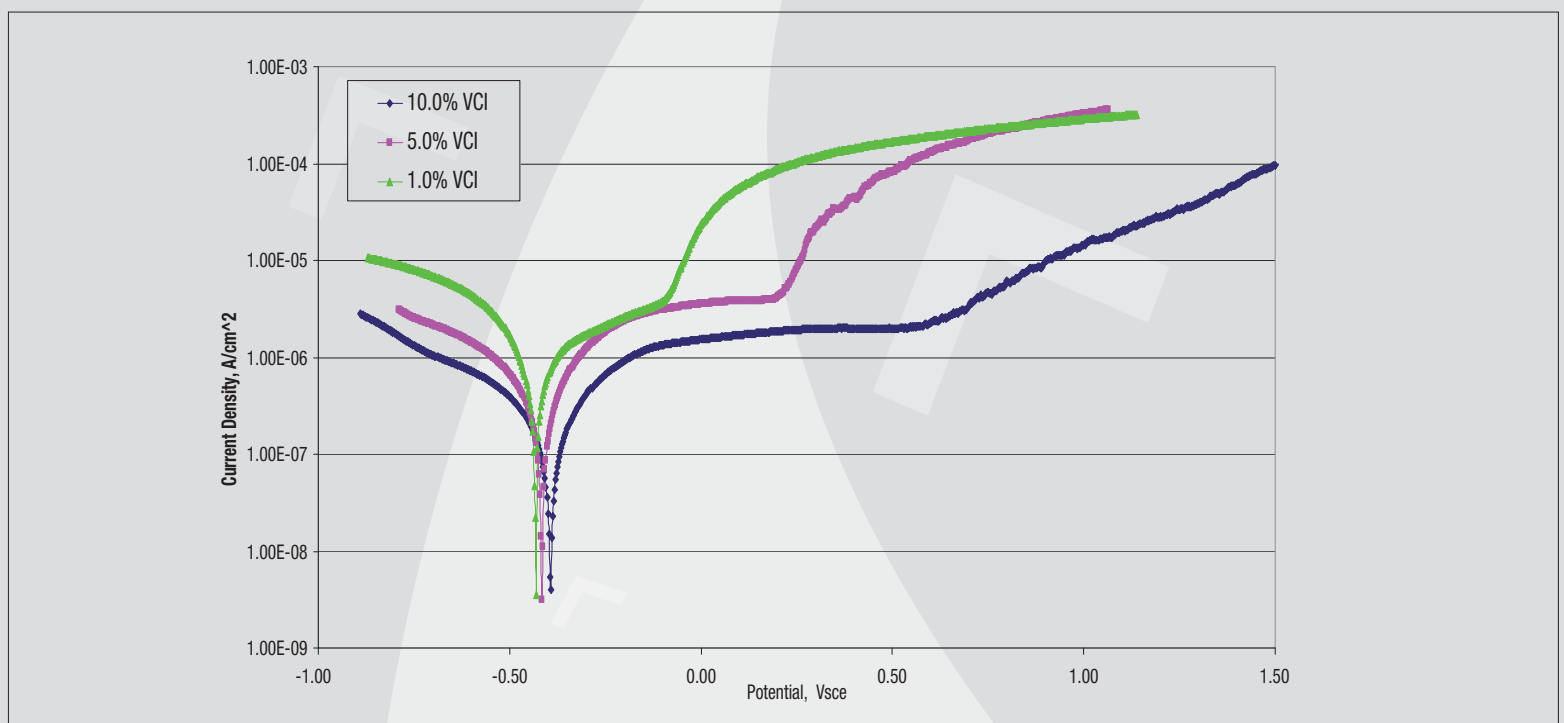
Plot 1. Corrosion Behavior of ASTM A-470Steel in +200ppm Cl- with different %VCI 337 in Solution ASTM G61

Sample	Ec, mVsce	Ic uA/cm ²	Eb, mVsce	CR, Mpy	Passive Range mVsce	I _{pss} uA/cm ²
200ppm Cl ⁻ +0.0%VCI	-675	1.47	-450	0.63	None	NA
200ppm Cl ⁻ +1.0%VCI	-460	0.389	+45	0.17	-300 to +20	3.12
200ppm Cl ⁻ +5.0%VCI	-415	0.304	+240	0.13	-200 to +200	3.22
200ppm Cl ⁻ +10.0%VCI	-392	0.0832	+1060	0.04	-100 to +950	1.92

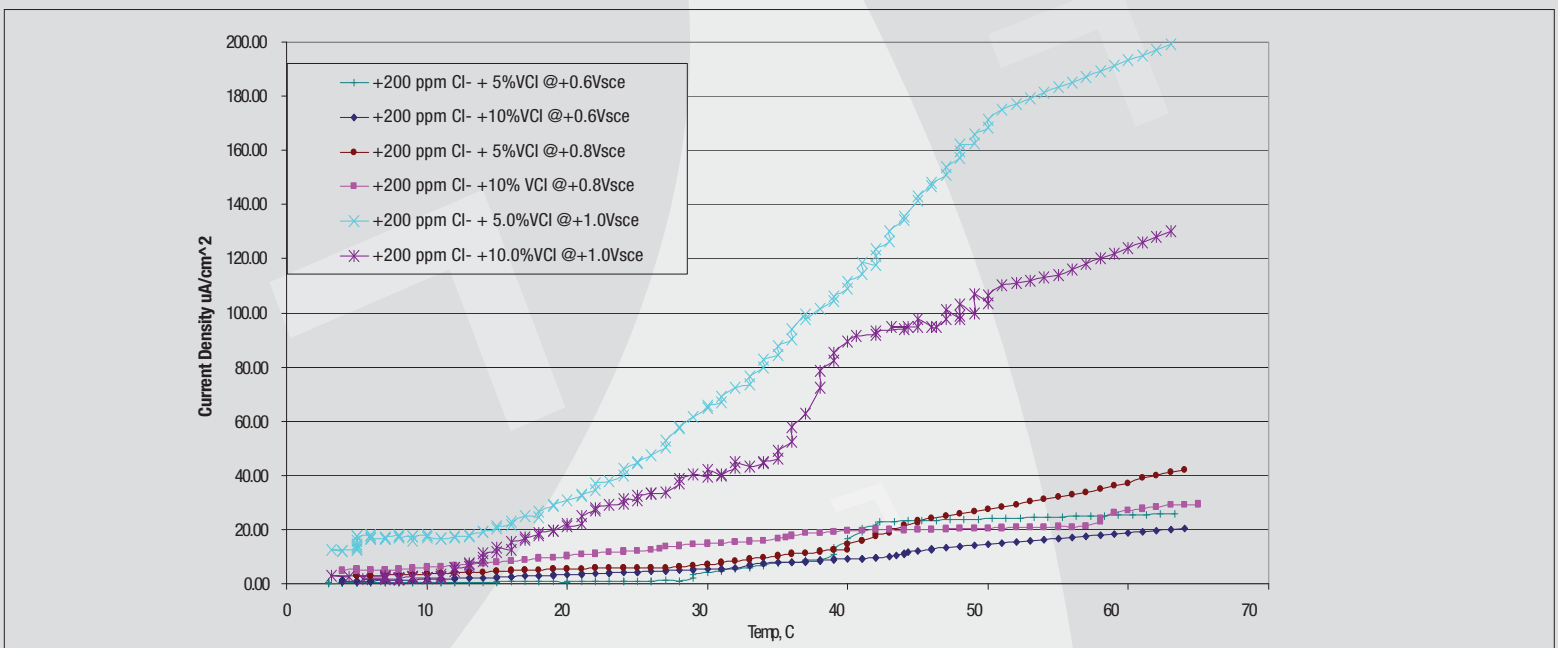
Plot 3. Critical Pitting Temperature Tests on ASTM A470 with VCI 337 at different anodic applied potentials, ASTM G150

HE tests confirmed that none of VCI inhibitors could cause any harmful effect on ASTM A470 up to -1.5 Vsce. Presence of both VCI 337 and Ecoline 3690 inhibitors increased; critical pitting temperature to $45-50^{\circ}\text{C}$, while non-protect ASTM A470 showed a CPT of 8°C in 200ppm Cl^{-} solution.

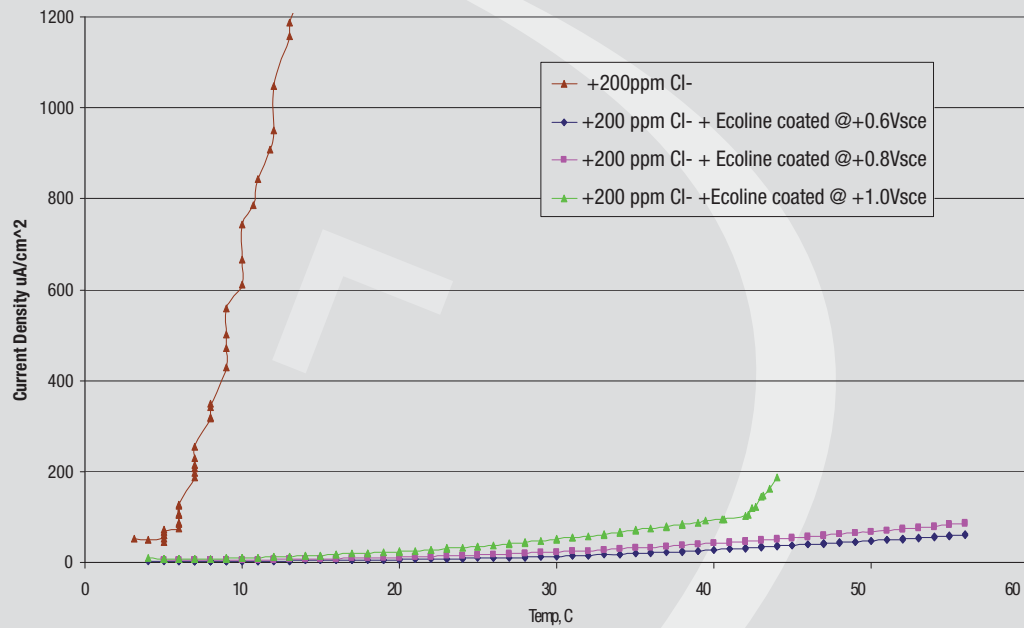
Plot 4. Critical Pitting Temperature Tests on ASTM A470/Ecoline 3690 at different anodic applied potentials, ASTM G150
