MIGRATING CORROSION INHIBITORS
FROM GREY TO GREEN

In The News

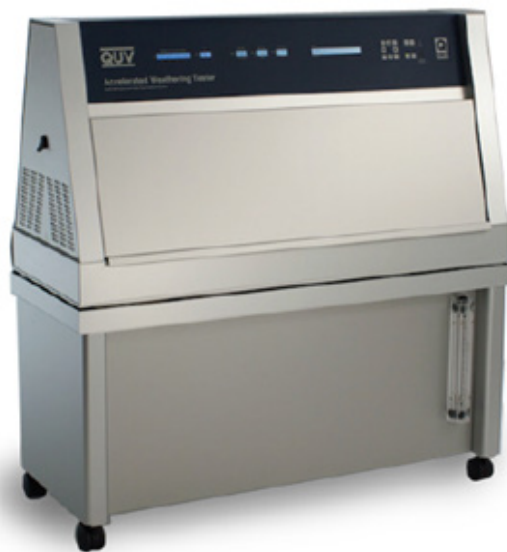
QUV Accelerated Weathering Tester by Q-Lab

Cortec® Laboratories has upgraded its lab with new equipment that can be used for the evaluation of MCI® coatings and surface treatments, among other Cortec® technologies. The new UV Weathering Chamber allows us to test the stability of materials such as MCI® EcoRainbow® Architectural Coating under UV exposure, high humidity, and fluctuating temperatures. In a recent example, we were able to put the UV Weathering Chamber to good use by testing the color fastness of fugitive dyes in MCI®-2018 FD and MCI®-2019 FD surface treatments!

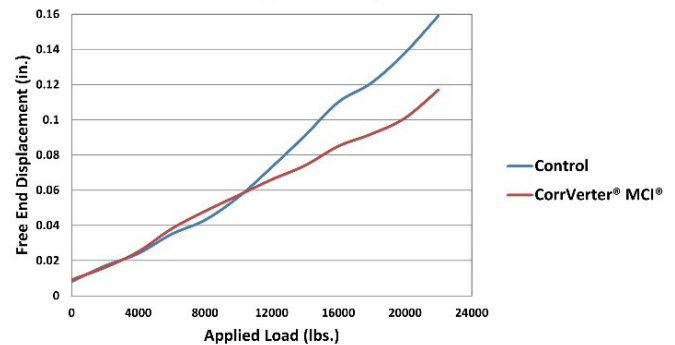
Bond Testing According to ASTM A944

CorrVerter® MCI® Rust Primer stands out with clear performance and application advantages to mitigate rebar corrosion for concrete repairs. CorrVerter® MCI® eliminates the intensive labor of abrasive or water blasting and shows similar bond strength to concrete compared with uncoated rebar (bond testing according to ASTM A944). Furthermore, competitor bonding agents offer vague or reduced corrosion protection benefits. One data sheet for a prominent cementitious epoxy resin claimed to reduce the corrosion rate by over 40% and triple time to corrosion, without specifying a standard test method used in the study. Another bonding primer reported excellent corrosion resistance in 120 hours of salt spray testing according to ASTM B-117 (application recommended at 31 mils [787.4 µm] minimum). A third competitive bonding agent alleged corrosion protection with no support data listed. In stark contrast, CorrVerter® MCI® Rust Primer reports 500 hours of corrosion resistance in salt spray testing (ASTM B-117) at only 3-5 mils (75-125 µm) DFT (applied at 8.7-14.5 mils [217.5-362.5 µm] WFT).

Considering these characteristics, CorrVerter® MCI® Rust Primer appears to be the clear winner for concrete repairs in terms of convenience and dependability. Take a closer look at this topic here: https://www.cortecvci.com/whats_new/announcements/CorrVerter_MCI_Stand_Stand_Out_as_Clear_Winner_Text_PR.pdf

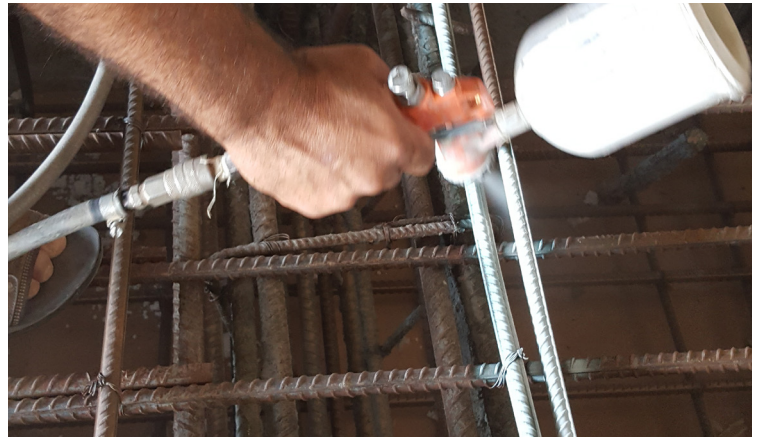
Rebar Preservation at Saudi Medical City

A few years ago, in the summer of 2017, a new medical complex being built in Saudi Arabia faced construction delays after much of the concrete work was already finished. This left quite a few exposed rebar in expansion joints and in-fill beams. CorrVerter® MCI® Rust Primer (for rusted rebar) and MCI® CorShield® (for non-rusted reinforcement) provided an economical and satisfactory solution to preserve the exposed reinforcement during the delays. Read the full case history here: https://www.corteccasehistories.com/?s2member_file_download=access-s2member-level1/ch694.pdf

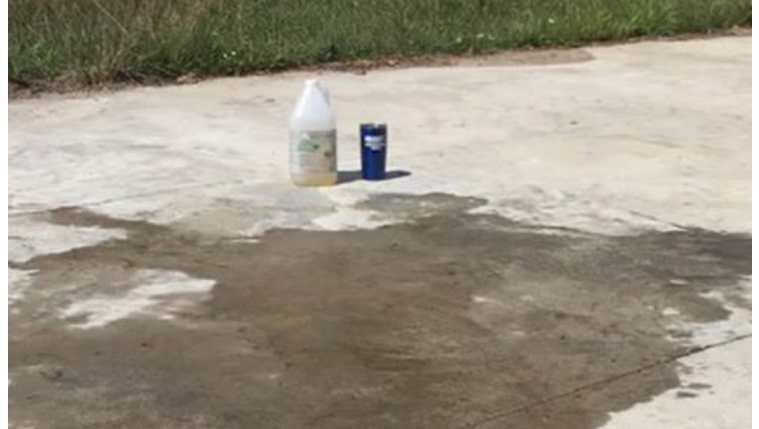
Golf Course Concrete Parking Pad Cleanup with MCI®-2061

MCI®-2061 was used at a golf course in August 2020 to clean up a concrete pad where parked equipment had left oil stains. The customer was very happy with the results and effortless application (no blast cleaning), and treatment was captured in a short demo video (watch here: <https://www.cortecvci.com/new-demo-video-available-on-mci-2061-concrete-cleanup/>). Read the full case history here: https://www.corteccasehistories.com/?s2member_file_download=access-s2member-level1/ch697.pdf

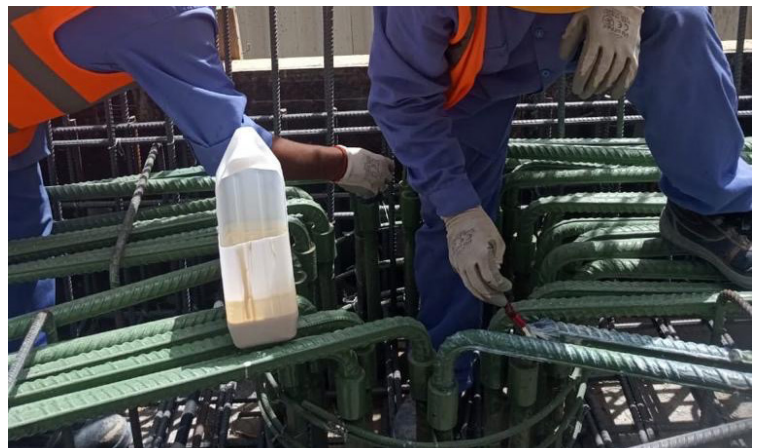
Preserving Damaged Rebar in Dubai Utility Project

May 2020 found workers applying MCI® CorShield® to rebar at a utility project in Dubai. The protective epoxy coating had been damaged during installation, so MCI® CorShield® was applied to the damaged areas to ensure long-term preservation. Read the full case history here: https://www.corteccasehistories.com/?s2member_file_download=access-s2member-level1/ch691.pdf

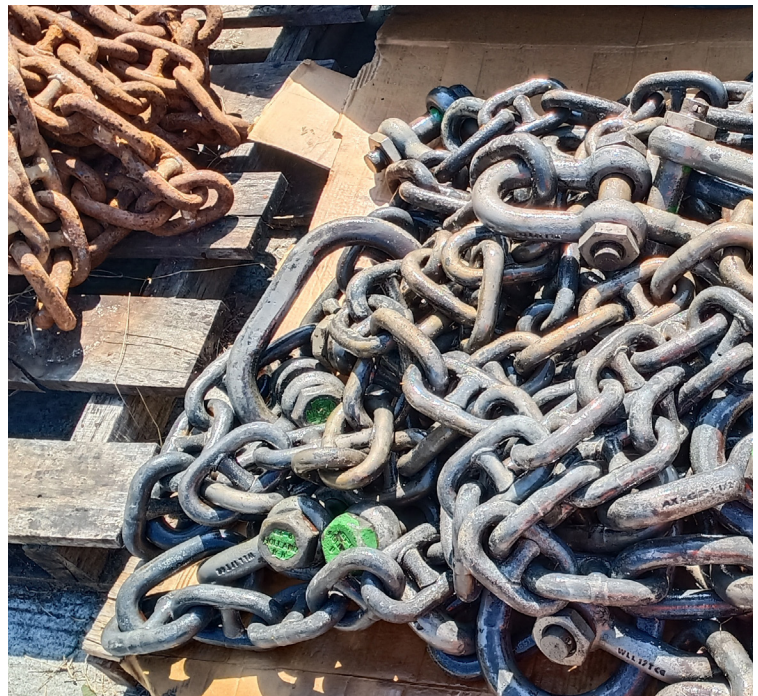
MCI® Super Remover for Corroded FPSO Chains

Some products like MCI® Super Remover are favorites for use even in non-construction applications. One Cortec® distributor in Indonesia recommended this for a company restoring and preserving chains from a FPSO (floating production storage and offloading) unit that was going into layup last year during the COVID-19 pandemic. The corroded pick-up and hang-off chains were first dipped in a 1:3 dilution of MCI® Super Remover for initial rust removal. The remaining rust was removed with VpCI®-423 before rinsing the chains in VpCI®-416 and applying Cor-Shield® VpCI®-369 removable coating for ongoing preservation. A key benefit of this method was that it did not require special cleaning tools on intricate surfaces. Read the full case history here: https://www.corteccasehistories.com/?s2member_file_download=access-s2member-level1/ch693.pdf

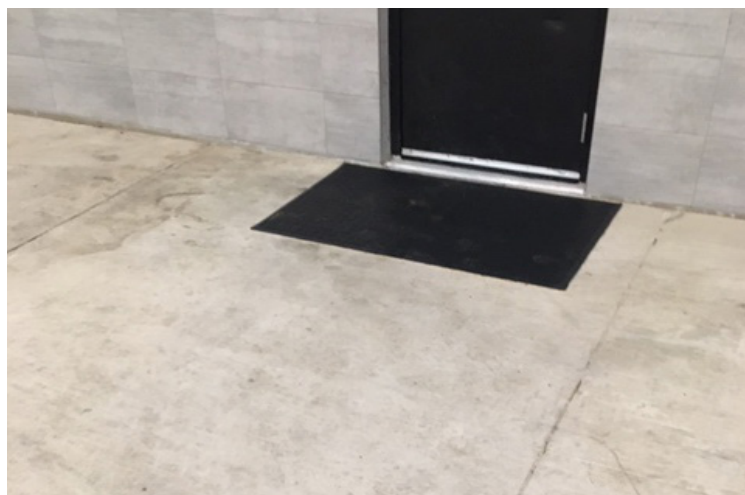
Gahan House Walkway Cleanup

In September 2020, the Gahan House Restaurant used MCI®-2062—our new “green” MCI® cleaner for organic waste—to clean up the concrete slab outside the back door of the restaurant. Building management had asked the restaurant to clean up organic and food waste stains that had occurred when taking garbage to the dumpster. The restaurant wanted a cleaner that was not abrasive or damaging to the concrete appearance. They used MCI®-2062 to clean up and were very happy with the results. Read the full case history here: https://www.corteccasehistories.com/?s2member_file_download=access-s2member-level1/ch690.pdf
