**PRESS RELEASE**

## Achieving Sustainability by Utilizing Migratory Corrosion Inhibitor Technology

### Preventing Tragic Events of Collapsing Structures

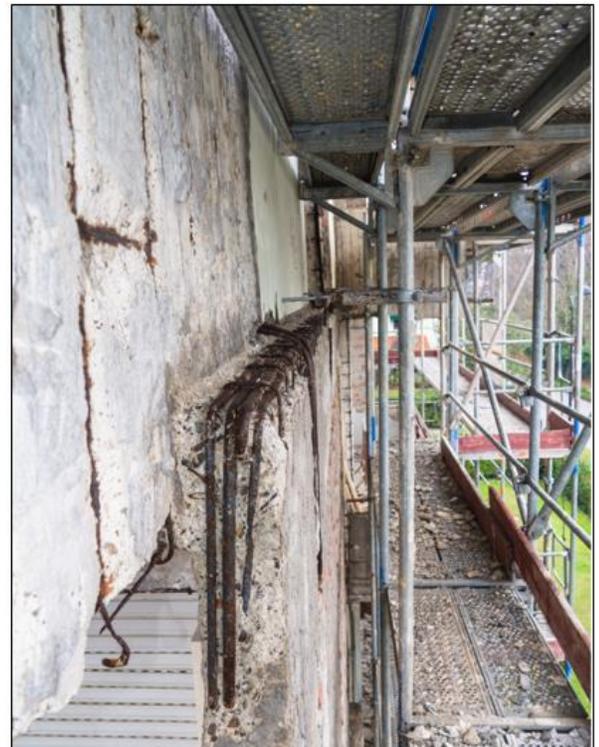
**Reinforced concrete structure deteriorated due to effects of corrosion**

What exactly happened with this building is still to be examined but more evidence indicates that corrosion was one of the root causes of the accident. Rebar corrosion and concrete spalling might have caused the structural failure. Harsh environmental effects in Florida on steel and concrete structures are well known. Reports discuss abundant cracking and spalling in the concrete columns, beams and walls in the parking garage located under the

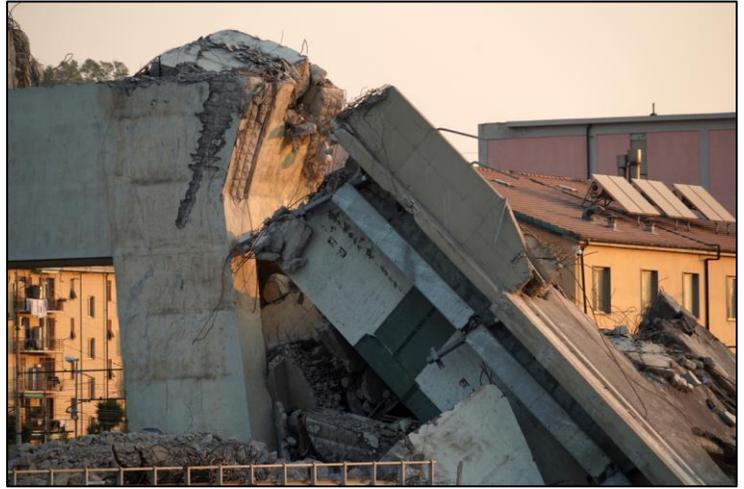
**Italian engineering experts believe that corrosion on the bridge’s steel cables contributed to the collapse. It decreased the bridge’s overall strength by 20%.**

bridge has been there for more than 35 years, corrosion of tendons or reinforcement was a contributory factor,” said Ivana Liposcak, Cortec’s MCI® technical support manager for Europe. “The long-term behavior of viaducts subjected to heavy traffic and situated in [an] aggressive environment shows that at the time of planning obviously many concepts about the sustainability of the bridge were not known and considered. Due to the vibration in concrete, microcracks occur, through which the moisture leads to oxidation and corrosion of steel and in that way, [the] structure gradually loses its capacity due to corrosion,” noted Liposcak.

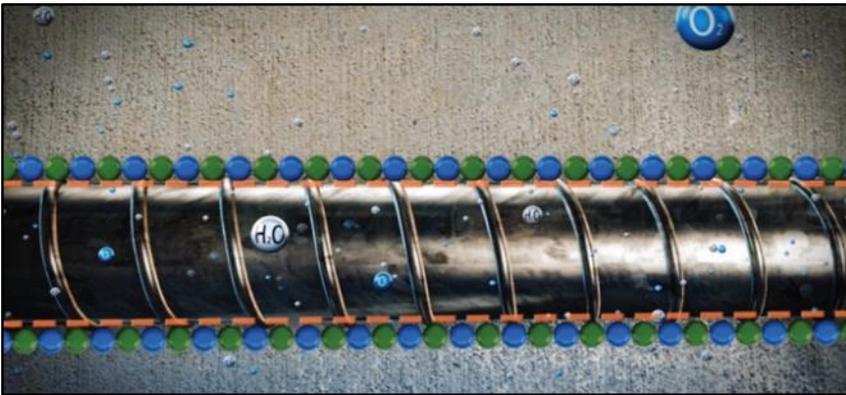
Migrating Corrosion Inhibitors form a protective layer on the surface of embedded steel reinforcement.

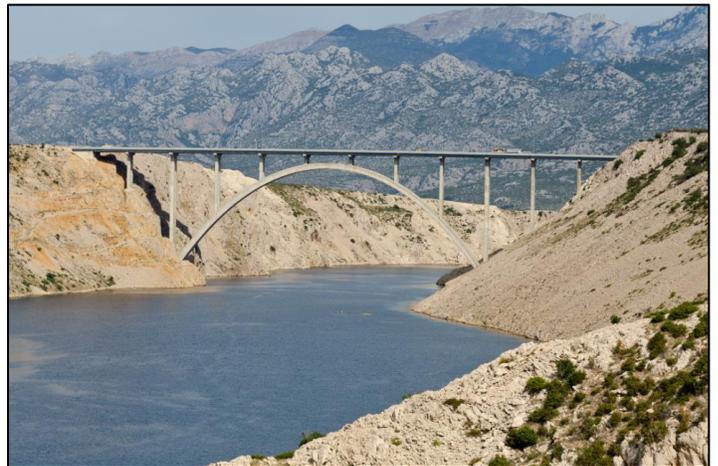
There are many cases of using Migrating Corrosion Inhibitor™ Technology in projects located in salty and corrosive environments around the world. Take, for example, the Maslenica Bridge in Croatia, one of the largest bridges of its type with an arc of 200 meters (218.7 yd) in diameter. Because of the aggressive environment of changing temperatures, constantly fluctuating humidity, and strong wind containing salt from seawater, reinforcing steel

to corrode, causing concrete spalling. To restore the bridge and prevent future corrosion from happening, all spalling concrete was water-blasted off, along with dirt and corrosion on the rebar. CorrVerter® MCI® Rust Primer was brushed on exposed rebar to passivate the metal from further corrosion, and MCI®-2020 was applied to the entire concrete structure using an airless sprayer to prevent any potential corrosion that was not apparent.

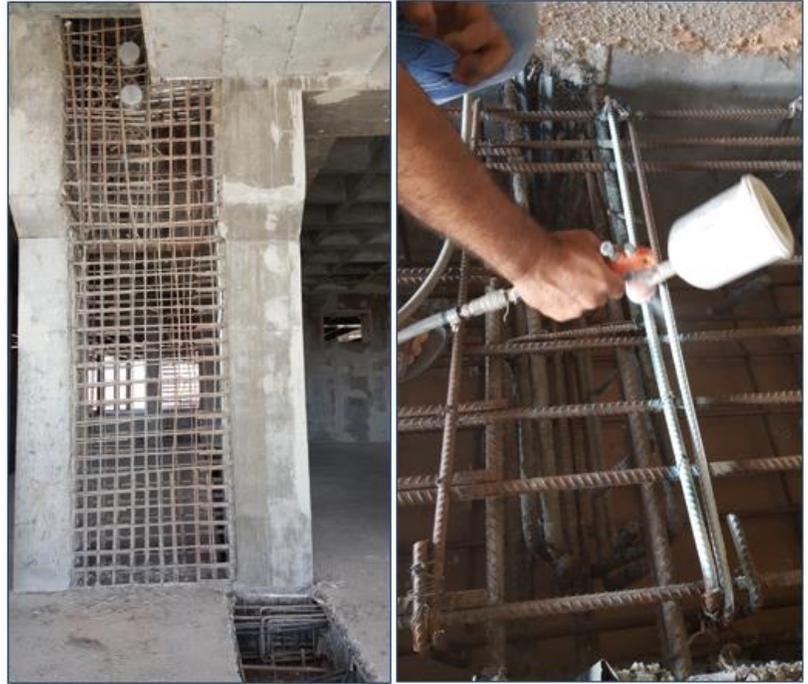
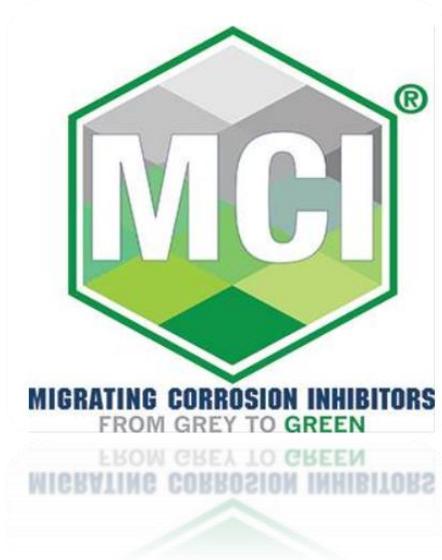
Another project was facing construction delays after the majority of concrete work had been completed. The main issue was corrosion on exposed rebars of a significant number of in-fill beams and expansion joints that needed protection from the corrosive environment during the delay. Two stages of protection were conducted: Rusted rebars were treated with CorrVerter® MCI® Rust Primer and MCI® CorShield® was then applied on all exposed reinforcement to provide the necessary outdoor exposure protection during the construction delays. This provided an economical and efficient solution to preserve exposed reinforcement and satisfied the requirements of all parties involved in the project.
