Chapter 6 Case Histories

6.1 New Construction

MIGRATORY CORROSION INHIBITOR (MCI®) PRODUCTS FOR CONCRETE

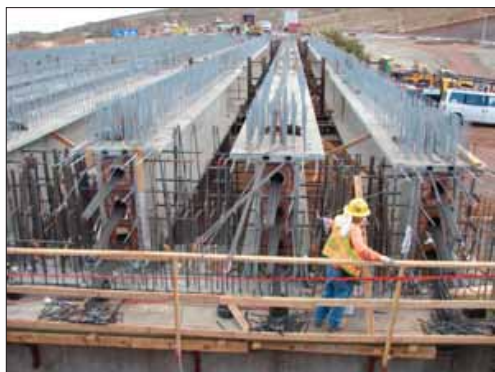
North-South Roadway Bridge Deck

New construction application: Post tensioned cables were shipped from the mainland with no corrosion protection and inserted into steel ducts in the girders of the bridge. Because they were to sit for a period of time before grouting, corrosion of strands was a concern. MCI®-309 was fogged into the ducts to provide temporary corrosion protection to the cables.

Due to the corrosive nature of the environment, MCI®-2005 NS was also added to the ready mix concrete placed for the new bridge deck, to extend the life expectancy of the structure. MCI® Mini Grenades were used in hand lay-up and mortars to exposed tie in reinforcing steel specifically at junction points in areas where direct pour of ready mix concrete was not feasible.

Long Term Protection of the Bridge Deck: MCI®-2005 NS was added to the ready mix concrete at the batch plant with the mixing water at a rate of 1.5 pt/yd³ (1 l/m³). MCI®-2005 NS does not change the setting time of the concrete or adversely affect any other properties of the mix. Unlike the calcium nitrite based corrosion inhibitor used on previous projects, MCI®-2005 NS did not increase shrinkage cracking of the deck.

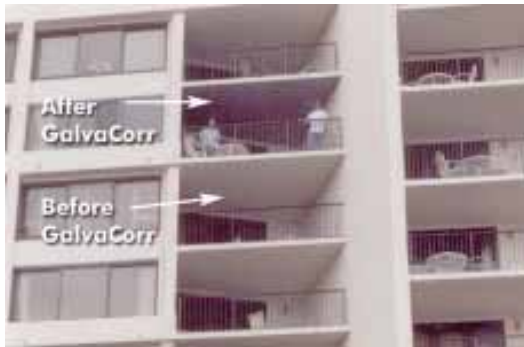
Beachfront Highrise Resort

Corrosion of embedded reinforcing steel was causing spalling of concrete on the walls, ceilings, and floors of balconies at this beach side resort.

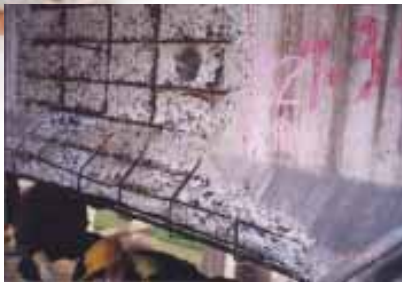
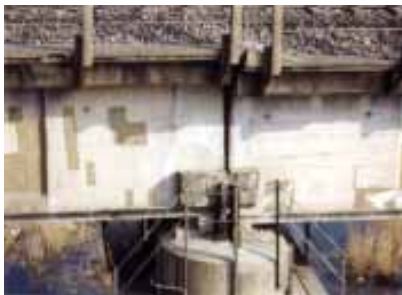
CHINA RAILROAD BRIDGE

Xuzhou Railroad Bridge, which is 1080 meters long with 108 arches, was built in the 1980's. Contamination of the concrete structure occurred over the years due to leaking of corrosive materials from trains. Corrosion of embedded reinforcement has led to deterioration of the structure. Inspections have shown that over 50% of the bridge is in an active state of corrosion, leaving the bridge owner with two choices: replace all of the beams and rebuild the bridge, or repair with new technology. After extensive research and evaluation, repairs using Cortec® Corporation's MCI® products were accepted. The repair project started in 1999 and continued thru 2002.

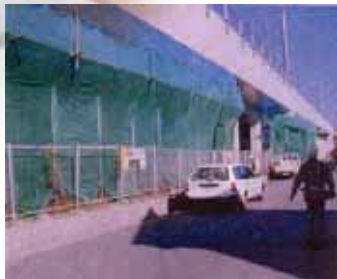
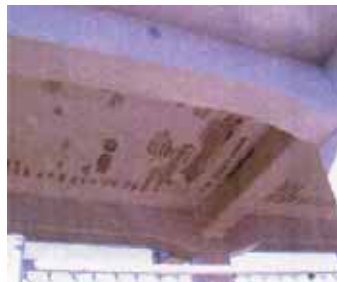
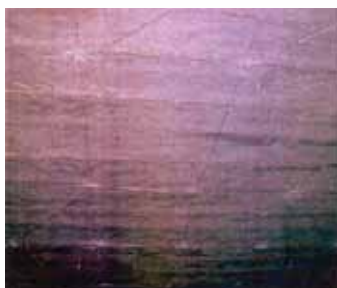
Seashore Sand (NaCl content is 2-3 kg/m³) was used in the concrete for construction of the bullet train bridges. Water to concrete ratios exceeded 70%, which created poor quality concrete. The structure exhibited numerous spalled areas with exposed corroded rebar. Not only did the spalled and corroded areas need repair, but they also needed to be protected from further corrosion.

The MCI® products selected for this project were:

- MCI®-2023: 32.90 kg
- MCI®-2020: 31.02 kg
- MCI®-2005: 3.69 kg
(mixed with Tough Ace Emulsion produced by LION Co.)

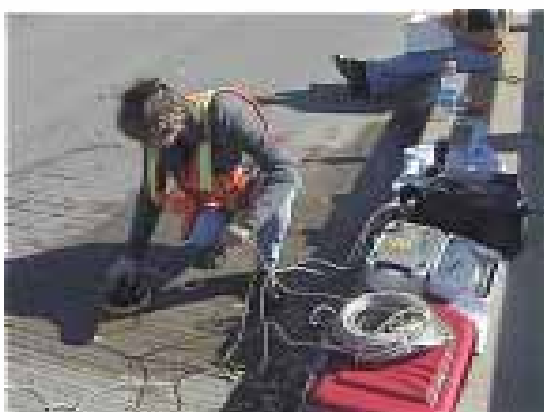
Randolph Avenue Bridge Restoration

The Randolph Avenue bridge deck was rehabilitated in 1986. This was a repair project involving a patch and overlay using low slump, dense concrete (LSDC). The original concrete was removed from the deck above the first layer of reinforcing steel and was milled to a depth of 0.5 inches (13 mm). The LSDC was used over the entire bridge deck. The concrete on the westbound lanes contained MCI[®]-2000, a corrosion inhibiting concrete admixture, dosed at 1 pint/yd³ (0.6 L/m³). The same concrete was used on the eastbound lanes, but without the Migrating Corrosion Inhibitor (MCI[®]). These eastbound lanes have served as a control for all chloride samples taken, and corrosion rate and half-cell potential readings performed since the repair was completed.

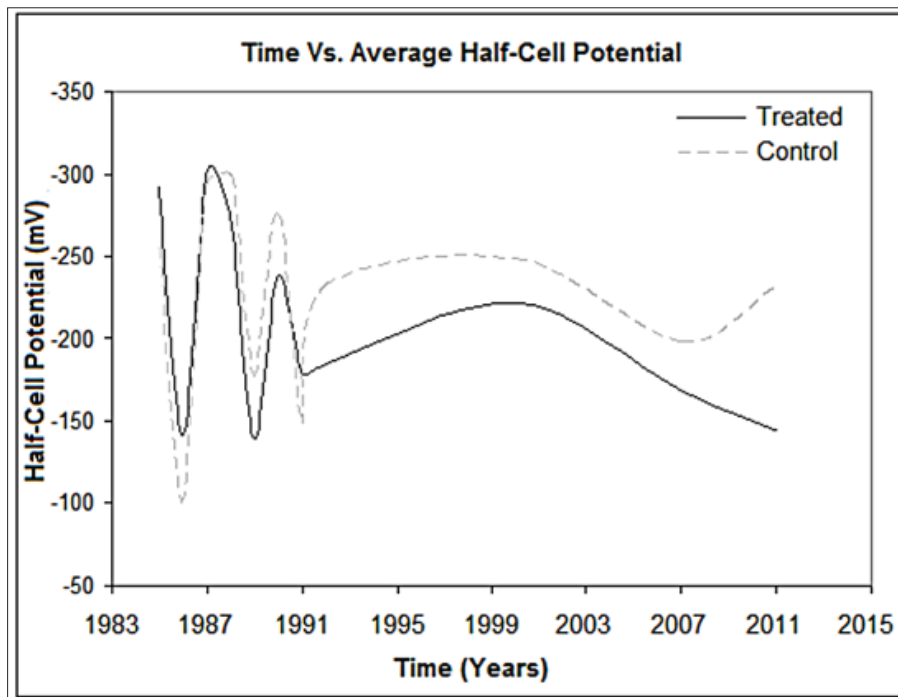
Figure 2: Average half-cell potentials of the Randolph Avenue Bridge

The time versus average half-cell potential results, shown in Figure 2, shows that the potential for corrosion within the bridge is higher on the control side and has been for 20 years. This data along with the rest of the supporting information suggests that levels of corrosion in the treated side are lower than in the control.

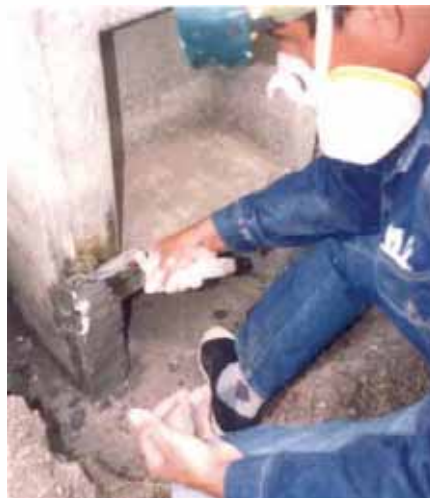
The electric transmission support poles are made of precast concrete. Years of exposure to chloride and carbonation attack caused concrete spalls and cracks on many of the poles. The spalling cracks compromised the ability of the poles to structurally support their loads. To compound the problem, the rural local of the poles made access difficult.

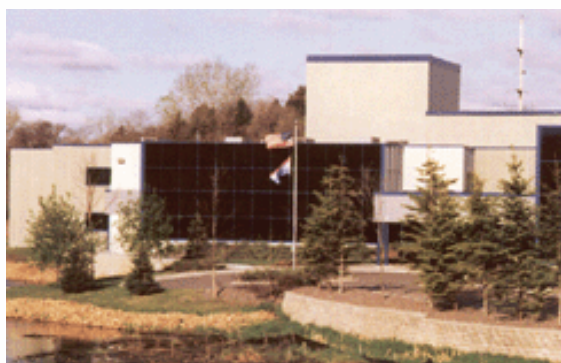
The chemical manufacturer had just completed an expansion, Phase 3, to their existing plant using masonry and precast concrete panels. The existing building was experiencing signs of weathering and rust stains had started to show on some precast panels where the rebars had insufficient concrete coverage. The problem was how to inhibit the corrosion, protect the building and tie the existing building and new addition together to be esthetically pleasing structure.

The entire structure was pressure washed to remove any dirt and dust. A 2-coat application of custom mixed colors (grey, tan, green, and blue) of VpCI®-386 was applied using an airless sprayer. VpCI®-386 was chosen because it is an environmentally friendly water-based coating that provides superior outdoor protection, corrosion inhibiting properties, ease of application and quick clean-up.

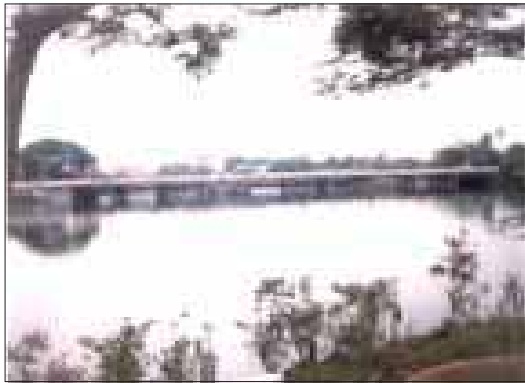
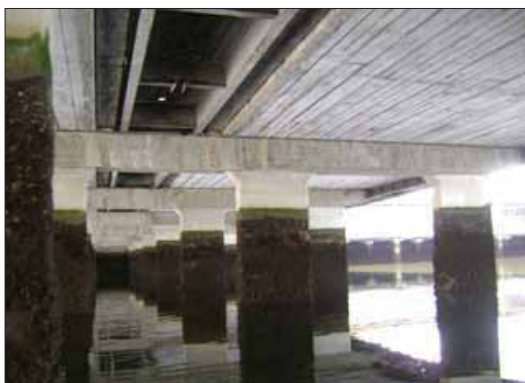
River Bridge Restoration

PROBLEMS
River Bridge "5 de Junio", located in the heart of Guayaquil City was built 30 years ago. Chlorides and carbonation attack had deteriorated the concrete and corroded the structural steel. The municipality needed an environmentally safe product to extend the life of the structure, protect the reinforcing steel, and allow the concrete to breathe.

APPLICATION
After sandblasting, VpCI®-365 was brush applied to the structural steel beams of the bridge. MCI®-2020 was then sprayed onto the concrete.

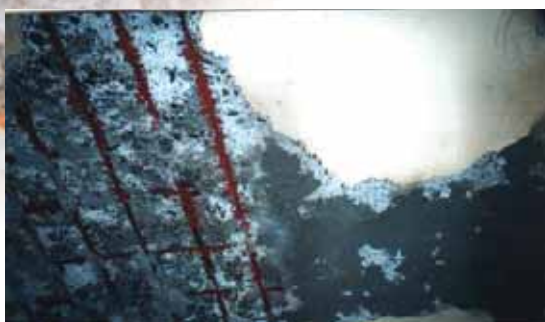
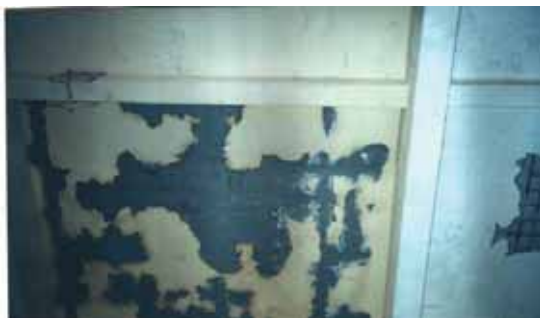
Concrete spalling due to rebar corrosion. This corrosion was due to hydrochloric acid fumes.

Spalled concrete along with dust and loose aggregates were removed. Corrverter was applied to rebar before the application of MCI® 2020. After the MCI® 2020 was applied MCI® 2038 Repair grout was used.

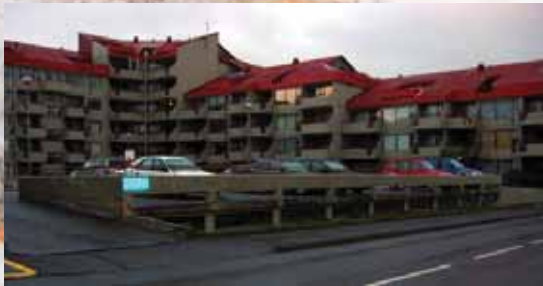
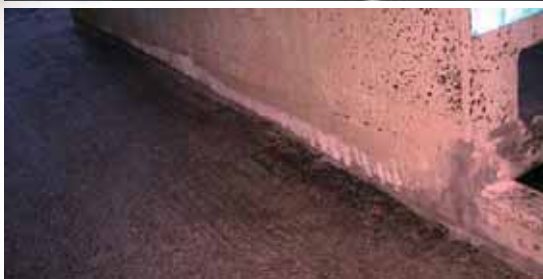
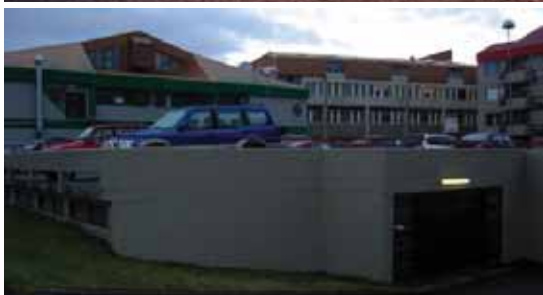
Water was leaking from an above ground parking lot into sublevel garages through cracks and faulty joints in the concrete.

1. The entire surface was pressure washed at 150 bar.
2. MCI®-2023 passivating grout was applied as a primer to joints and corners of the parking lot, followed by a top coating of MCI®-2038 finish repair mortar.
3. MCI®-2020, a water based, topically applied, migrating corrosion inhibitor, was sprayed over the entire surface and allowed to penetrate for three days.
4. After the three- day waiting period, the entire surface was again pressure washed at 150 bar.
5. MCI®-2022, a silane/siloxane based sealer containing migrating corrosion inhibitors, was sprayed over the entire surface.

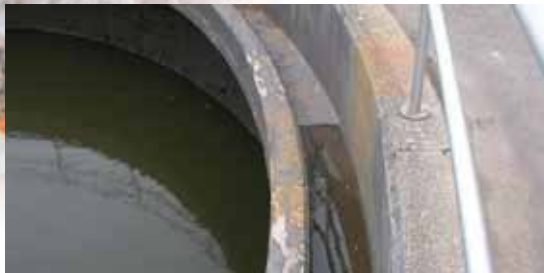
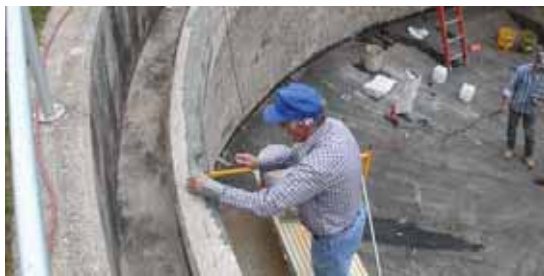
Tanks were originally constructed in 1939, and no repairs had been made in almost 20 years. Corroding and spalled areas, as well as exposed rebar had to be repaired.

Concrete was sandblasted and pressure washed. Exposed rebar was coated with MCI® 2023 and spalled areas were repaired with MCI® 2038. This was followed by an application of MCI® 2020 to the entire surface area of the tanks. After application of the Cortec® products, two coats of coal tar epoxy were applied.

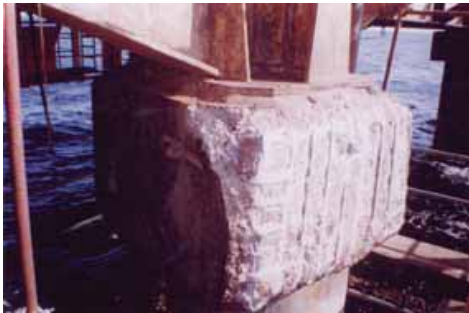
Structural Repairs to Trinmar Platform 15

Trinmar has extensive Offshore Oil Production in the Gulf of Paria in Trinidad and Tobago. Some of the production platforms are over thirty years old and chloride attack has caused extensive rebar corrosion to the piles and pile caps; resulting in spalling of the concrete.

1. Spalling concrete was hydroblasted at 20,000 psi.
2. VpCI®-611 was applied to protect against rebar flash rusting.
3. MCI®-2023 was applied to exposed rebars.
4. MCI®-2020 was sprayed on spalled areas.
5. A tie coat of MCI®-2039 was brush applied for adhesion.
6. MCI®-2039 was trowel applied in lifts of 2" and built up to 6" in some areas.
7. MCI®-2020 was then sprayed on entire surface.
8. After fourteen days, MCI®-2021 was sprayed on entire surface.

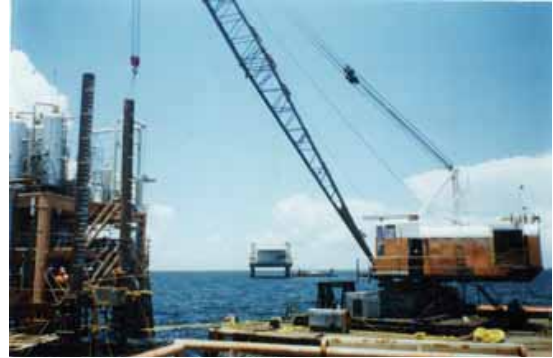
Piles being driven into the sea bed

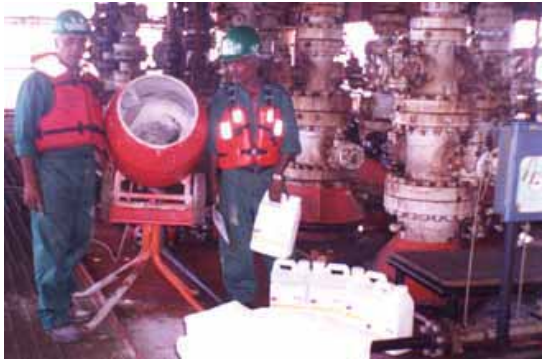
Mixer and MCI® - Repair materials

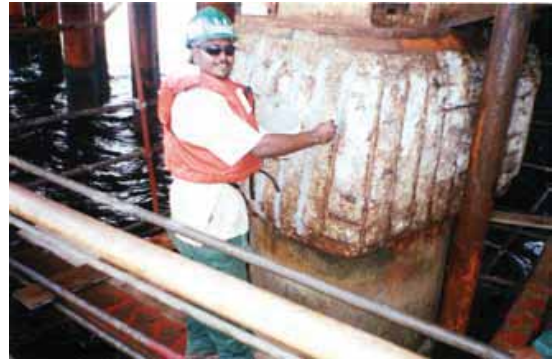
MCI®-2023 rebar coating applied on Pile-cap

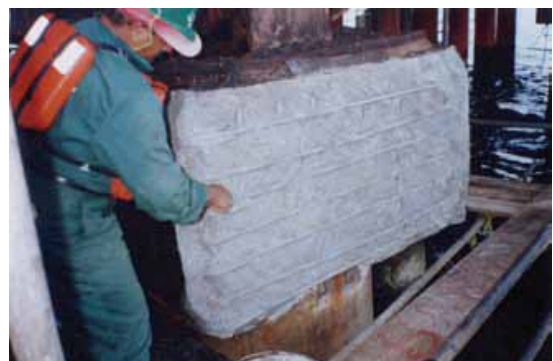
MCI® - 2039 Tie Coat

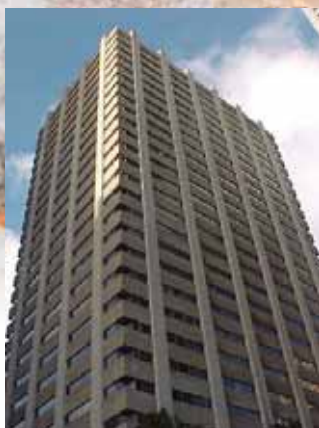
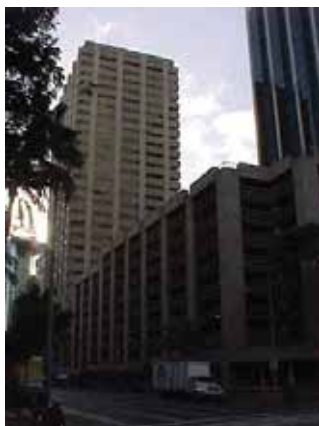
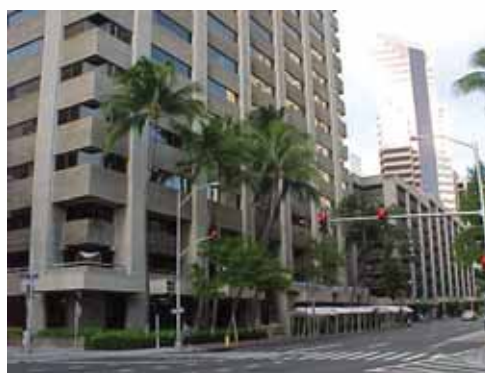
Carbonation and Spalling of Concrete

Carbonation and spalling of the concrete. MCI®-2020 containing a fugitive dye was sprayed on the entire structure including the parking garage. The structure has a bush hammered finish. This irregular finish acts to hold moisture, salt and volcanic emissions in the facade, leading to corrosion of embedded reinforcement. Since the project is located on a Pacific Island, a high degree of moisture laden trade winds strike the structure. In addition, over the last 10-12 years, Hawaii has experienced a high degree of volcanic activity which contributes to acid rain.

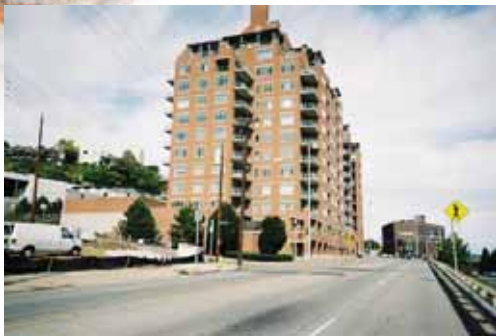
Repair of Condo Balconies

Condominium Complex needed their balconies repaired. Overhead patching and caulking was completed, and followed by a sealer treatment. The owner wanted a product that was a corrosion inhibitor and water repellent that could be applied in one step, so MCI-2019 was chosen

MCI®-2019 was applied as a water repellent containing Cortec's Migrating Corrosion Inhibitors

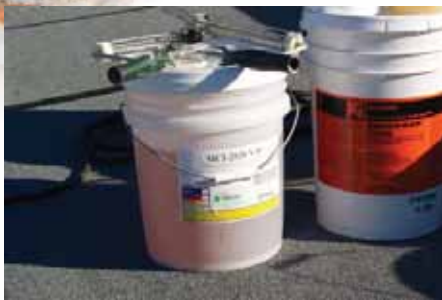
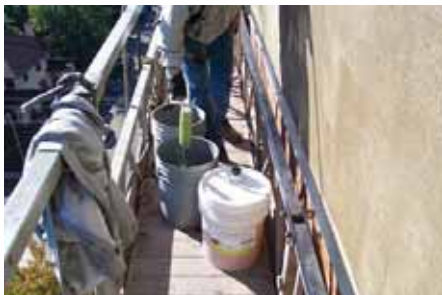
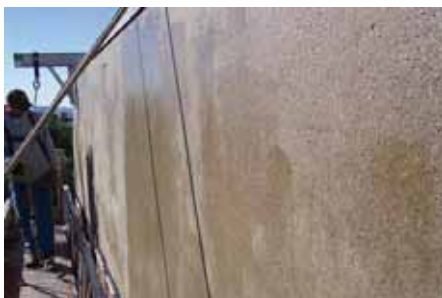
High Rise Building Restoration

Horizontal concrete precast at floor levels supports brick in fill. Lack of proper flashing details along with highly porous concrete is allowing water to enter matrix and interior.

All repairs have been proven successful. Cores were extracted and tested to prove migration of MCI®-2020 V/O

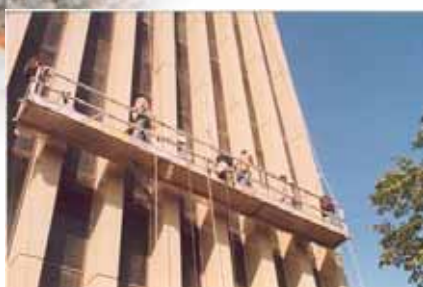
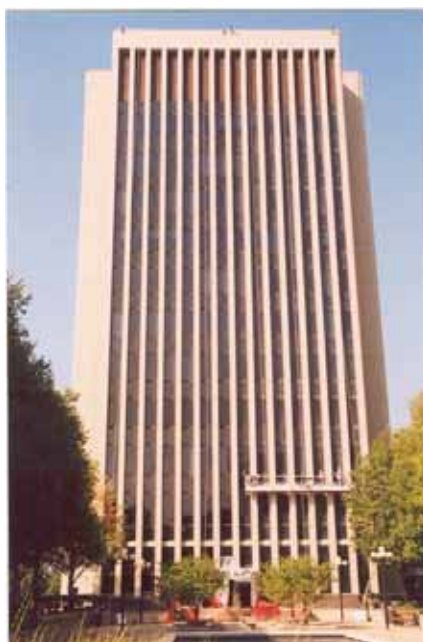
CASE HISTORY Restoration of Building Facade

First, the removal all loose concrete was done, then exposed steel was treated and patched with a polymer modified mortar. MCI®-2020 V/O was then applied. A block filler was then applied to close pores, followed by, two coats of an elastomeric coating.

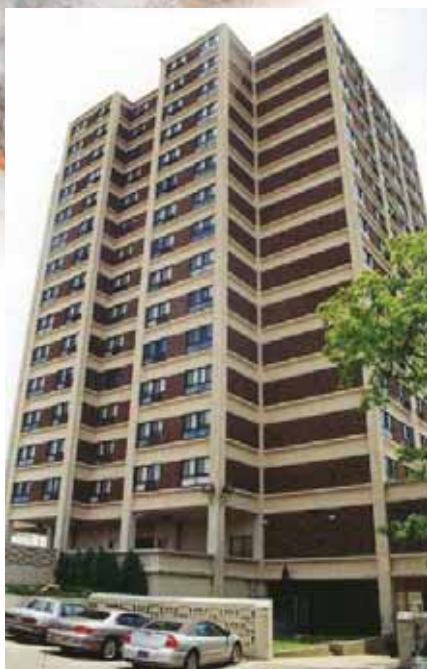
Restoration of Marquette Manor

The existing coating failed and was subsequently stripped off to absolute virgin concrete. All delaminations were patched with a polymer modified mortar. The structure was then treated with MCI®-2020 V/O and coated with an elastomeric coating.

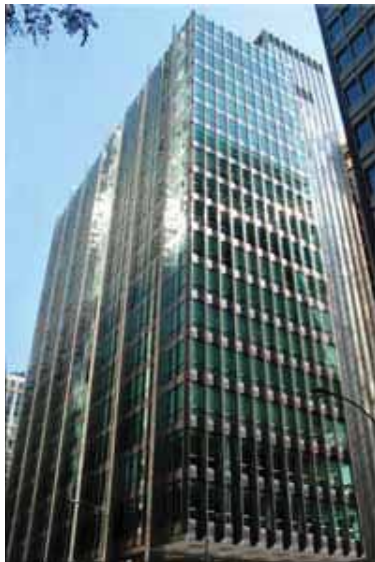
Inland Steel Headquarters is one of the original high rise buildings of the Chicago skyline located on the famous Monroe Street. Built between 1954-1958, it stands 332 feet high, (100.0m) having 19 floors with a surface area of 309,660 sq. ft. (28.618 sq. m.). The building is one of the National Registry of historic places, having been designed by the world renown architect, Lou Sullivan and appears in many architectural reviews as being a predecessor of the high rises of downtowns such as Chicago and New York.

CORTEC® Corporation was approached in 1983 by Dr. Robert Legault, one of Inland Steel's key corrosion scientists to assist in solving a corrosion problem with their headquarters building. The problem was attributed to a variety of factors, some of them influenced by the design (galvanic corrosion between structural steel and stainless steel "skin") and some of them caused by lake effect (humid conditions due to the proximity of Lake Michigan).

As a result of the joint effort between CORTEC's staff and Inland Steel's team, a unique system was devised to preserve the integrity of the building: MCI®-2020 has been injected in critical areas where the occurrence of corrosion was the greatest, in the order of magnitude 200+ Mils (4000 microns). The injection was accomplished using a high pressure portable sprayer on the locations around the perimeter of the building, from every second floor of the thirty-two floors. The

To document the success of the MCI®-2020 protection method, Inland Steel engineers have developed corrosion monitoring systems using atmospheric rate measurements on sites throughout the building. The late Dr. Legault was a world renown scientist in the field of atmospheric corrosion of metals and his results have shown that MCI®-2020 has almost completely stopped further corrosion of the structural steel and thus preserved the structural integrity of this historic building.

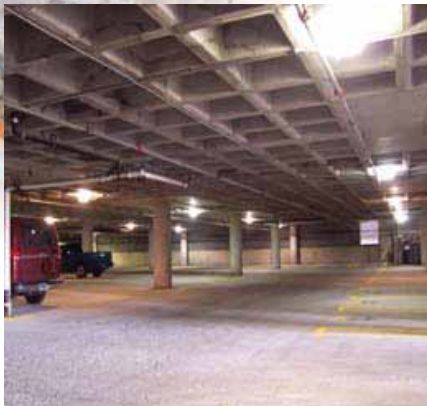
American Center Building

Improper drainage caused water contaminated with de-icing salts to pond and leak through cracks and defective expansion joints. Resulting corrosion caused damage to plaza concrete and structural concrete beams and columns.

Replaced defective expansion joints, repaired plaza and structural concrete. MCI® 2020 was applied on all areas where corrosion is anticipated, and installed membrane water proofing on plaza surface.

Due to the successful application of the MCI® 2020 on this structure since 1996, further damage has been minimized on areas treated with MCI® 2020, while areas repaired using other products are displaying corrosion damage. In 2006, the customer will proceed with repairing the parking deck ceiling using the MCI® systems approach.

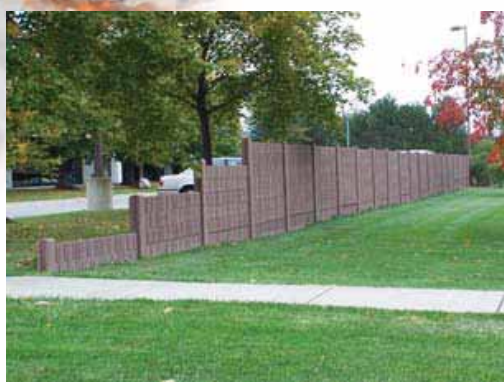
Cumberland Tech Center Masonry Screen Wall Restoration

Segmental precast concrete wall was under going significant damage from corrosion. Embedded reinforcement corroded, causing cracking and spalling throughout.

This screen wall was exposed to continuous moisture and road salts over many winter seasons. The chloride content in the wall is high and caused significant corrosion damage. Four years (winter cycles) after repair, evidence of continued corrosion damage is difficult to find.

Repaired spalled concrete units with Tamms Dural Top Gel. Injected cracks with epoxy resin, and applied MCI 2020 to both sides of the wall, followed by an application of Tammscoat, which is a decorative and protective coating.

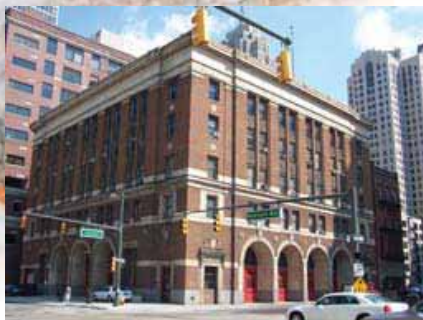
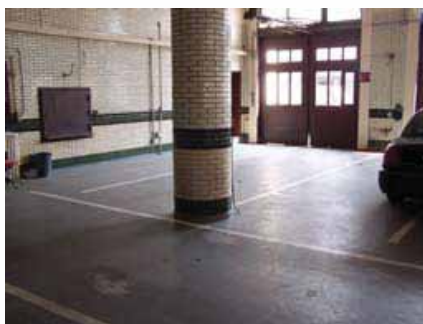
City of Detroit, Fire Station #6 Concrete Floor Restoration

Age & road salts resulted in significant deterioration of the street level supported floor slab used by the station fire trucks.

Removed damaged concrete and corroded reinforcement as required. Sandblasted surface and placed a conventional concrete mix containing MCI® 2000 admixture.

A December 2005 site visit indicated that MCI® 2000 is performing as anticipated, with no visible corrosion problems in the new station floor.

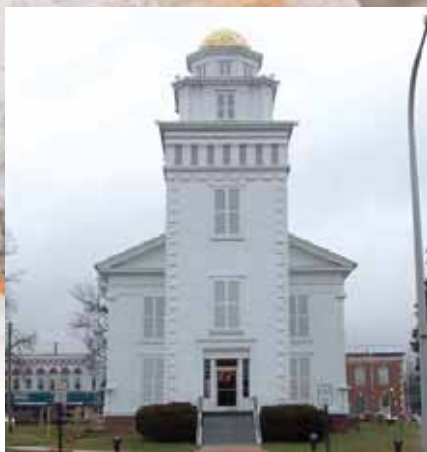
Lapeer County Courthouse Restoration

The mortar and brick were porous allowing the ingress of moisture and the effects of carbonation to damage the brickwork.

The restoration included the application of a masonry coating after the repair and sealing of the exterior walls. The application of MCI 2021 with the coating application have provided an effective method to restore the building to date, based on a January 2006 site visit.

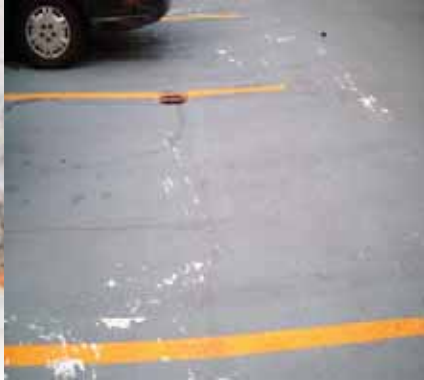
Washtenaw County Courthouse Parking Deck Restoration

Significant damage of the floor slabs due to corrosion of reinforcing steel.

A systems approach to inhibit corrosion with MCI products was used in the repair plan. After removal of the delaminated concrete surface, MCI 2020 was sprayed on the concrete substrate to migrate to the reinforcing steel, which was still embedded in chloride contaminated concrete. MCI 2000 admixture was added to the repair concrete mix to provide corrosion protection to the steel mesh in lieu of epoxy coated reinforcing, providing a significant cost savings to the owner. Upon completion of all work the new surface was sprayed with MCI 2021 to seal and densify the surface while also providing additional MCI corrosion inhibiting action.

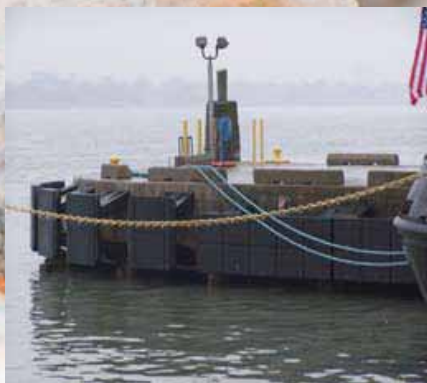
United States Coast Guard Base, Detroit Concrete Pier Repair - Reconstruction

The primary reason for the pier repair was due to impact by ships, with the secondary reasons being age and corrosion. At least two previous repairs did not hold up.

The plastic and hardened physical characteristics of the concrete with MCI® 2005 NS were all very satisfactory. High strengths were achieved with no cracking indicated 30 days after placement.

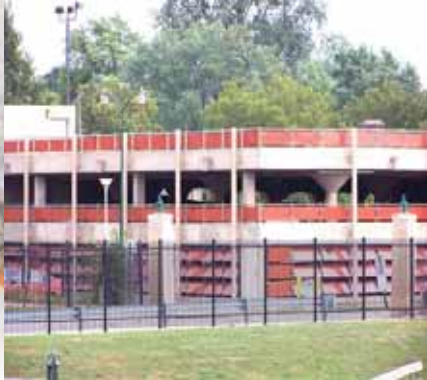
Riverhouse Co-Op Apartment Parking Structure Restoration

The first supported level of the parking deck suffered extreme corrosion damage due to heavy exposure to road salt and improper drainage. Damage to the structural slab extending up to 5" in depth, well beyond the top layer of rebar.

The deck was inspected in December of 2005 and showed little sign of any problems on the level repaired with MCI 2000. The engineer and contractor responsible for the repair of the second supported level in winter of 2005 resisted attempts to use MCI. DCI was used in the mix design, and less than a year later heavy cracking has occurred.

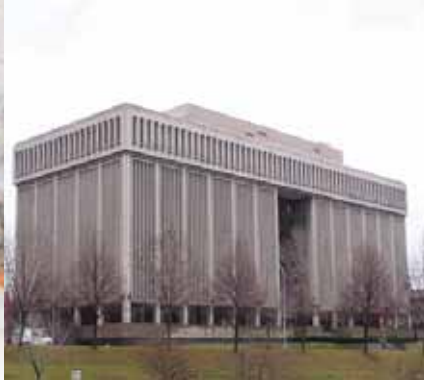
Macomb County Courthouse Restoration

Corrosion of embedded reinforcement due to the inadequate concrete cover led to the damage on the precast concrete façade. The damage was particularly great at the cornice and on the upper portions of the building.

Deteriorated areas of concrete were removed to sound concrete. The areas were prepared with shotblasting and were then treated with MCI 2020. Patches were done using a cement based repair mortar containing MCI inhibitors.

A January 2006 inspection of the site showed that the repairs were intact and there was no visual evidence of corrosion or other problems.

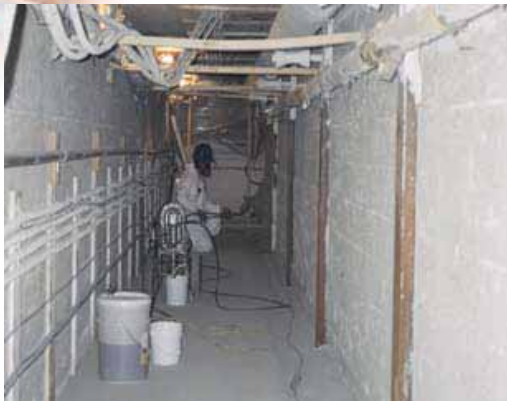
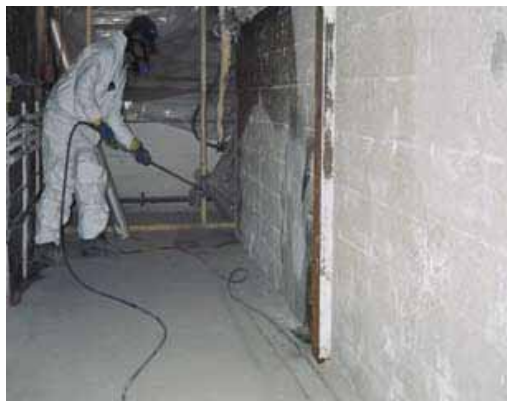
MCI® 2020 V/O

Corrosion of rebar in steam services tunnels.

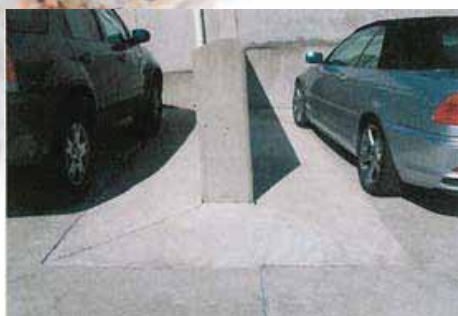
Parking Structure Concrete Repair

The precast, pre-topped, twin tee concrete parking structure was completed in 2001. Many areas of the cast-in-place concrete were found to be of poor quality as the result of large air void content, a high water/cement ratio of up to 0.53, carbonated surface to 5.8" deep, and poor compressive strength of 2,500 to 3,800 psi. Significant deterioration had taken place in a very short period of time, including extensive corrosion of the reinforcement, particularly on the top level. Also, as a result of the high permeability of the porous concrete, chlorides (de-icing compounds) penetrated the cast-in-place concrete and contaminated the precast in which it had contact, resulting in corrosion of the precast reinforcement.

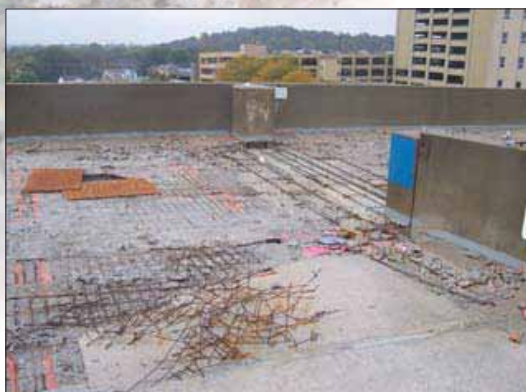
Miami Valley Hospital Garage Restoration

Miami Valley Hospital Garage is a pre-topped, precast, double tee garage. The top level had an existing membrane, which was removed. The underlying precast double tees had advanced corrosion which led to full depth concrete slab repairs being needed.

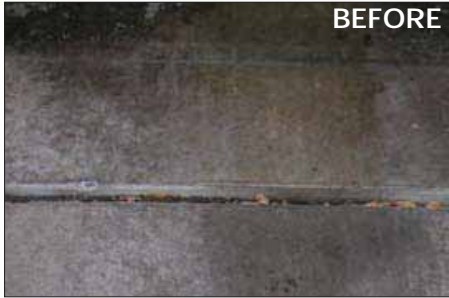
BEFORE

The customer's concrete floors were regularly being stained with automotive fluids and oil.

MCI®-2061 mixed with water was applied to half of the stained concrete by pouring and brushing on the surface, allowing it to stand for 20 minutes, and then the area was brushed with a broom for 30 seconds. The solution was then sprayed off with a hose, and excess water was removed with a squeegee.

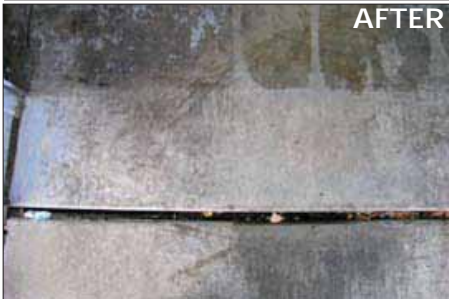
AFTER

MCI®-2061 is an environmentally friendly alternative that eliminates the need for harsh solvent-based and alkaline cleaners. It solved the customer's problem by removing the stains and improving the appearance of the concrete it cleaned.

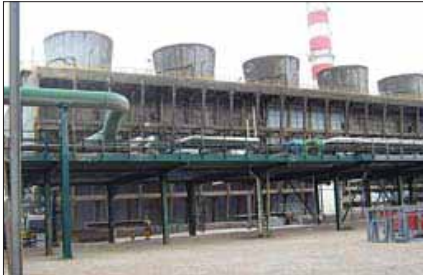
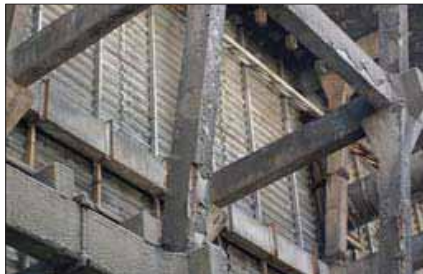
Rehabilitation of the Cooling Tower for Repsol YPF-Tarragona Refinery

The deterioration of a concrete cooling tower at the Repsol YPF Refinery had occurred from the aggressive environment; which included heavy thermal gradients and constant humidity changes. Spalling of the concrete occurred due to generalized corrosion on the reinforcing steel. The corrosion also affected the strength of the rebar and caused a decrease in the tower's structural integrity. In addition to the evident damage, the goal was to passivate any potential corrosion that was not yet visible.

In order to make the repairs needed to the damaged areas, the following steps were taken:

- Using a very high pressure sprayer (35,000 psi), the spalling concrete and corrosion were removed.
- Q-2023 grout (equivalent to MCI®-2023) was applied to passivate corrosion on the rebar.
- Q-2039 T, a polymeric mortar similar to MCI®-2039, was used to return the concrete structure to its original shape.
- MCI®-2020 was applied to the entire structure using an airless sprayer at the recommended dosage rate.
- Carbon fiber reinforcement, followed by an acrylic, anti-carbonation coating (similar to MCI® Architectural Coating) was applied to restore the structural integrity of the main support beams for the ventilation chimneys.

Cortec's MCI®-2020 was applied to over 2,000 linear meters of concrete pillars along with over 5,000 linear meters of concrete beams in the building. About 1,500 m² of concrete slab was repaired using Quimilock's mortar followed by Cortec's MCI®-2020.

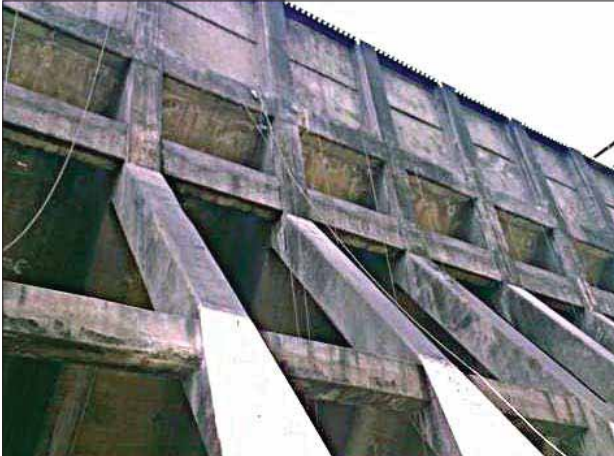
Kriel Power Station Repair

The Coal Staitths at Kriel Power Station needed to be repaired and then coated in order to prolong the lifespan of the structures.

Defective concrete was removed and replaced with repair mortars containing MCI-2006 NS. The corrosion inhibitor was added to the repair mortar mixes prior to application to add corrosion protection to the reinforcement within, and surrounding the patch. After all patchwork was completed, both of the structures were then coated with MCI-2020 to ensure corrosion rate reduction on the rest of the embedded reinforcement.

*More specifically, two repair mortars, Pro-Struct 528 VO MCI® +- 12m³ and Pro-Struct 531 MCI® +- 1.5m³, containing MCI® -2006 NS and a surface applied product, Pro-Struct MCI® -2020 +- 2750 Lt, containing MCI® -2020.

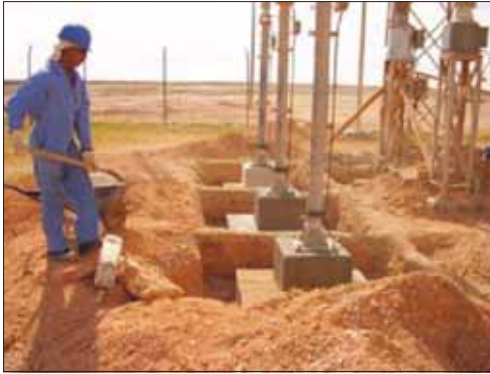
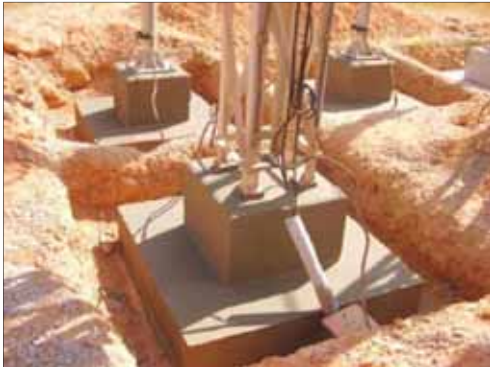
Runib Switchyard Foundation Repair

The concrete foundations at PDO's Runib Switchyard were experiencing visible cracking, spalling, and delamination. The structures were over twenty years old, with repairs made in 2002 - some of which had already failed again. The main threat to the structural integrity of buildings in this region lies in the highly saline soil and shallow groundwater. The prevalence of Sabkha in the Gulf region introduces highly corrosive mineral deposits in the soil with salinity levels exceeding three times that in seawater.

A field investigation was done by United Corrosion Technologies to determine the cause of the failure and it was confirmed that failure was due to the ingress of chlorides from the soil. A repair methodology was developed to prevent structural failures, extend the switchyards service life, and allow for safe application in the live station.

1. The foundations were excavated to allow for chiseling of all spalled and delaminated concrete.
2. Cortec's MCI® 2020 was applied to all exposed concrete surfaces, and CorrVerter® was applied to all exposed rebar. CorrVerter® was selected because it can be applied directly to rusted steel, avoiding the use of abrasive blasting which was not permitted in the live Switchyard.
3. Shuttering and repair with Unicrete 500 microconcrete reinforced with MCI® Mini-Grenades.
4. The repair was allowed to cure and a waterproofing agent was applied.

It was estimated that concrete foundations were given an extended service life of 30 years after the repair. This extended service life is derived from the proper execution of repair utilizing patented MCI® technology. Cortec's patented MCI® technology protects reinforcing metal in concrete from corrosion therefore extending its service life. Being bio-based, it is environmentally friendly and safe. It is NSF-61 certified for use with potable water.

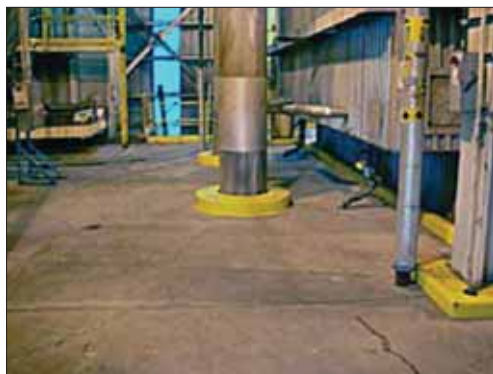
Northwest Paper Mill Recovery Boiler Concrete Slab Replacement

A paper mill, located in the Pacific Northwest region of the United States, was experiencing corrosion from sulphur dioxide gas, SO₂. Concrete was in danger of falling 25 feet between deck levels. Concrete curbs were severely deteriorated and drainage needed to be re-sloped. Wall cladding would be difficult to remove because it was transite, a combination of asbestos and cement. Therefore, the customer determined that the anchoring needed to stay.

MCI® 2005 AL was used as an admixture in all of the concrete to protect against SO₂ corrosion and the ring anode effect at the transite anchors.

Cortec® products provided a solution to the customer where they were able to repair the concrete slabs and they did not need to disturb the asbestos cladding.

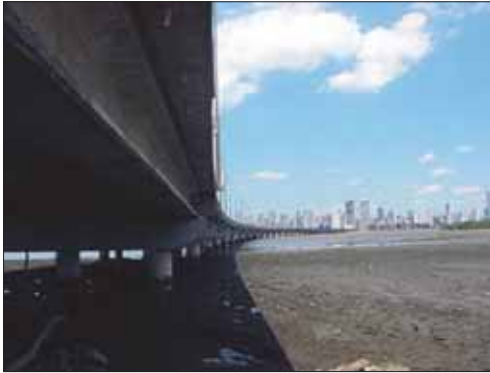
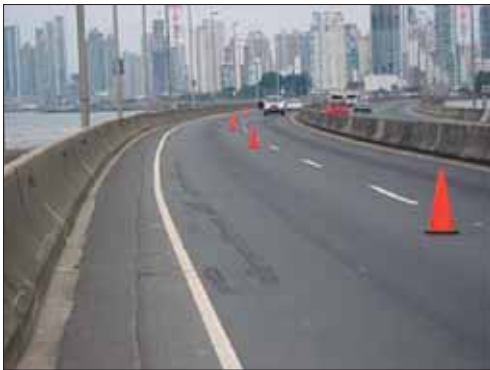
Repair of Corredor Sur-Tramo Marino Bridge

PROBLEM
The precast beams of the Corredor Sur-Tramo Marino bridge were showing signs of corrosion from 10 years of exposure to the extreme surrounding environment. The bridge had to be repaired and protected from future corrosion problems.

APPLICATION
The concrete beams were cleaned and prepared. All spalls and areas where corrosion was evident were chipped out. Rebar was exposed and rust was removed mechanically; in some places the rebar was replaced. Two coats of MCI® 2023 were applied on the exposed rebar, a repair mortar was used to patch the spalled areas, and a single coat of MCI® 2020 V/O was applied to the beams. Finally, the beams were painted with an epoxy protective coating.

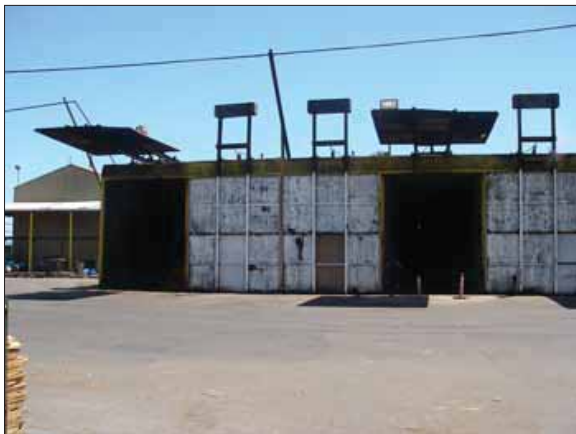
PROBLEM
Steam vats that process logs into lumber had severe concrete deterioration. The customer was considering tearing them down.

APPLICATION
The corroded concrete was removed, and the surfaces were treated with MCI®-2020. The rebar was coated with MCI®-2023. Spalled areas were patched with MCI®-2702. The contractor then epoxy injected structural cracks and coated the interior for chemical resistance and to brighten the spaces.

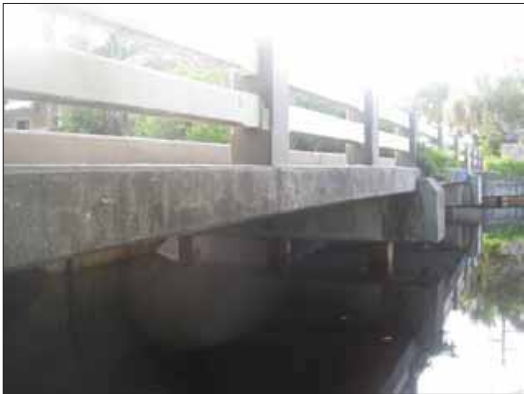
The bridge was spanning a salt water canal which exposed it to severe elements. Corrosion of reinforcement led to deterioration and spalling of the underside. Tidal changes in the area required the repair to be timed with the tide levels.

At low tide the dirt, grime, and loose concrete was removed. Then MCI®-2023 was applied by brush to all exposed rebar and damaged areas. The next day a second coat of MCI®-2023 was applied just before applying MCI®-2039 repair mortar. After curing the repair mortar MCI®-2020 V/O was applied to the underside of the bridge.

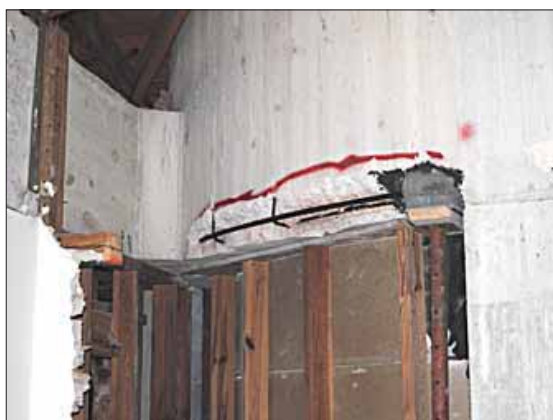
BEFORE

A multi-million dollar waterfront residence built in 1940 and located in Fort Lauderdale was experiencing severe concrete deterioration from:

Because of the extent of the spalling, some columns and beams were deemed too deteriorated and were replaced. Crews then followed ICRI Guidelines for making structural repairs using VpCI®-422 to clean the rebar, VpCI®-415 to neutralize, MCI®-2246 bonding agent and a modified repair mortar. MCI®-2020 V/O was then applied to all concrete grade beams, tie beams, and columns.

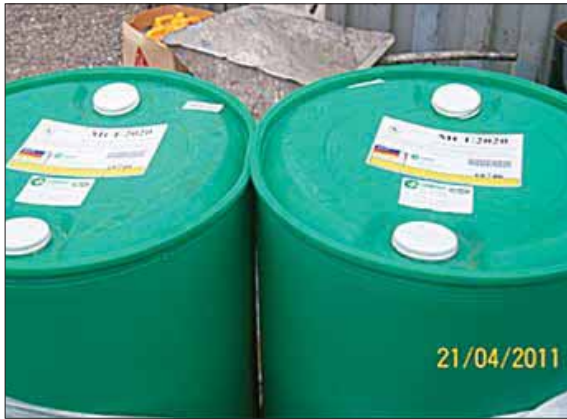
Drums of MCI®-2020 waiting application

MCI®-2020 was chosen over the competitor product (Ferrogard 903) due to its superior corrosion protection, better coverage rate with fewer required coats, and ANSI-certification.

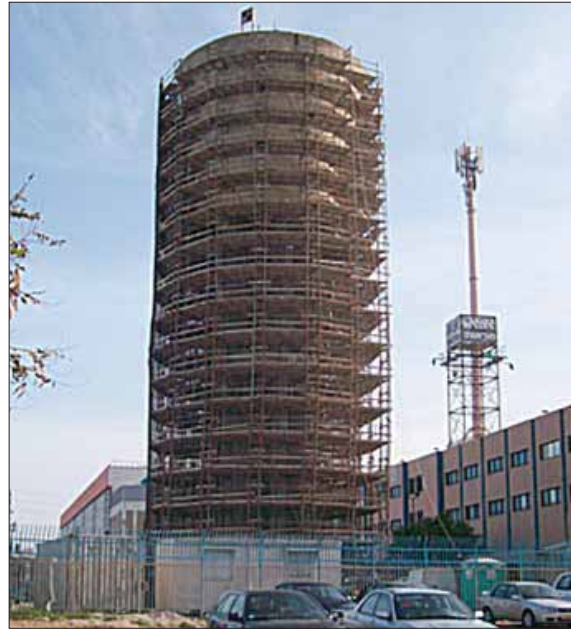
The 40 year old water tower developed cracking due to corrosion and leaks necessitating repair.

Holot Tower during restoration

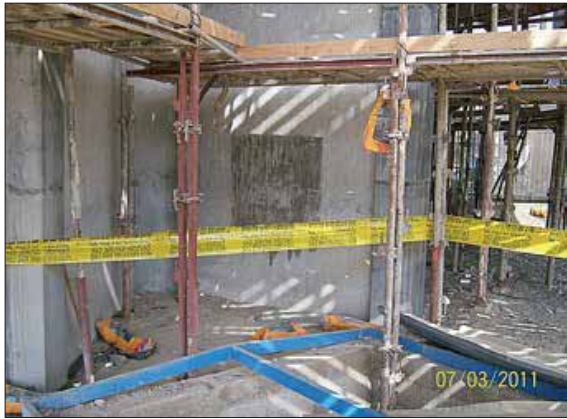
Demonstrating MCI®-2020 application on 1 Square Meter

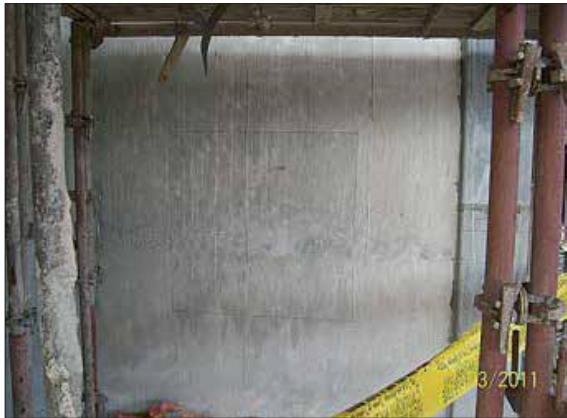
MCI®-2020 demonstration two weeks from application - almost undetectable

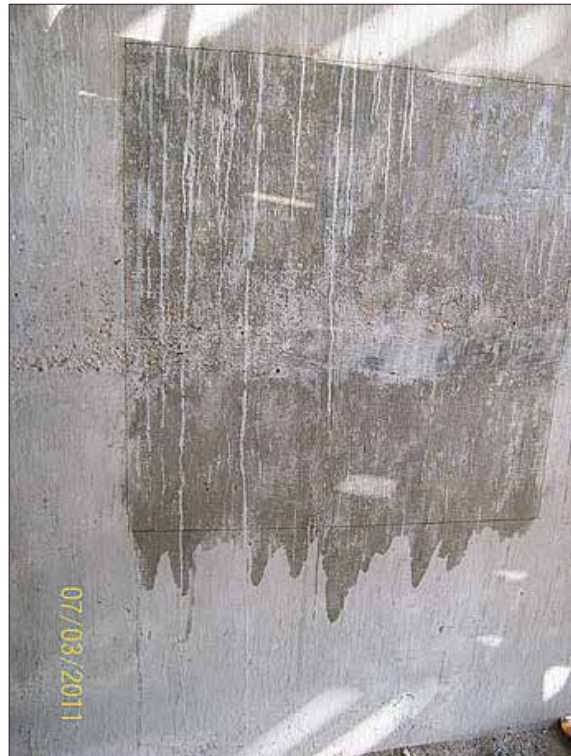
Demonstrating MCI®-2020 application on 1 square meter

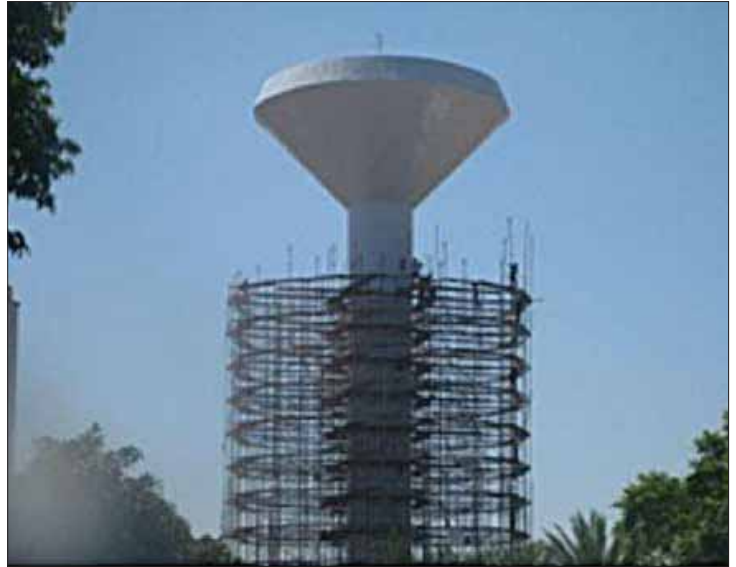
South Tower during application.

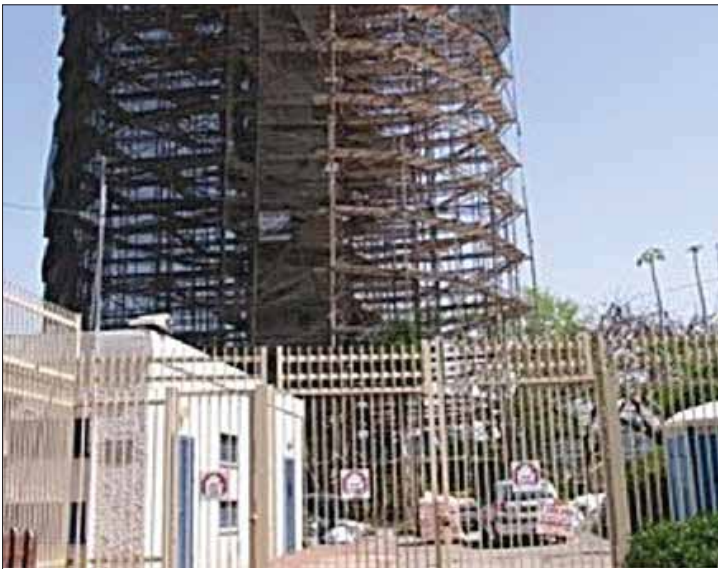
South Tower during application.

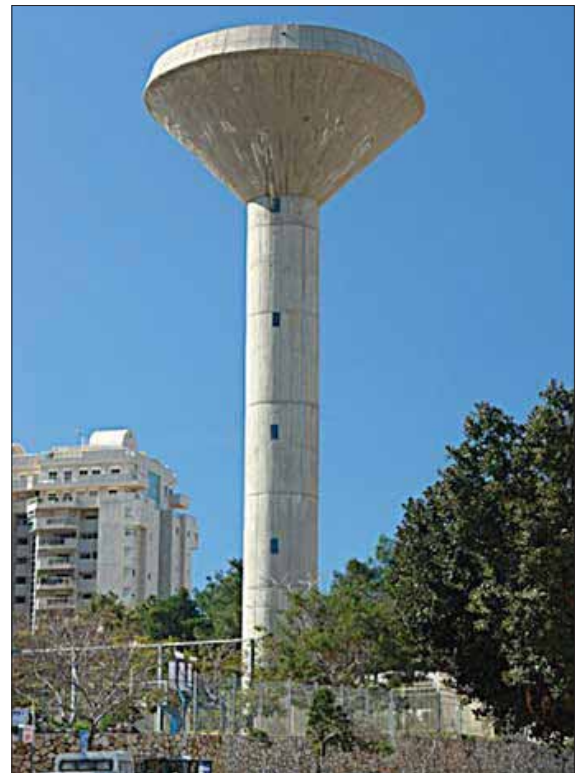
This 25 year old water tower developed corrosion cracking, spalling and water leaks necessitating repair.

South Tower prior to application.

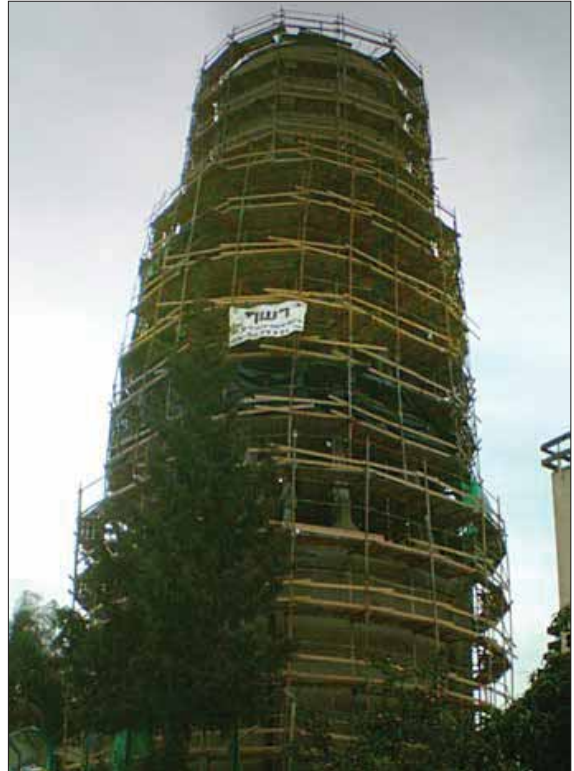
This 50 year old water tower developed corrosion cracking, spalling and water leaks necessitating repair.

Ha'alia Hashnia Tower during preservation.

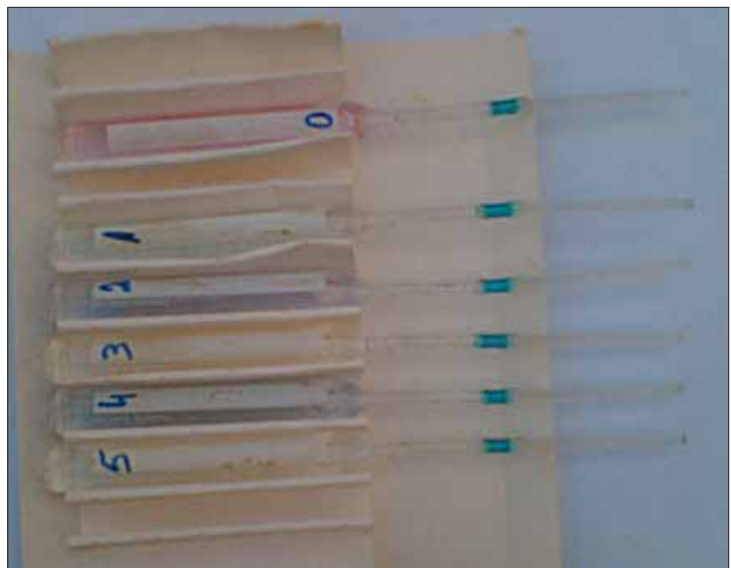
Tests of MCI[®]-2020 3 months after application: 5 concrete samples were taken from various locations on the tower. Vial marked 0 is reference de-ionized water. It was deduced that insufficient MCI[®]-2020 amount was applied at locations 1, 3, & 5, which were re-applied.
