Chapter 6 Case Histories

6.1 New Construction

MIGRATORY CORROSION INHIBITOR (MCI®) PRODUCTS FOR CONCRETE

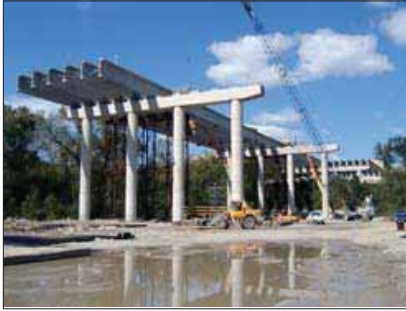
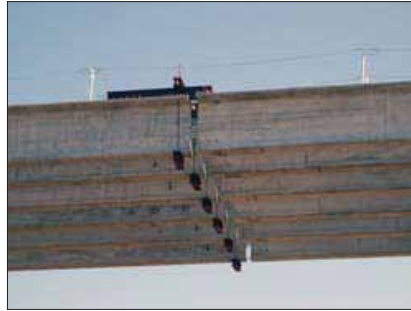
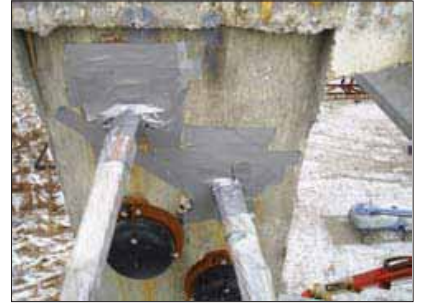
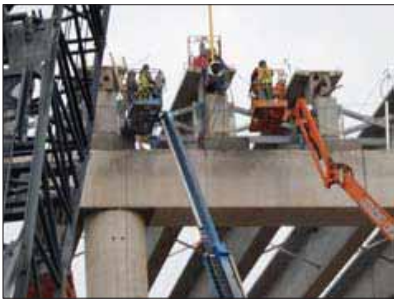
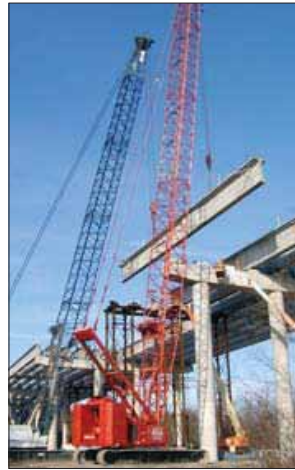
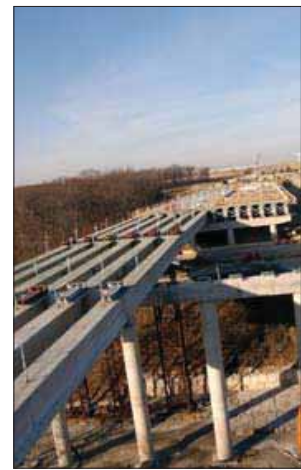
Figure 1

P.T. ducts were filled with MCI® 309 in November 2006. In April 2007, an independent test lab pulled out 1/2 (440 feet/134 meters) of the strand to see if it had corroded due to moisture in the duct. It looked as good as the day it was installed (See Figures 1, 2, and 3).

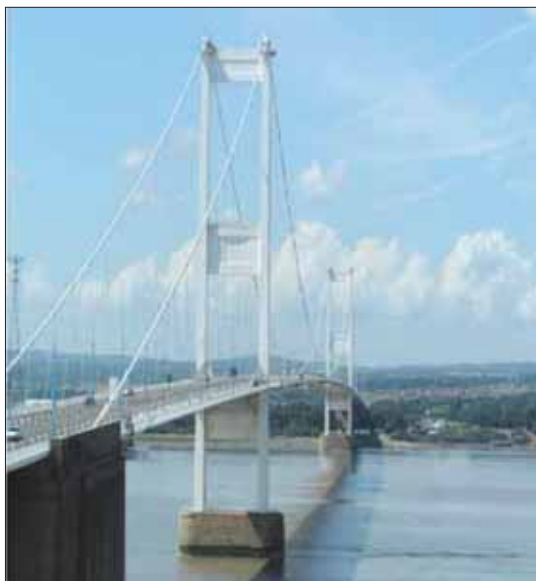
The suspension cables on this type of bridge are known to corrode over a long period of time. The 20 inch (508 mm) diameter main cable is constructed from 8322 high tensile galvanized steel wires of 0.196 inches (4.98 mm) in diameter. The total area of the cable is 314 in² (202,580 mm²) of which approximately 20% is comprised of voids. The cable is wrapped in 0.144 inch (3.66 mm) mild steel galvanized wire. Dehumidification is used to reduce the level of moisture around the cables.

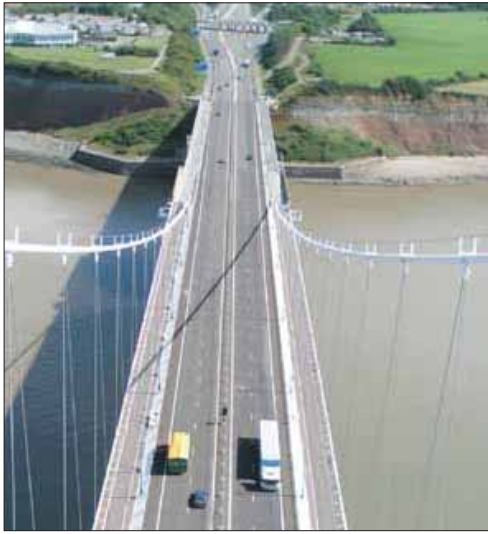
A simple hatch and crate system that is a part of the main dehumidification pipework was developed. This allowed the inhibitor to be put into the airflow without disrupting the system when the product needed to be changed out. Five (5) PTC Emitters per unit are placed into a basket inside the crate with no special separation or spacing of the individual emitters being required. The dosage rate of 5 PTC Emitters per 10 injection sleeve inputs per month was determined by Mott MacDonald/Lake Chemicals.
