Protecting the unseen.

Julie Holmquist, Cortec® Corporation, and
Tim Whited, MESA, USA, explore mitigating
corrosion on cased pipeline crossings.

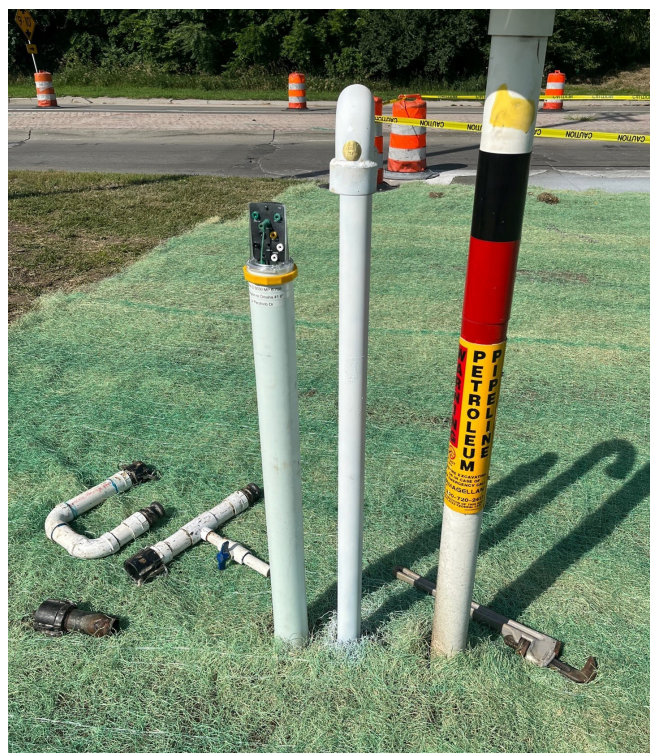
Figure 3. The centre pipe is the ventilation duct to the pipeline casing buried underground at this pipeline crossing. A similar vent on the 'low side' (ventilation to the bottom of the pipe) is where CorroLogic VpCI Gel application is ideal. The left pole is where the electrical potential can be measured to determine CP condition. (Source: Cortec, courtesy of Eric Uutala)

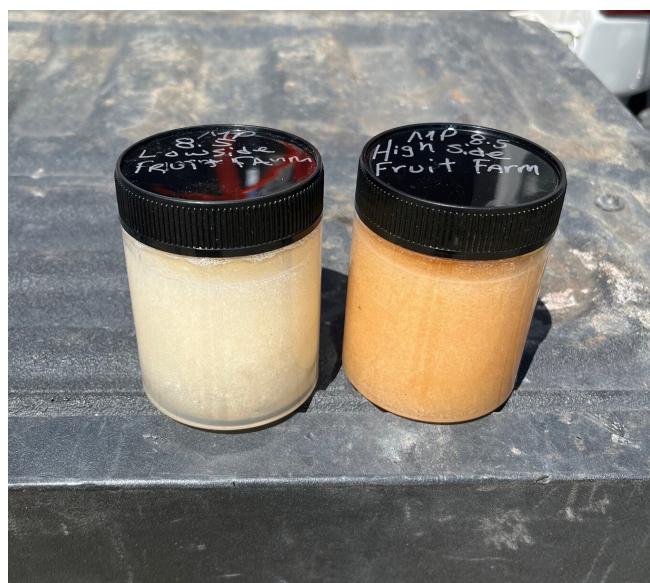
Figure 4. CorroLogic VpCI Gel is pumped through the filler pipe into the lower portion of the casing until it can be detected coming out the other side. Inevitably, it often picks up some of the debris contaminating the inside of the casing, which is why the right sample is darker than the left one. (Source: Cortec, courtesy of Eric Uutala)

Cortec's CorroLogic VpCI Filler technology was developed in response to these needs and was patented several years later. The gel filler is comprised of two parts that are mixed onsite. The product is intended to gel at the last moment so it forms a soft, viscous substance within the casing annular space. Vapour phase Corrosion Inhibitors diffused throughout the gel form a protective molecular layer on all metal surfaces in direct contact with the gel. They also have the ability to migrate in vapour form to areas that are difficult to reach – hence the potential for them to find their way under disbonded coatings and adsorb onto the metal at coating holidays. In 2014, the basic technology was described and included in the NACE Standard SP0200-2014 for steel-cased pipeline practices.¹⁰ The technology also falls within PHMSA requirements for acceptable alternatives to addressing shorted carrier pipes when it is not practical to clear the short using isolation.¹¹

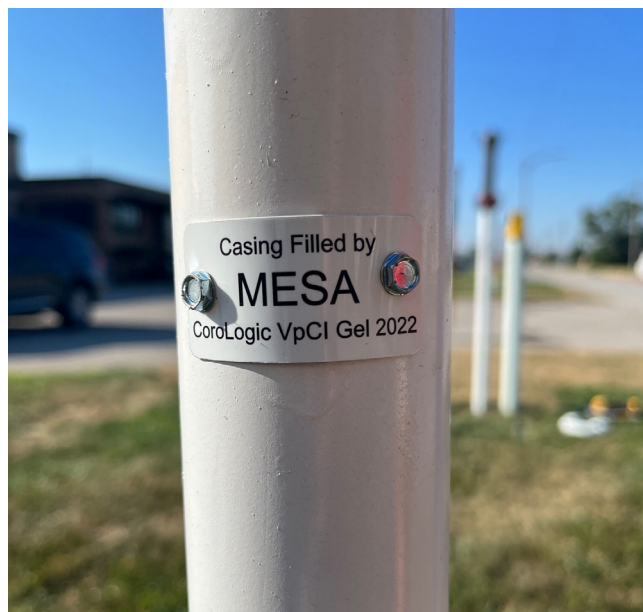
Figure 5. Sign on cased pipeline crossing vent indicates when the casing was protected by MESA. (Source: Cortec, courtesy of Eric Uutala)
