New Severn Bridge Article References use of Vapor phase Inhibitors for Corrosion Control!

CUTTING OUT CORROSION

REMEDIAL WORK IS GIVING THE SEVERN BRIDGE SUSPENSION CABLES A NEW LEASE OF LIFE

Suspension Cable Protection

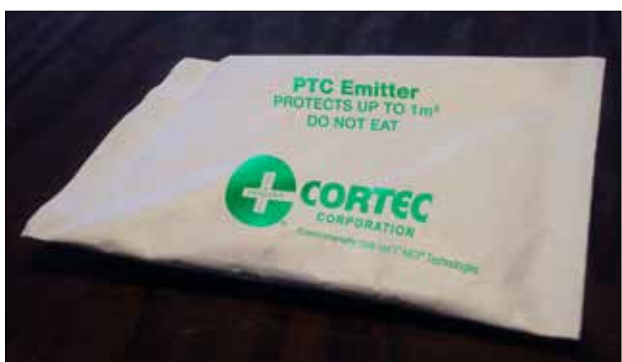
Since fogging of VpCI® powder or water based inhibitor was not acceptable to the project owner, a new system was created by packaging VpCI® in breathable pouches. These new PTC Emitters were to be placed by fives in each of the simple hatch and crate system units that were part of the main dehumidification pipework. As the dehumidification air is blown through the pipework, it now carries VpCI® along with it to adsorb on the surfaces of the cables and protect them from corrosion.

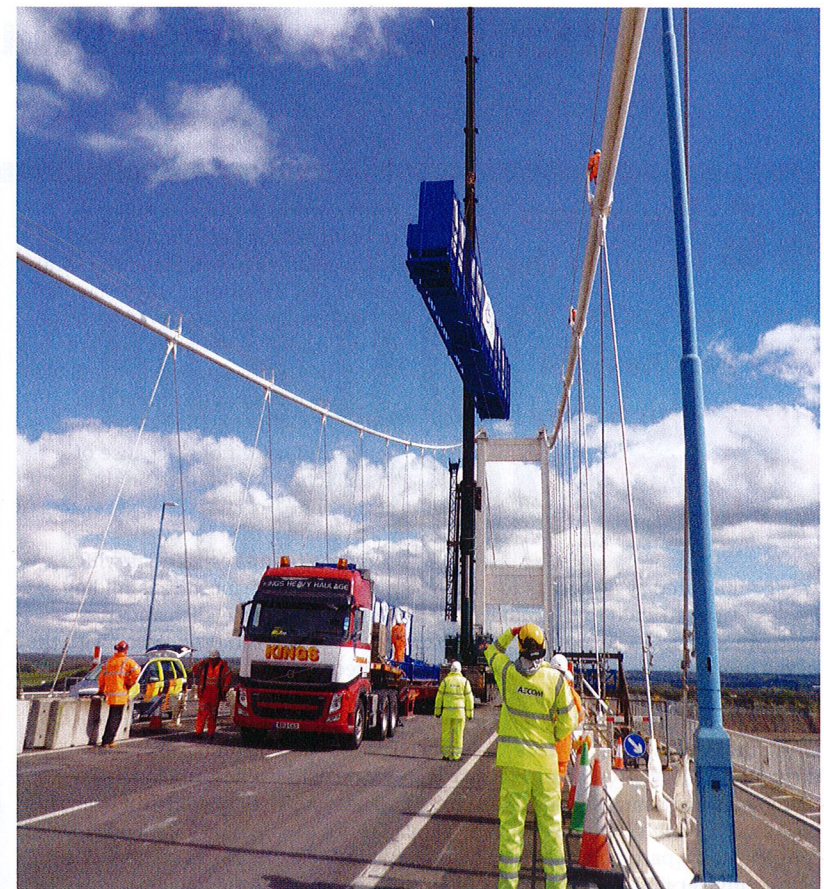
Left: Stripped cables are inspected for corrosion and breaks
Right: The high level inspection scaffolding is lifted into place

The inspections themselves were akin to open heart surgery. Each of the cables was first stripped of its white protective polyethylene sheath, the original red lead paint was then removed to expose the 8,322 individual 5mm diameter parallel high-tensile steel strands which make up the overall main cable.

Inspecting the cables higher up was also a challenge. Each area has had to be inspected from a 30m long, high level scaffolding system which was hoisted up to wrap around the cable.
