**PRESS RELEASE**

**Cortec's Solutions Rehabilitate Vulnerable Structures:**

**MCI® Technology Used to Restore Historical Buildings in Europe!**

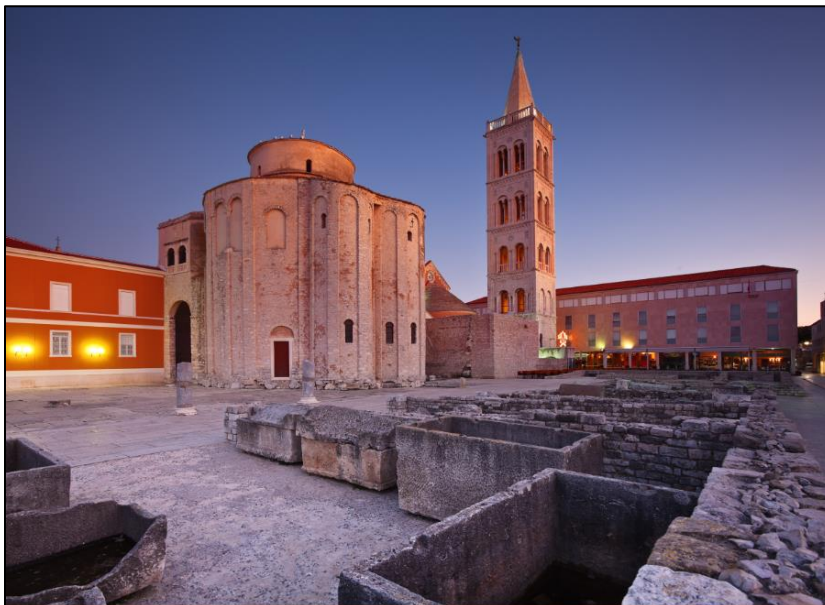
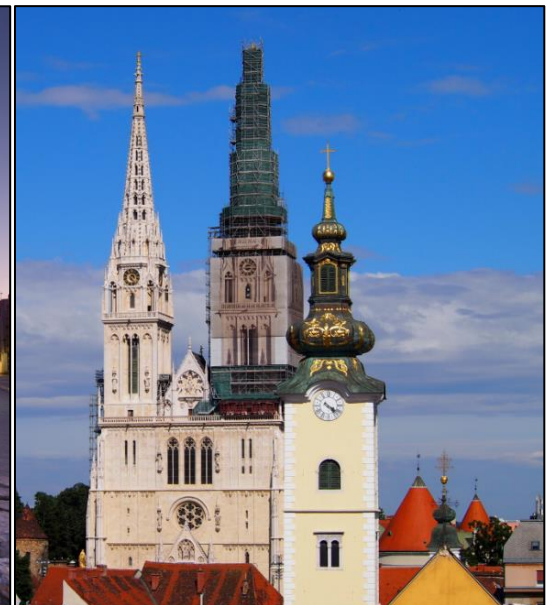
**Saint Donatus church (left) and Zagreb Cathedral (right) are among o most valuable European historic monuments. Architects and engineers recognized Cortec's world renowned MCI® technology for restoration of these delicate, vulnerable structures.**

1927-1930, the stability of foundation was compromised and reinforced concrete support construction was implemented under the roof from the south side, connecting the outer and inner rings of the church. The moisture penetrating into the medieval monument, in combination with the sea dust, very seriously endangers the reinforced-concrete structure, which holds the church of St. Donat.

Last year a repair project was initiated and Cortec's MCI® 2020 inhibitor was specified as coating to protect support structure against corrosion. MCI® 2020 is a surface applied corrosion inhibitor designed to migrate through even the densest concrete structures and seek out the steel reinforcement bars in concrete. Even when not in direct contact with metal, the product will migrate through concrete to provide full protection. This environmentally safe inhibitor stops further corrosion of reinforcing metals, significantly extending the service life of the structure.

The famous Zagreb Cathedral is the tallest and one of the most valuable buildings in Croatia attracting tourists from the whole world. As the most impressive gothic-style sacral building southeast of the Alps, it is characterized by great architectural and historical value. It's construction dates back to 1093 and enriching of the cathedral continued by famous architects during the following centuries.

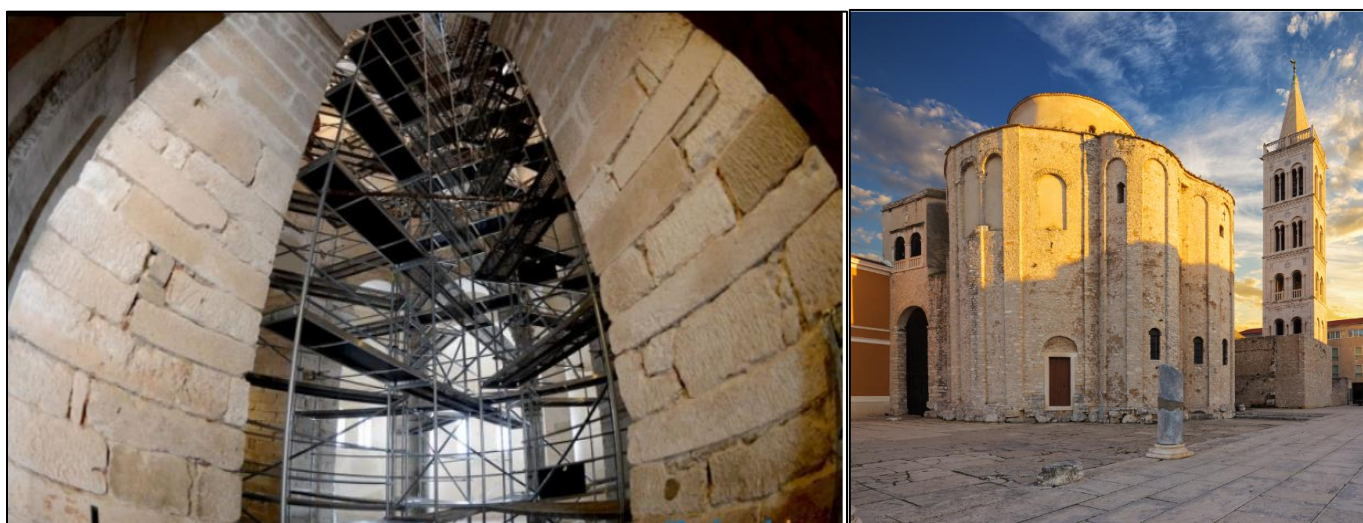
**The moisture penetrating into the medieval monument, in combination with the sea dust, very seriously endangers the reinforced-concrete structure, which holds the church of St. Donat.**

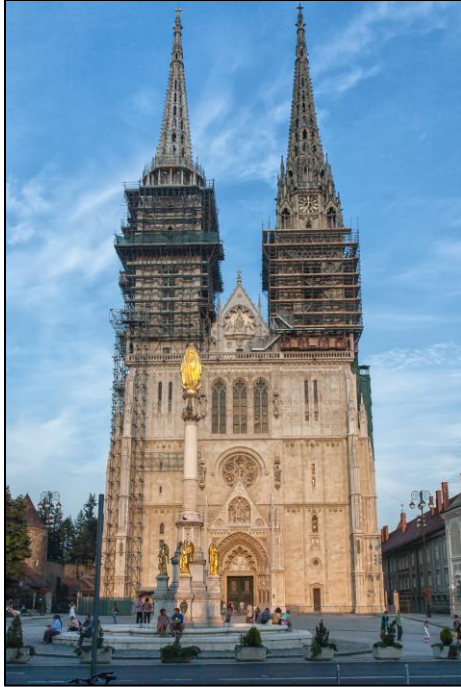
During reconstruction work on the south tower, damaged steel bands were detected surrounding the tower approximately every 3m in height. They were covered with rust and in drainage areas. Visual damage to the diameter of the bands was present.

Economical approach with a minimum of intrusion to the structure was required to fix the condition of the bands. The mechanical resistance and structural stability of the tower needed to be maintained or improved. Faculty of Mechanical Engineering examined the bands and performed experiments on the steel bars. They recommended removal of loose corrosion from the bands surfaces, enhancing the bands in the areas of damage and application of Cortec's anticorrosion protection product- CorrVerter®.

This water-based primer that quickly converts rust into a protective layer and is capable of penetrating into the depths of corroded surfaces. It contains a novel chemical chelating agent that modifies surface rust into a hydrophobic passive layer. Two-layers of CorrVerter® coating were brushed onto smaller surfaces and sprayed in larger areas directly onto the metal bands. The bands were then reinforced with steel fishplates that were welded on the bands and also protected with CorrVerter®.

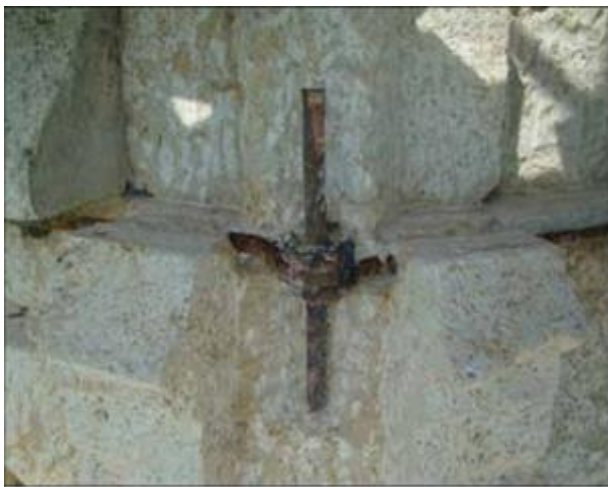
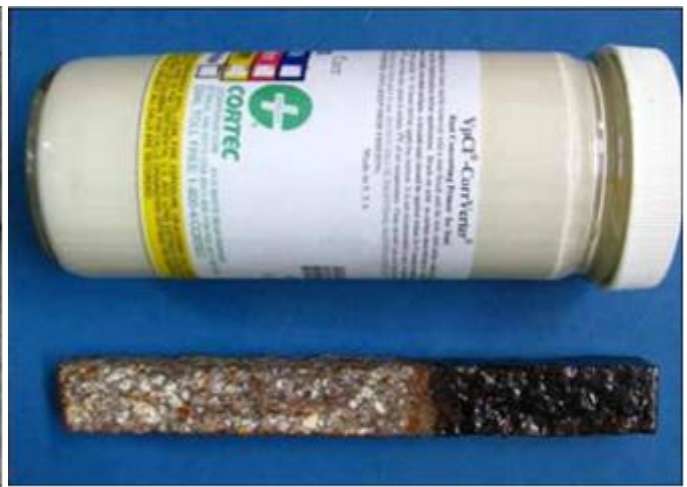
**Left picture: Damaged steel bands. Right picture: CorrVerter® applied to the right side of the band; the coating has converted the corrosion into a protective layer.**

With the help of a skilled team and good project management the entire project was completed successfully with minimal cost or intrusion as specified. CorrVerter® coating penetrated to the non-corroded part of the metal and stopped further advancement of the corrosion process.
