VOL 208 - NO 4642 JUNE 2018

POLYMERS PAINT COLOUR JOURNAL

# Protecting Croatia's most vulnerable historical buildings

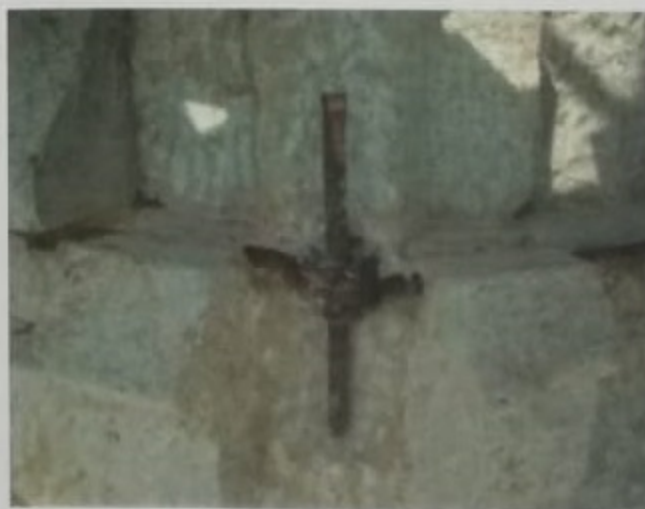
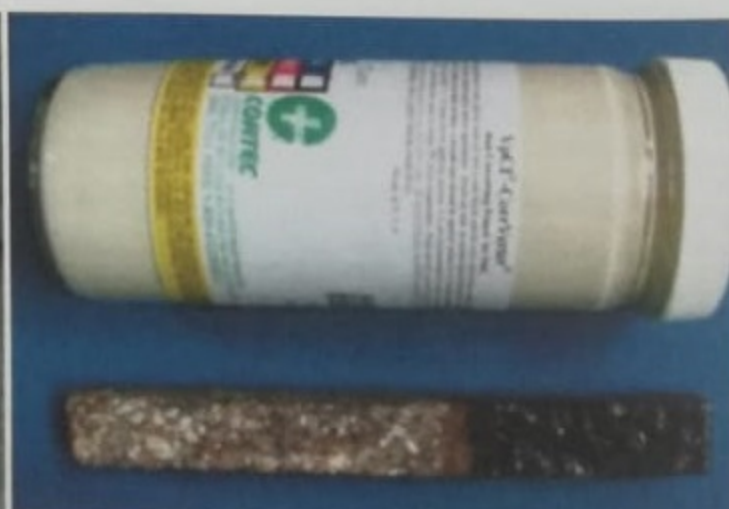
During reconstruction work on the south tower, damaged steel bands were detected surrounding the tower approximately every three metres in height. They were covered with rust and situated in drainage areas. Visual damage to the diameter of the bands was present.

**Left picture: Damaged steel bands. Right picture: CorrVerter applied to the right side of the band; the coating has converted the corrosion into a protective layer**

is capable of penetrating into the depths of corroded surfaces. It contains a novel chemical chelating agent that modifies surface rust into a hydrophobic passive layer. Two-layers of CorrVerter coating were brushed onto smaller surfaces and sprayed in larger areas directly onto the metal bands. The bands were then reinforced with steel fishplates that were welded on the bands and also protected with CorrVerter.

With the help of a skilled team and good project management the entire project was completed successfully with minimal cost or intrusion as specified. CorrVerter coating penetrated to the non-corroded part of the metal and stopped further advancement of the corrosion process.
