Preservation of historical structures with MCI® technology!

Over the last 30 years, extensive restoration work has been undertaken on the famous Zagreb Cathedral in Croatia, with ongoing repairs to this day

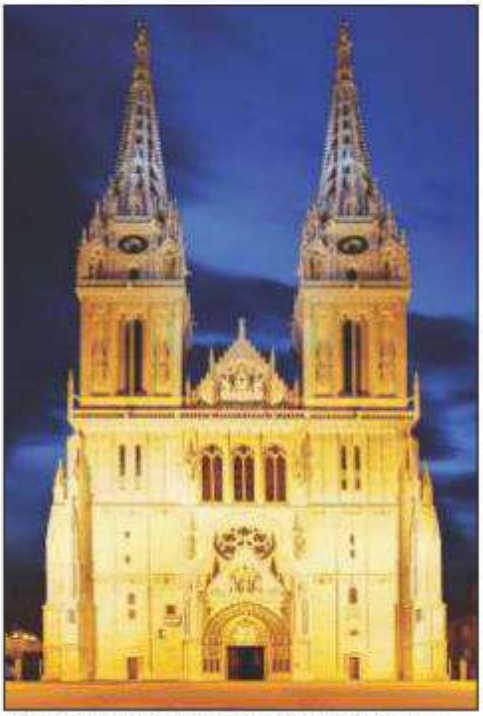
Over the last 30 years, extensive restoration work has been undertaken on the cathedral, with ongoing repairs to this day.

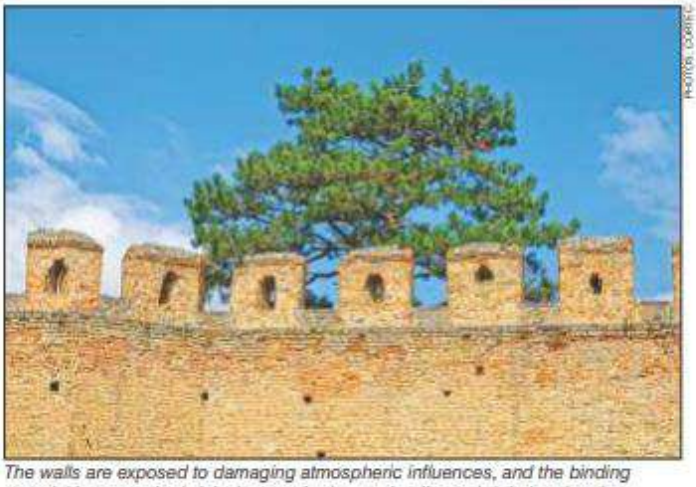
The walls are exposed to damaging atmospheric influences, and the binding material between the bricks has washed away, leading to brick deterioration.

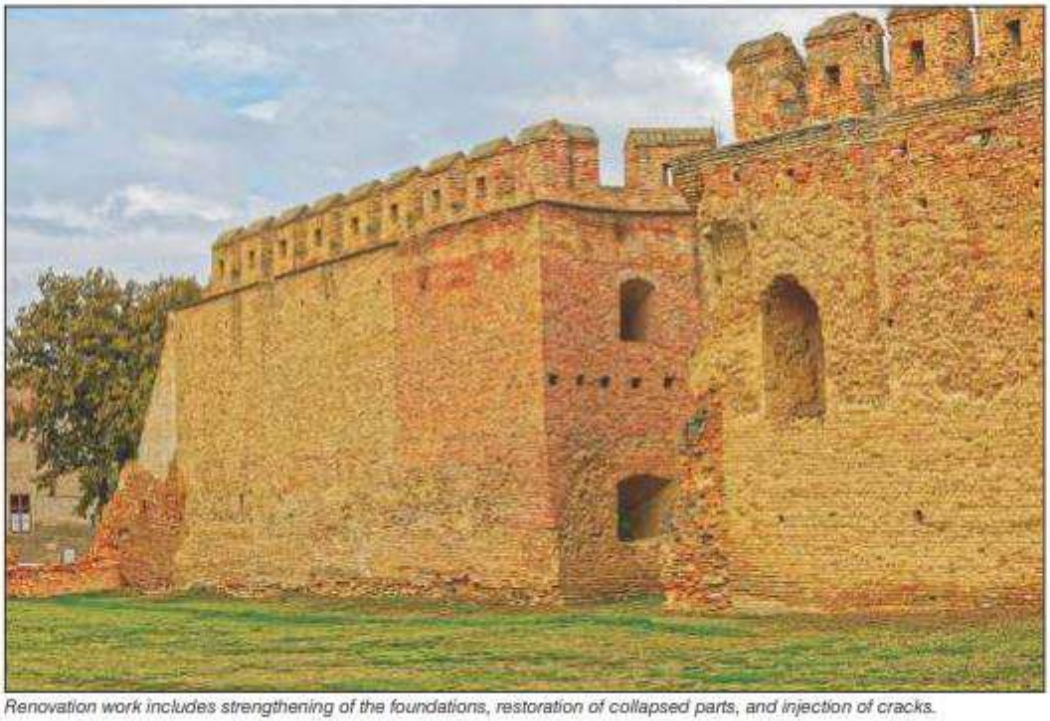
Renovation work includes strengthening of the foundations, restoration of collapsed parts, and injection of cracks.
