CORROSION OF ELECTRONIC CONTROL SYSTEMS IN GAS TREATING ENVIRONMENTS

ABSTRACT

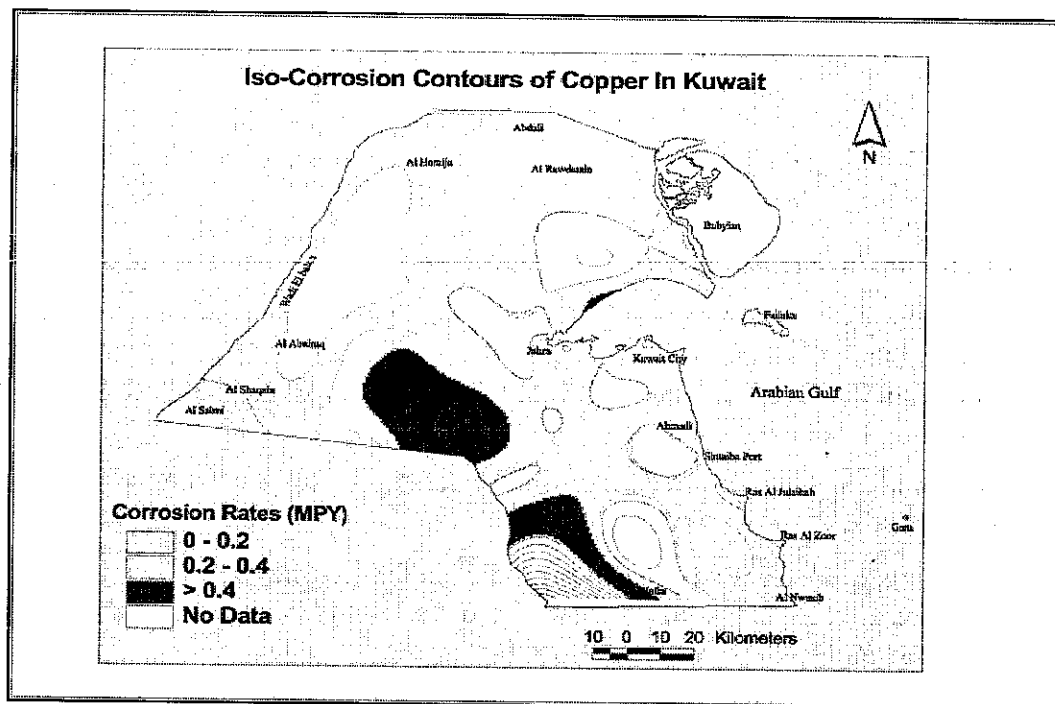
Surveys of atmospheric corrosivity over a number of gas plants and refineries have found the most corrosive areas to be associated with sulfur handling areas and areas with H₂S and SO₂ emissions. In Kuwait, a broader study of atmospheric corrosion over most of the country found the highest atmospheric corrosion rates of copper to be associated with oil and gas producing areas, as shown in Figure 1.²

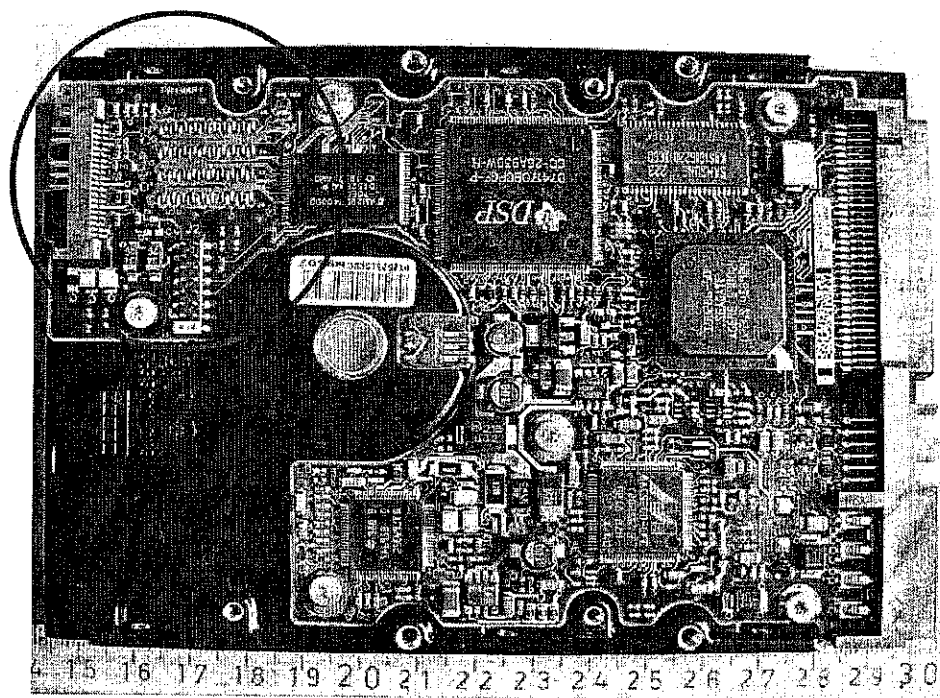
Visual and stereomicroscope examination showed that many circuit board pads and connectors were badly tarnished (Figures 2, 3). Though heavy copper sulfide (Cu_2S) corrosion products were present on many conductor tracks and pads, the circuit board's gold-plated external connector pins were not corroded (Figure 3). The hard drive's vacuum seal was still intact. Further laboratory investigation of the problem included microscopy and energy dispersive microanalysis (EDS) of extracted corrosion products, which were removed using a replication technique.
