Re: Vehicle and equipment corrosion protection during storage and transit – Trial Report

Scope

To protect military vehicles in storage and transit, as well as various equipments and spares being transported in ISO containers, over a six month period at Defence Support Group (DSG) at Aschurch, on behalf of the Data, Recording, Analysis & Corrective Action System (DRACAS), using Vapour phased Corrosion Inhibitors (VpCI's), supplied and treated by HITEK-nology Solutions Ltd (HSL). This trial was started on 17th September 2012.

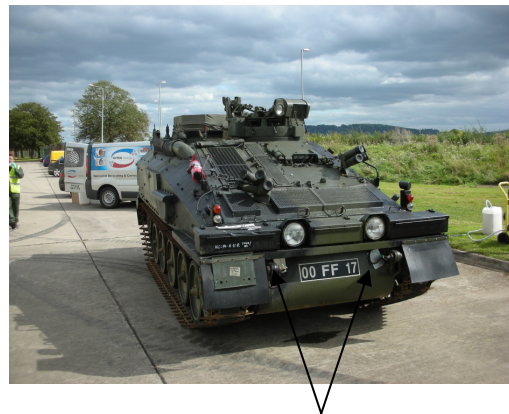
The two plates fitted to the front of the CVR(T). It can also be seen from this picture that the VpCI 389D dries to a clear finish

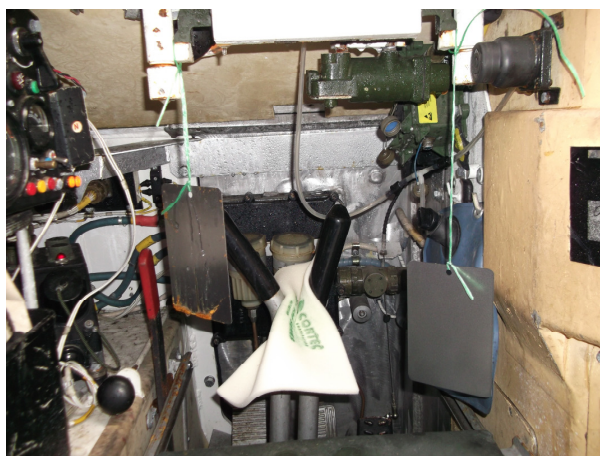
VpCI 132 foam pads fitted in the back of CVR(T) one, also a new low grade carbon steel plate was fitted alongside the existing plate

As planned, VpCI 132 foam pads were placed in the back of the vehicle and a fresh low grade carbon steel plate was also fitted alongside the existing plate, the old plate was left in to show that the foam pads would stop the existing corrosion in its current state as well as protect the new plate from future corrosion.

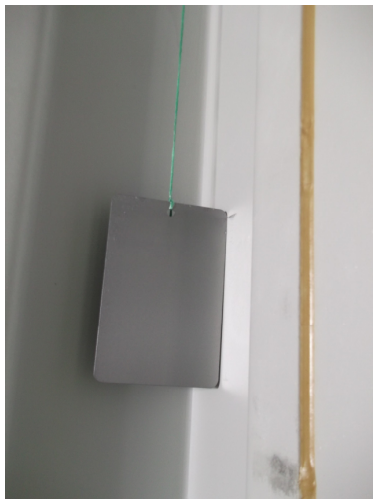
The plate fitted on the ISO container wall that was treated with VpCI 337, showing no signs of corrosion

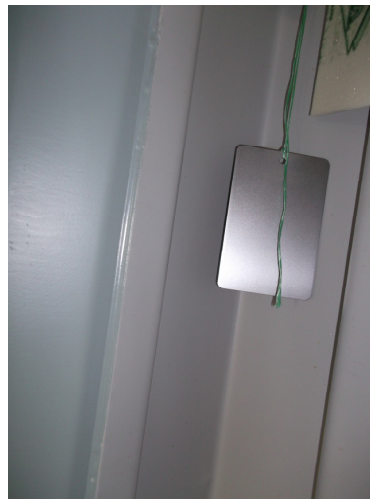
The plate fitted on the ISO container wall that was treated with VpCI 132 foam pads showing no signs of corrosion

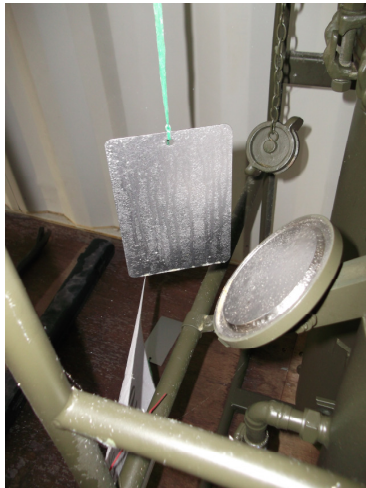
The plate fitted on equipment in the ISO container that was treated with VpCI 337, showing no signs of corrosion. The surface appearance is where the VpCI 337 has made direct contact with the plate during treatment

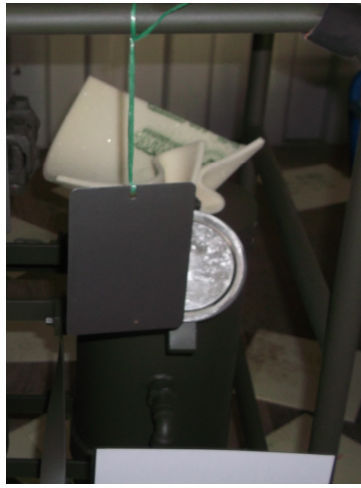
The plate fitted on equipment in the ISO container that was treated with VpCI 132 foam pads, showing no signs of corrosion

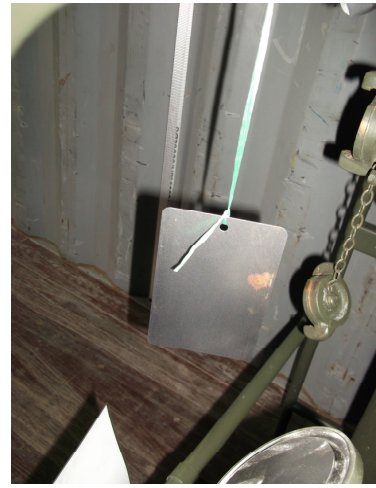
As can be seen in the following pictures, the plates fitted into the ISO container that had no treatment had degraded compared to the plates fitted in the ISO containers treated with VpCI 337 and VpCI 132 foam pads

The plate fitted on equipment in the ISO container that had no treatment, showing a small amount of corrosion

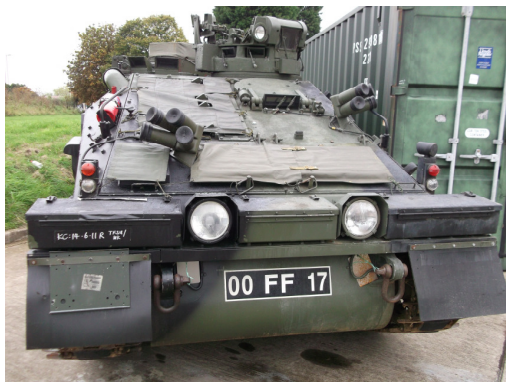
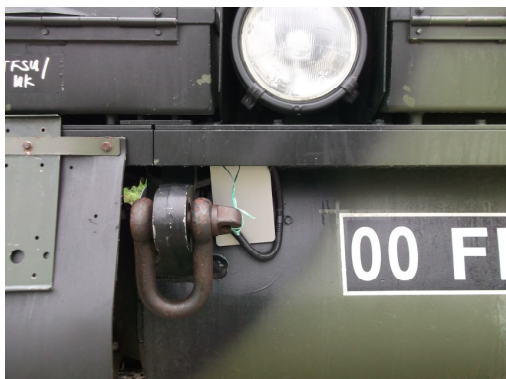
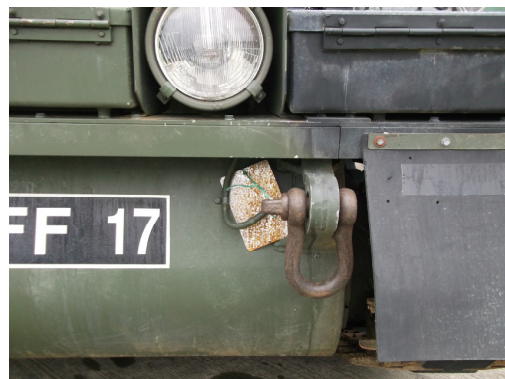
October 2012

Front view and close ups of the plate fitted to CVR(T) one, taken in October 2012, as can be seen one month in the plate treated with VpCI 389D is protecting the plate, and the vehicle

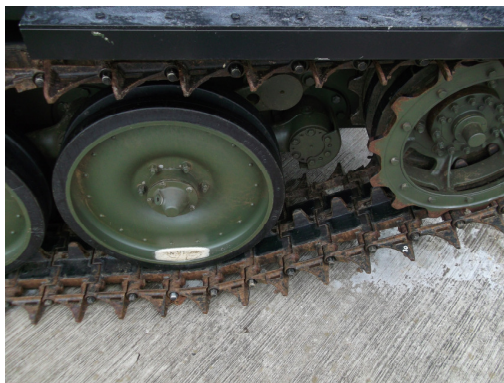
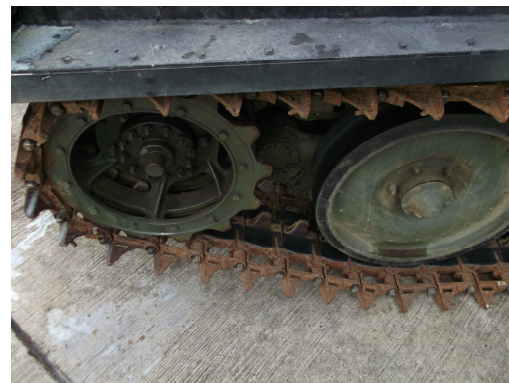
Pictures taken of the wheels / tracks of CVR(T) one in October 2012. The left side is the side treated with VpCI 389D.

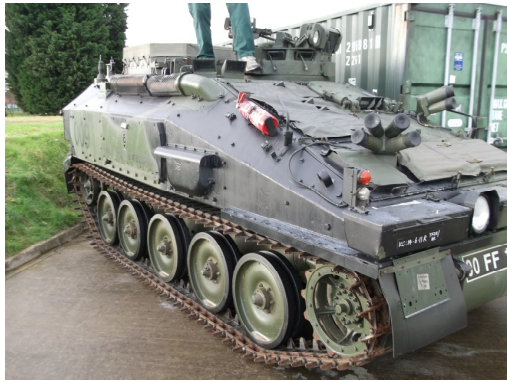
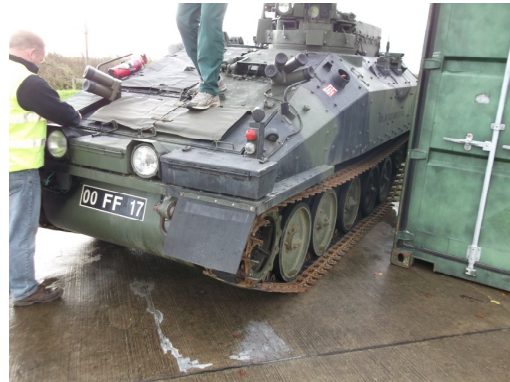
Pictures taken of the wheels / tracks of CVR(T) one in November 2012. The left side is the side treated with VpCI 389D. A visible difference can be clearly seen

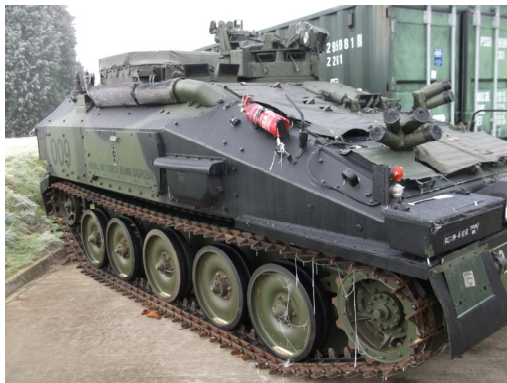
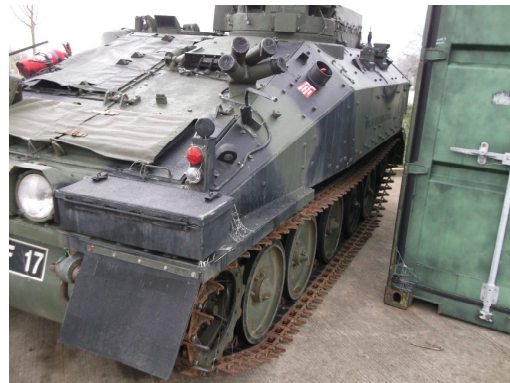
Pictures taken of the wheels / tracks of CVR(T) one in December 2012. The left side is the side treated with VpCI 389D.

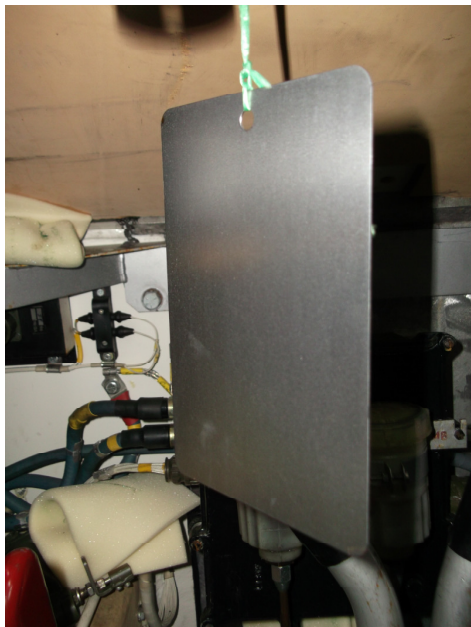
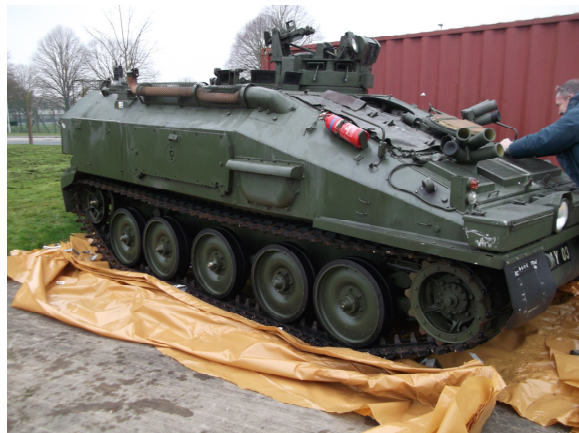
CVR(T) two shown above during the unwrap.

Left is the plate that was hung in drivers compartment during the six month trial, As can be seen it is in the same state as when it was fitted, showing no signs of corrosion

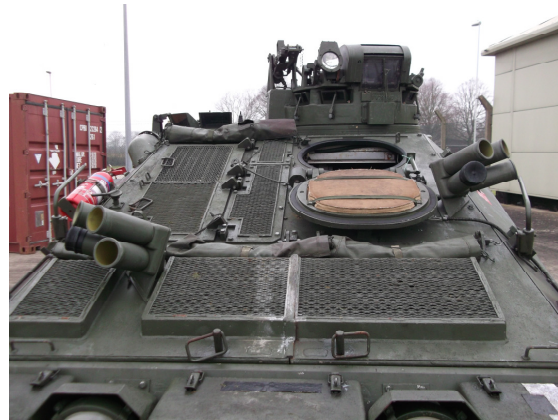
The decks of CVR(T) two (treated with additives and MilCorr)

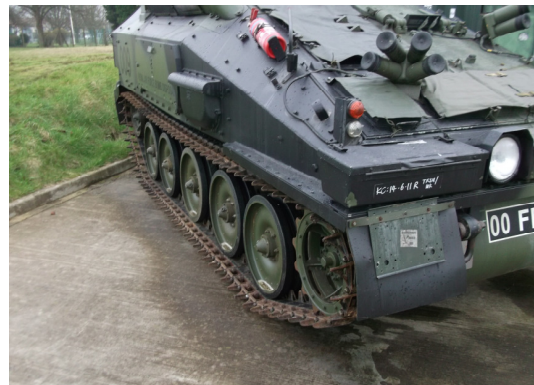
The side view of CVR(T) one (treated with VpCI 389D)

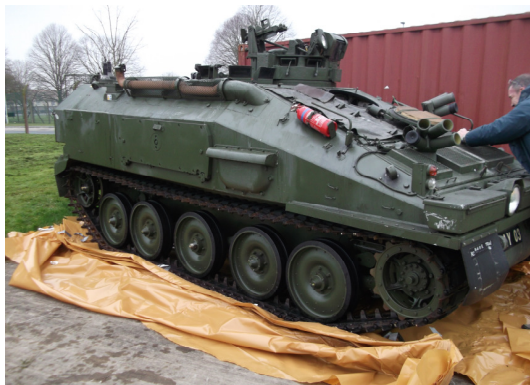
The side view of CVR(T) two (treated with additives and MilCorr)
