## ***Evaluation of Armor Film***

**Project #:** 19-156-1125.bis

**Background:** Our customer is a stamping company who is currently having corrosion issues with the Armor film they are using to protect parts during shipping. This report will evaluate the chemistry of the film as well as corrosion protection.

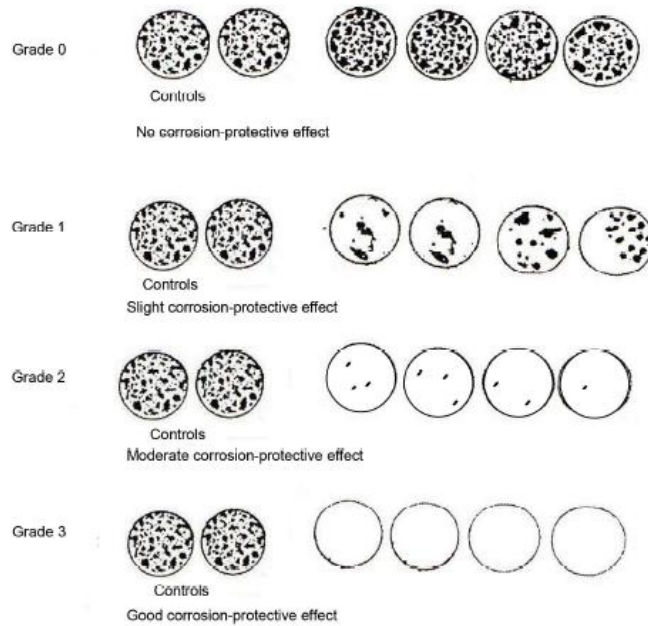
### VIA Test Grades

The results of the NACE VIA test show that the Armor film does not provide good vapor phase corrosion protection. Furthermore, the results of the razor blade test shows that the Armor film only provides contact corrosion protection for steel, but not for copper.
