**Development of a New Corrosion Inhibitor for
Corrosion Under Insulation at Elevated Temperatures**

ABSTRACT

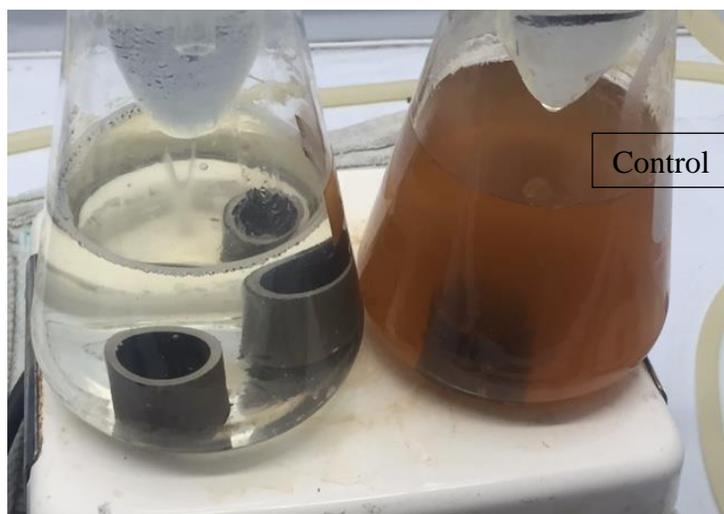
Figure 1: Corrosion set up for testing steel pipe in 200 ppm Cl⁻ solution at boiling temperature (100 °C) with and without inhibitor.

The corrosion behavior of API 5L X65 steel pipe (ISO 3183 L450) was investigated. Samples of this material (2.5 cm (1 inch) length x 2.5 cm (1 inch) diameter pipe) were used for the total immersion tests in boiling water consistent with the ASTM G123 test practice (Erlenmeyer flask and condenser, hot plate to maintain boiling temperature, Figure 1). Tests were conducted in a control solution of 200 ppm Cl⁻, no inhibitor, or in a solutions containing 1.0% VCI or 5.0% VCI added to the control solution. The test duration was 240 hours with surface condition of exposed samples documented after 120 hours and 240 hours.

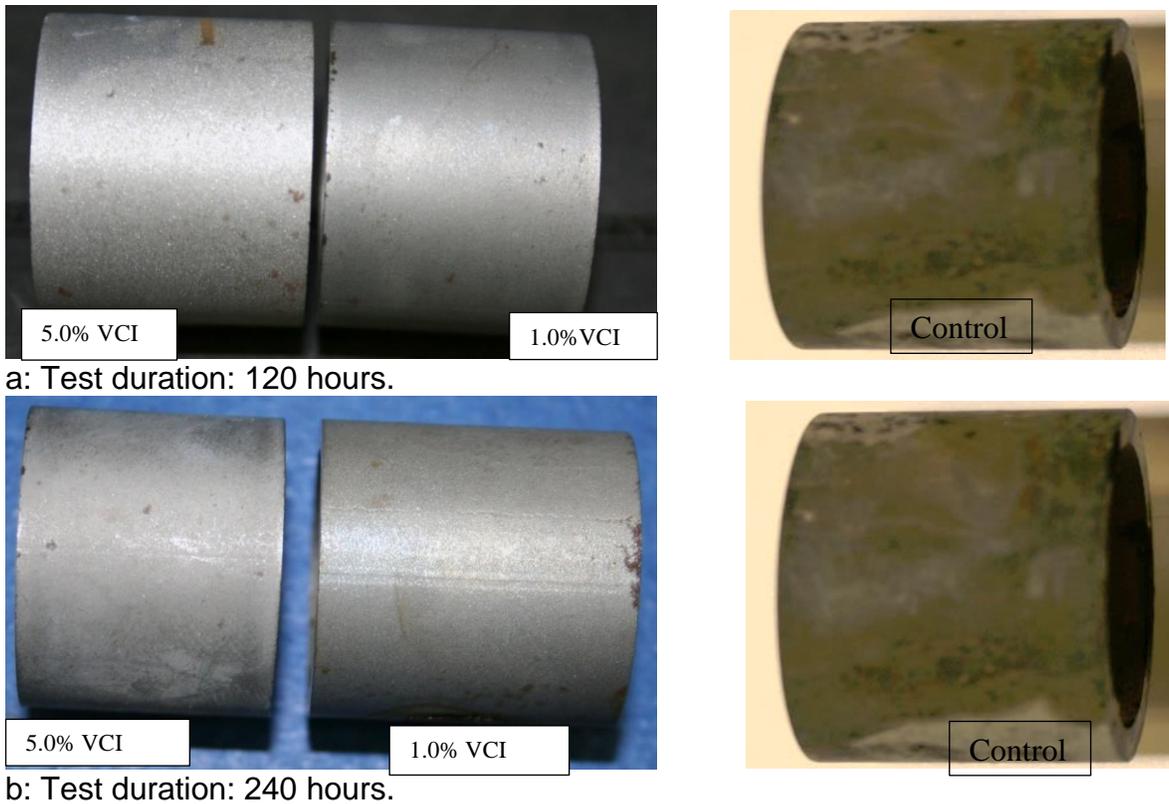
Figure 2: Corrosion behavior of steel pipe with addition of 1.0% or 5.0% VCI compared to control sample in 200 ppm Cl⁻ solution in boiling temperature (100 °C) for 120 and 240 hours.

The corrosion behavior of API 5L X65 steel pipe was investigated using immersion corrosion and CUI tests at different elevated temperatures. Segments of steel pipe were subjected to total immersion in boiling water with inhibitor and without inhibitor (control sample) using similar apparatus recommended in ASTM G123 (Figure 1). These tests were conducted in a control solution (200 ppm Cl⁻ solution, no inhibitor), and solutions with 1.0% and 5.0% VCI addition. Test duration was 240 hours. Figure 2 shows a comparison of samples tested with and without inhibitor for 120 and 240 hours in the elevated temperature in total immersion conditions. The

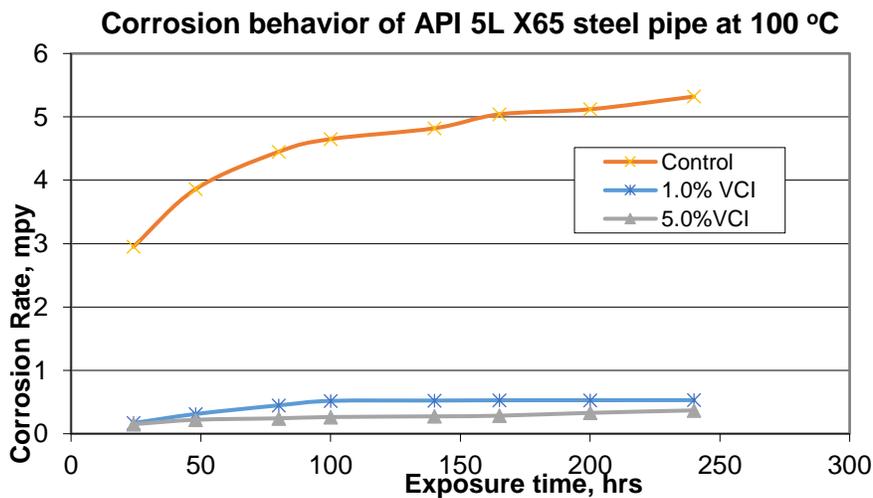
Figure 3: Corrosion behavior of steel pipes in boiling water solution at 100 °C. Control sample (with no inhibitor) shows highest corrosion rate.

inhibitor successfully protected the pipe samples against corrosion attack, the control samples were heavily corroded. In Figure 3, the graph shows the corrosion behavior of the steel pipes in the boiling water solutions. The control sample with no inhibitor shows a significantly higher corrosion rate and an increasing trend with time. The corrosion rate was ~5.3 mpy (mils per year) for the control samples, the 1.0% VCI treated solution corrosion rate was ~0.42 mpy, and 5.0% VCI treated solution showed a 0.36 mpy.

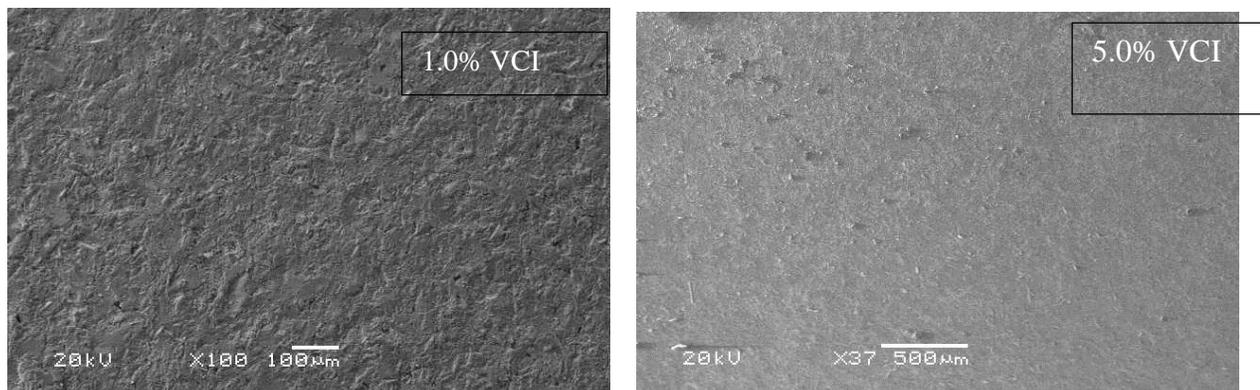
Figure 4: SEM micrographs of steel pipe with 1.0% and 5.0% VCI in 200 ppm Cl⁻ solution in boiling temperature (100 °C) for 240 hours.

Corrosion rates for both VCI treated solutions were very satisfactory and sample surfaces were corrosion free. The scanning electron microscope (SEM) images show corrosion free surfaces for the samples protected with inhibitor in Figure 4. The SEM/EDS analysis on the steel pipe in 1.0% and 5.0% VCI in 200 ppm Cl⁻ solution in boiling temperature for 240 hours, shows formation of Molybdenum -rich protective film on the surface (Figure 5).

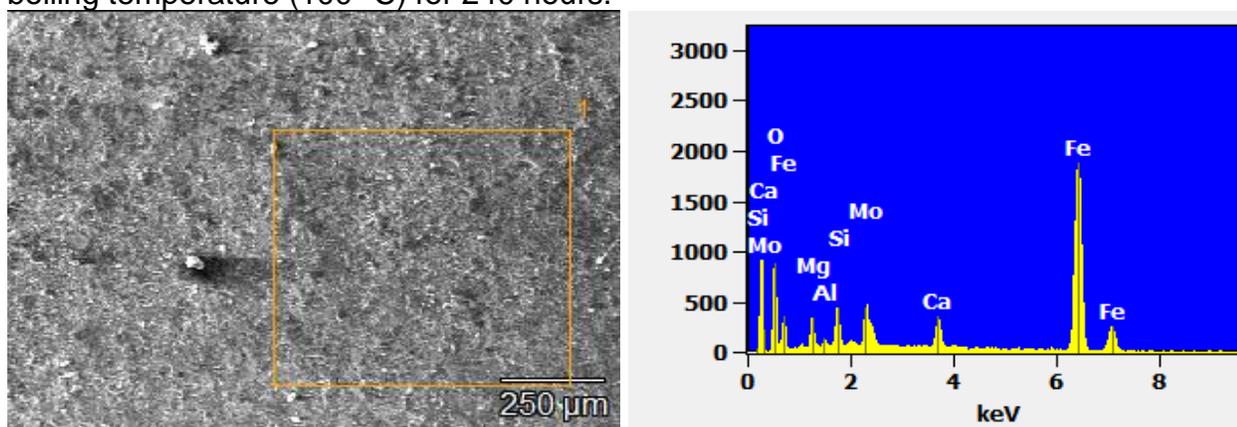
Weight %	O	Mg	Al	Si	Ca	Fe	Mo
VCI 1_pt1	13.13	3.07	0.83	3.59	3.54	67.73	8.11

Figure 5: SEM/EDS analysis on the steel pipe in 1.0% and 5.0% VCI in 200 ppm Cl⁻ solution in boiling temperature (100 °C) for 240 hours, shows formation of Mo-rich protective film on the surface

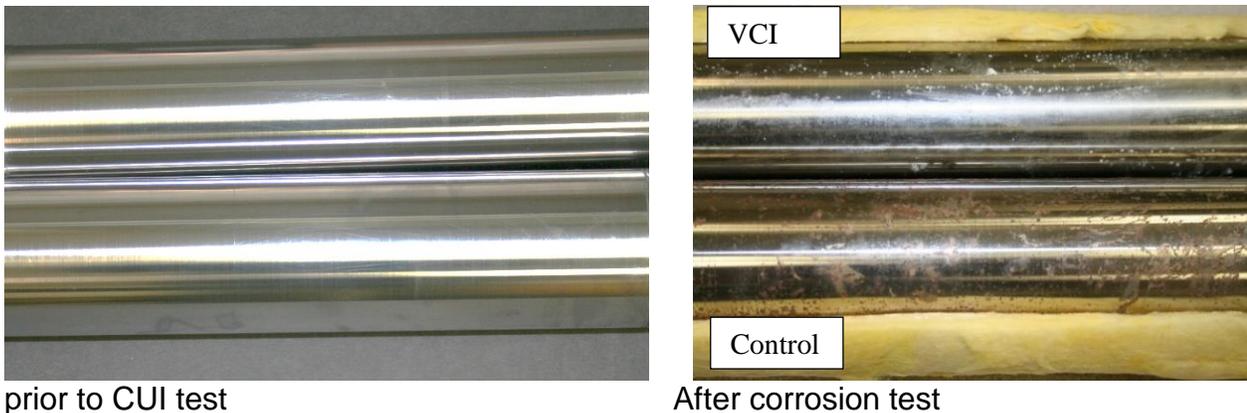
Figure 6: Surface condition of the pipe subjected to CUI tests after 240 hours at isothermal 77 °C and 20 ml of Cl- containing solution injected into pipe/insulation interface. Control sample showed localized corrosion and red rust formation.

Figures 6 and 7 show localized corrosion attack and red rust formation on the non-protected API 5L X65 steel pipe after 240 hours in cyclic corrosion tester. The inhibitor coated pipe showed no corrosion. Figure 8 shows the surface condition after CUI testing in thermal cycling conditions. Surface discolorations were observed on the tested pipe samples (Figure 8). Chemical analysis on surface deposits showed no corrosion species, but instead formation of the protective Mo-compound (the inhibitor is a molybdate base). The inhibitor treated pipes were relatively clean and free of corrosion. Figures 9 through 11, SEM/EDS analysis, showed formation of a molybdenum rich protective film on the tested pipe surfaces and no iron oxide formation was

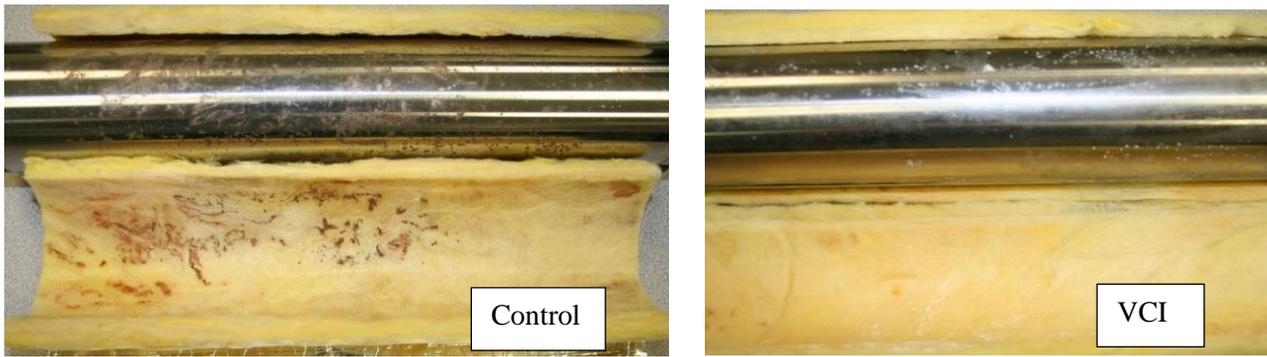
Figure 7: Surface conditions of the pipe and insulation subjected to CUI tests after 240 hours at isothermal 77 °C. Control sample showed localized corrosion and red rust formation. No sign of corrosion attack was observed on VCI treated sample.

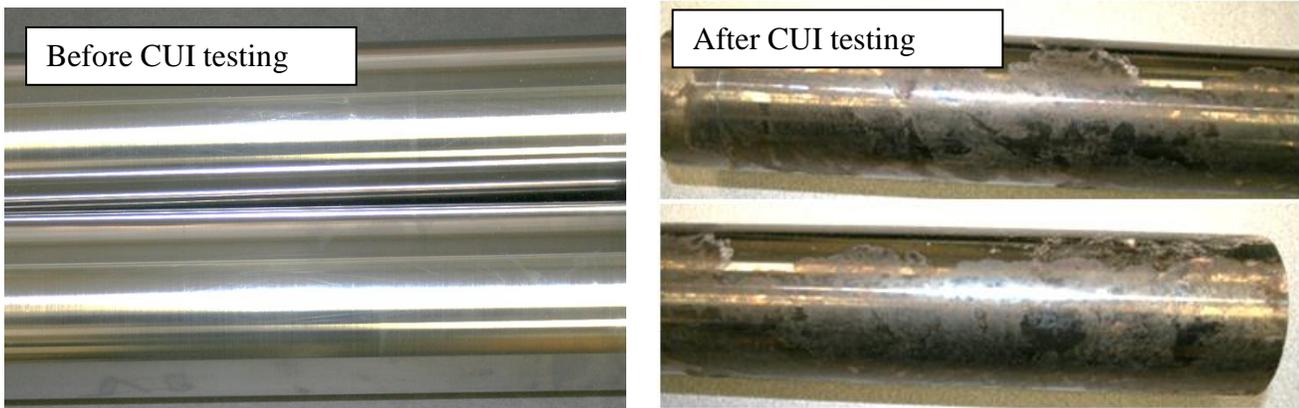
Figure 8: CUI tests on VCI coated pipe at thermal cycling between 77 and 177°C after 5 cycles with salt injection (240 hours), show outer surface discoloration, but no corrosion on pipe surface.

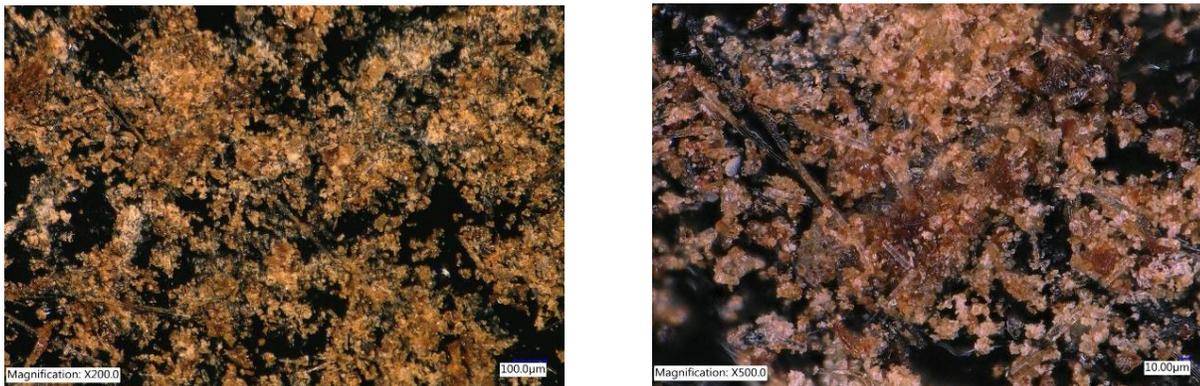
Figure 9: Pipe surface condition after CUI tests of the VCI coated pipe after five cycles of thermal cycling at 77 and 177°C, show morphology of surface deposits.

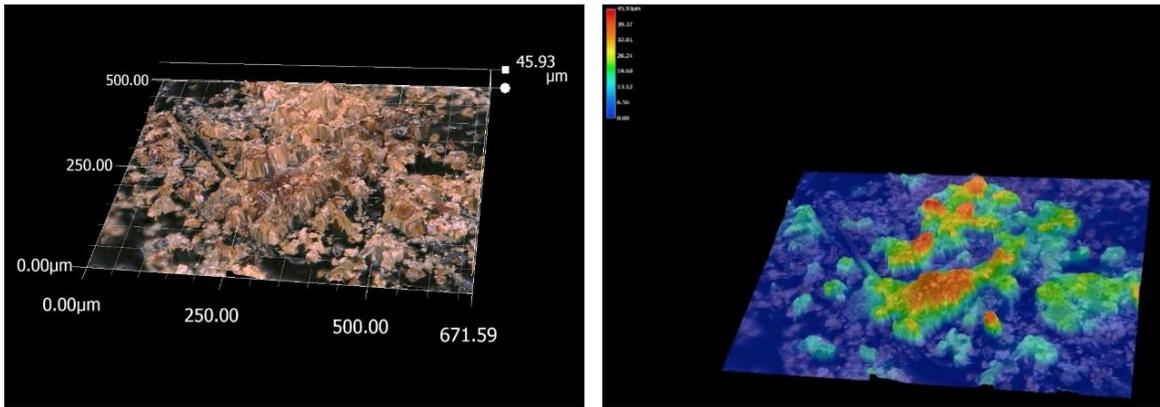
Figure 10: Surface condition of after CUI tests on VCI coated pipe at after five cycles of thermal cycling at 77 and 177°C. SEM/EDS analysis showed that there are Mo-rich deposits. No steel corrosion was detected in these deposits.

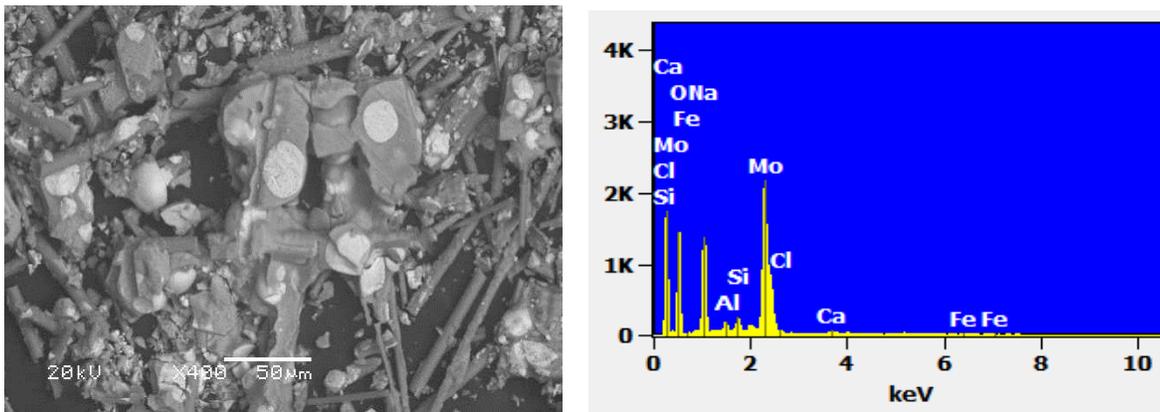
Weight %	O	Na	Al	Si	Cl	Ca	Fe	Mo
VCI_2_pt1	41.84	14.94	0.87	1.16	0.18	0.56	0.13	40.33

Figure 11: SEM/EDS analysis showed they are Mo-rich deposits (inhibitor compound) after CUI tests on VCI coated pipes five cycles of thermal cycling at 77 and 177°C. The detected iron level is very low indicating no corrosion of the pipe.
