4119 White Bear Parkway, St. Paul, MN 55110 USA Phone: (651) 429-1100, Fax: (651) 429-1122 Toll Free: (800) 4-CORTEC, E-mail: info@cortecvci.com • cortecvci.com • corteclaboratories.com . . **Evaluating Corrosion Protection Options for Customer** • • . . . • From: Cortec Corporation Laboratories . 4119 White Bear Parkway • St.Paul, MN 55110 . • • cc: **Boris Miksic** • Anna Vignetti • • • . **Project** #: 10-209-1825(bis) 0 • . • • . Ein Untala . Test conducted by: 0 . Eric Uutala . **Technical Service Engineer** 0 U. Rharshow -**Approved by:** Margarita Kharshan Laboratory Director

Background:	Customer sent cast iron pieces to Cortec. They would like various corrosion protection systems evaluated.
Sample Received:	Five cast iron pieces Castrol Rustilo 4163 Unknown blue polyethylene (PE) film
Method:	ASTM D-1735 Water Fog (100°F, ~95% relative humidity)
Materials:	Cast iron pieces Castrol Rustilo 4163 Unknown blue PE film VpCI-126 Blue Film BioCorr Rust Preventative (RP)
Procedure:	The following procedure was used:
	 Prior to testing, all cast iron pieces were cleaned with methanol. After cleaning, one piece was set aside to be used as a control. The remaining four pieces were tre

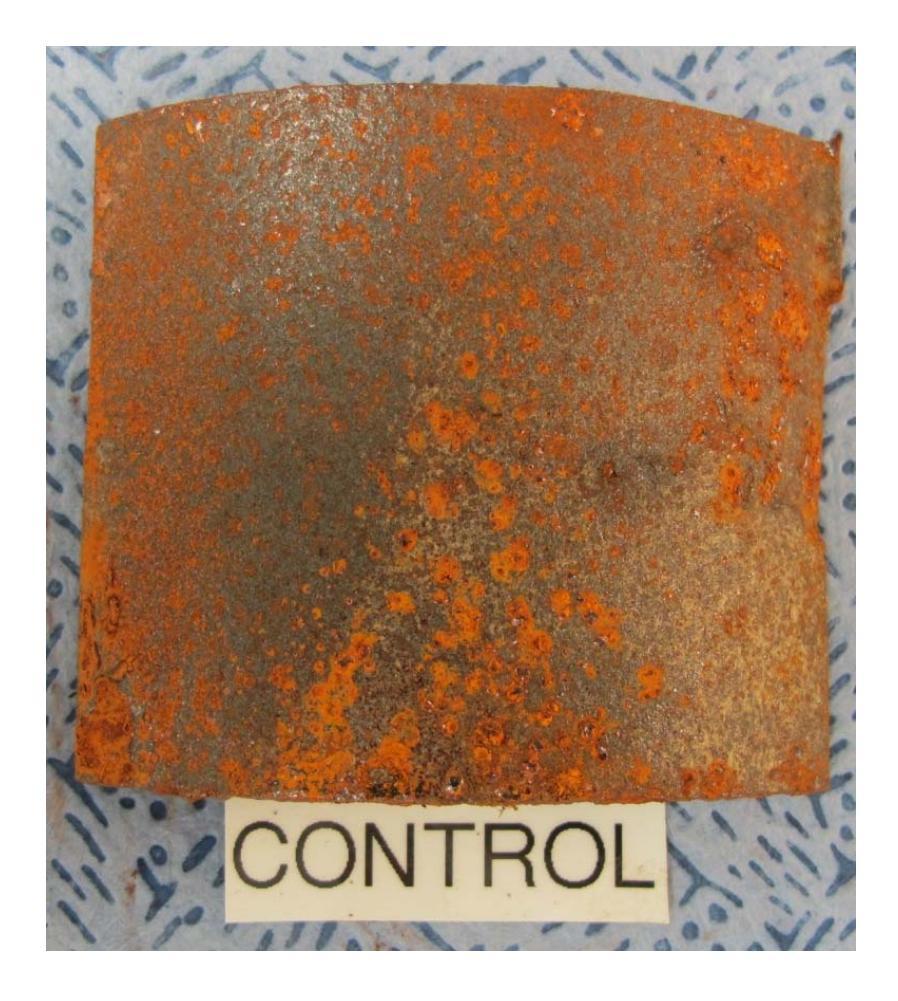
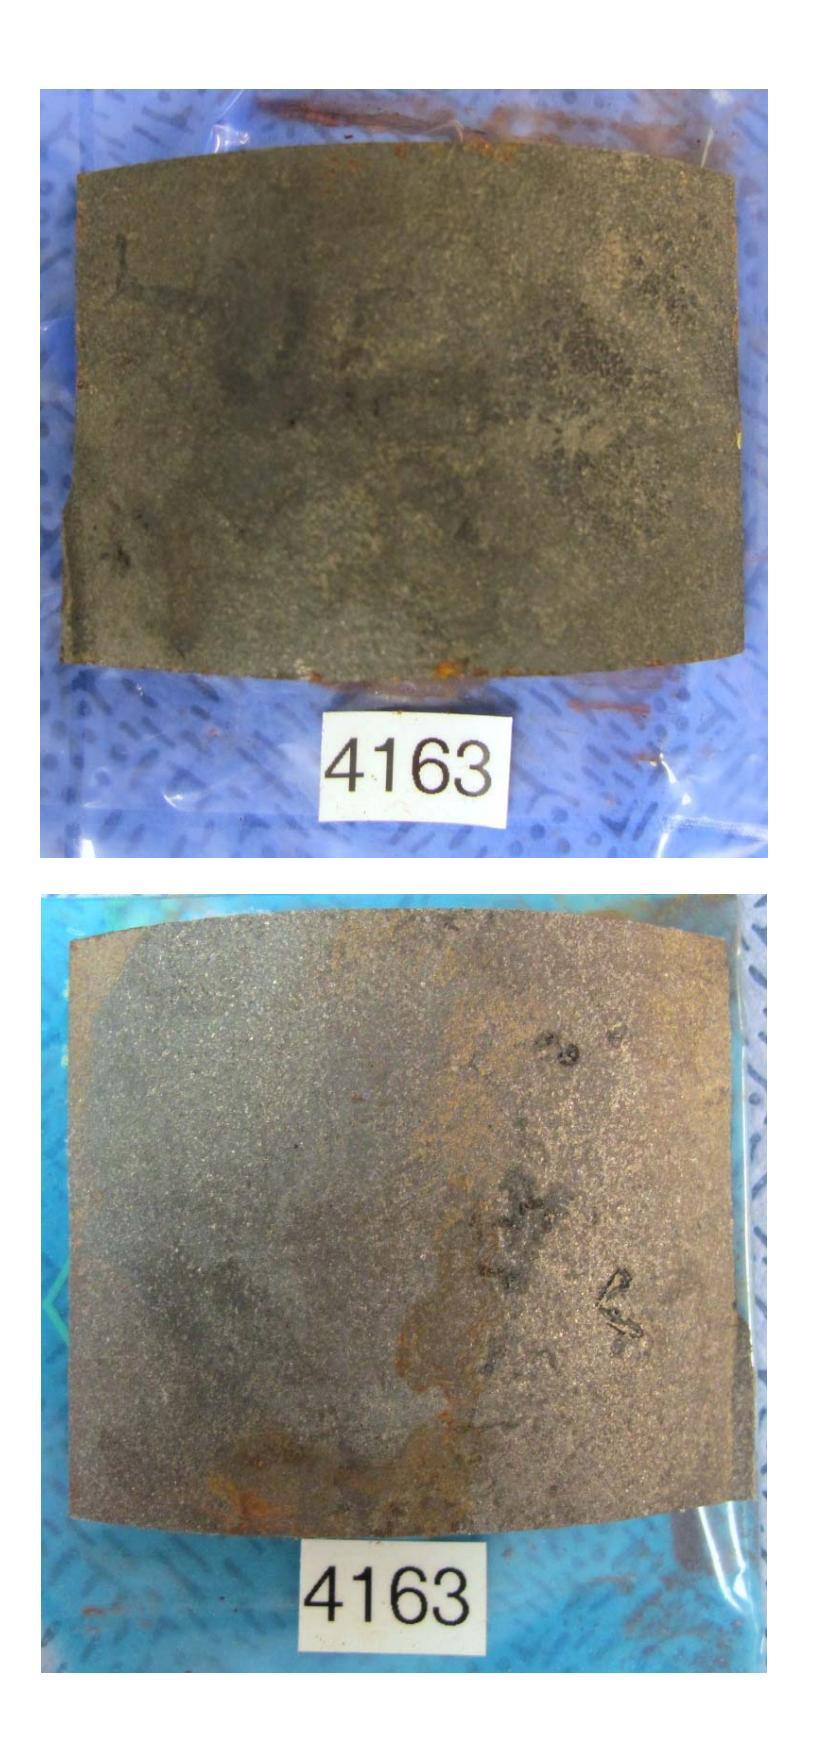
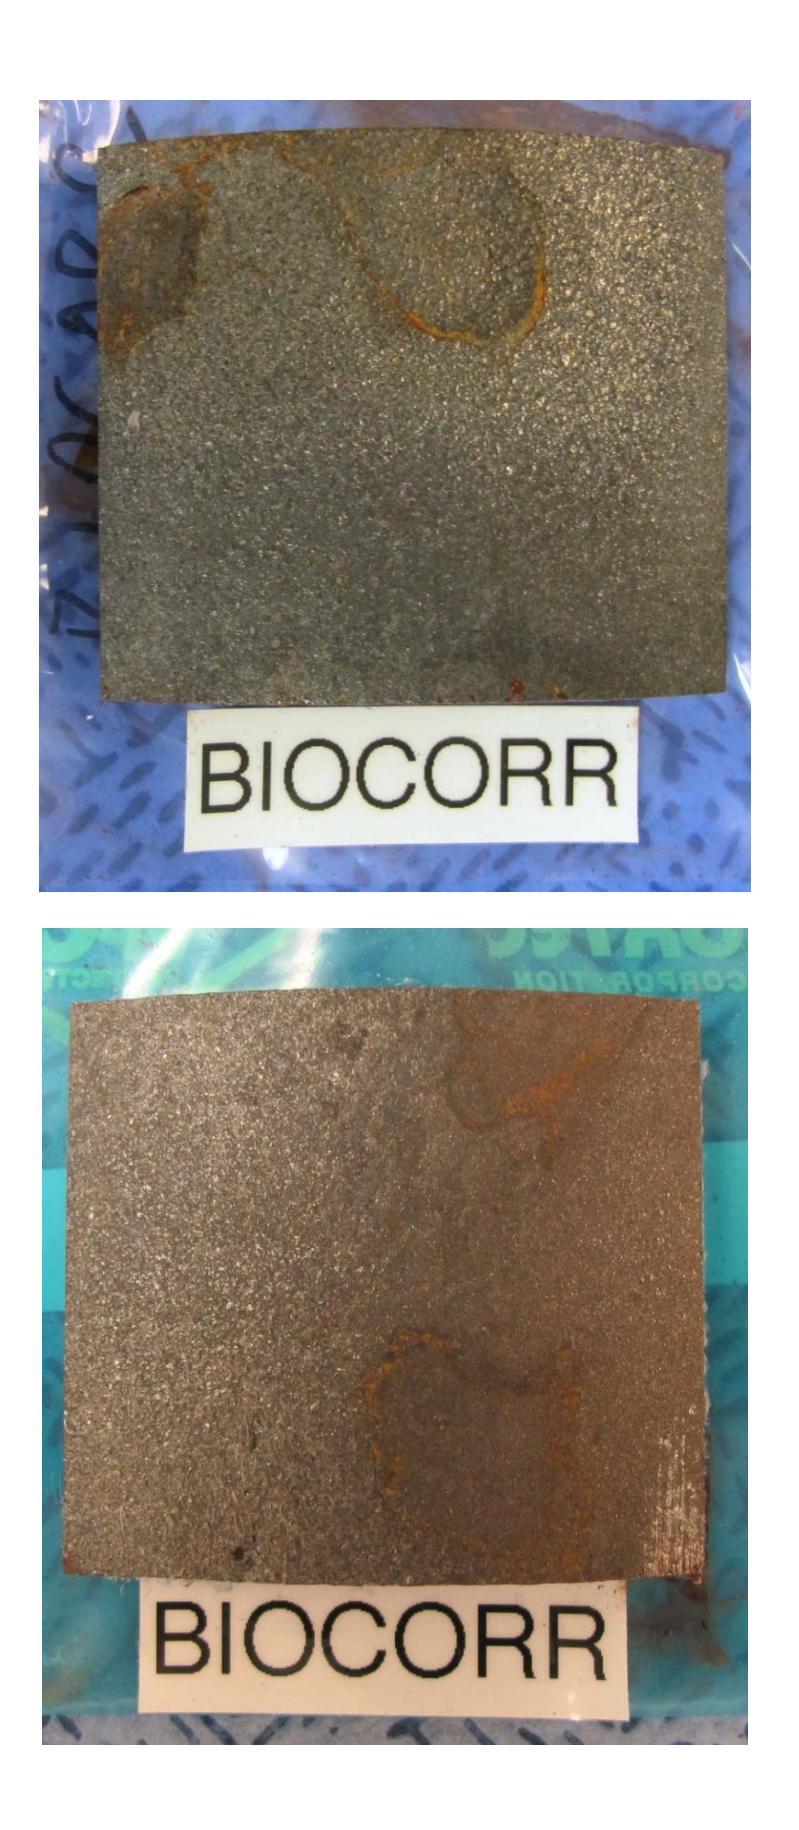
Photos:

Results:	The following results were found:

Protection System	Time to Failure (Hours)
None (Control)	<8
Rustilo/Unknown film	120
Rustilo/VpCI-126	192
BioCorr/Unknown film	168
BioCorr/VpCI-126	312

Interpretations:	The corrosion protection system of VpCI-126 Blue Film and
	BioCorr Rust Preventative provided the best protection on the cast
	iron pieces from customer.
