Attention: Editor August 30, 2018 PRODUCT RELEASE

# Preventing Tragic Events of Collapsing Structures by Utilizing Migratory Corrosion Inhibitor Technology

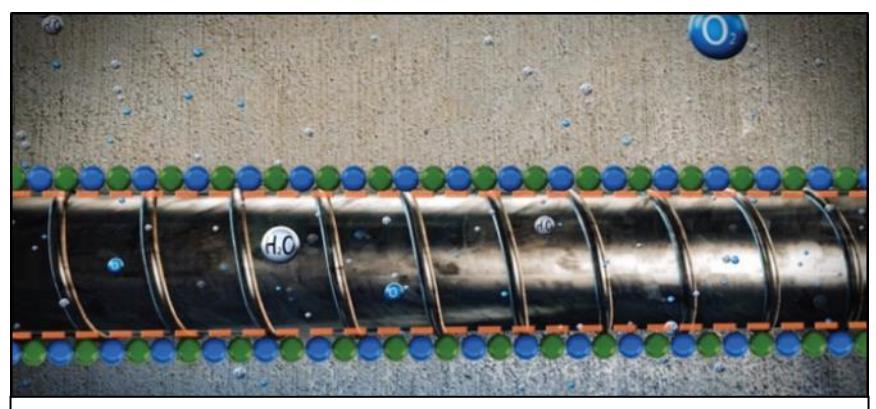
Migrating corrosion inhibitors form a protective layer on the surface of embedded steel reinforcement.

During last two decades there have been huge advances in technology to extend the lifespan of structures and avoid possible tragedies to happen. One of the most efficient uses of migrating corrosion inhibitors (MCI<sup>®</sup>) are when applied directly during construction phase as well as a part of the maintenance repair system in existing structures. For prestressed structures for bridges, MCI's are recommended for the protection of prestressed cables before grouting such as Cortec's MCI 309.

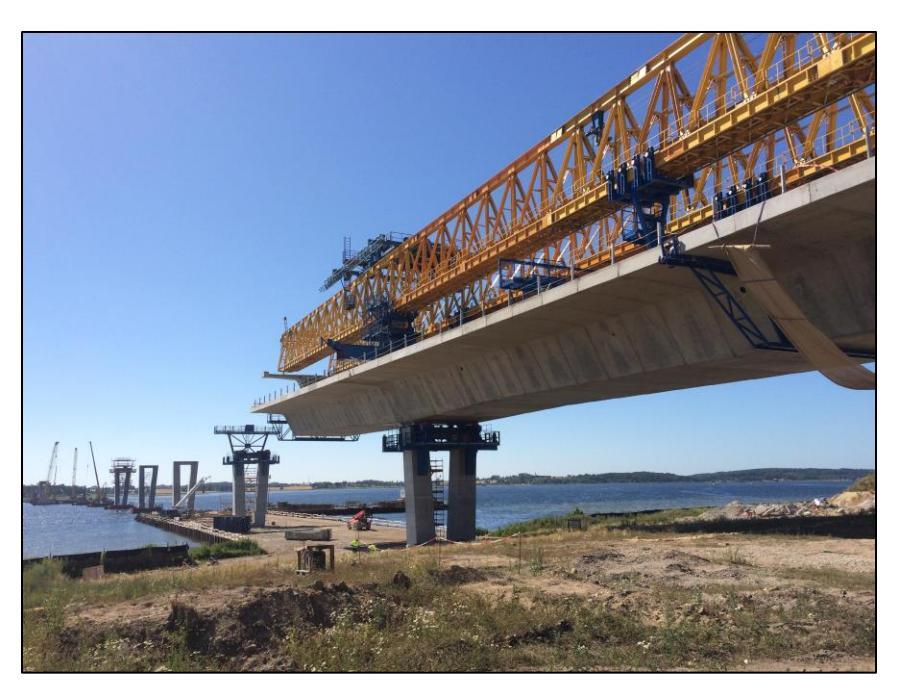
There are many current cases of using migrating inhibitor technology in projects around the word such as erecting the new Frederikssund bridge in Denmark (picture right). The aim is to replace the old bridge built in 1935 by providing an alternative to the only currently active bridge over the fjord. The project includes design & construction of an 8-kmlong dual-carriageway highway, comprehensive of a bridge over the Roskilde Fjord. MCI® 309 is used for corrosion protection of PT concrete segments.

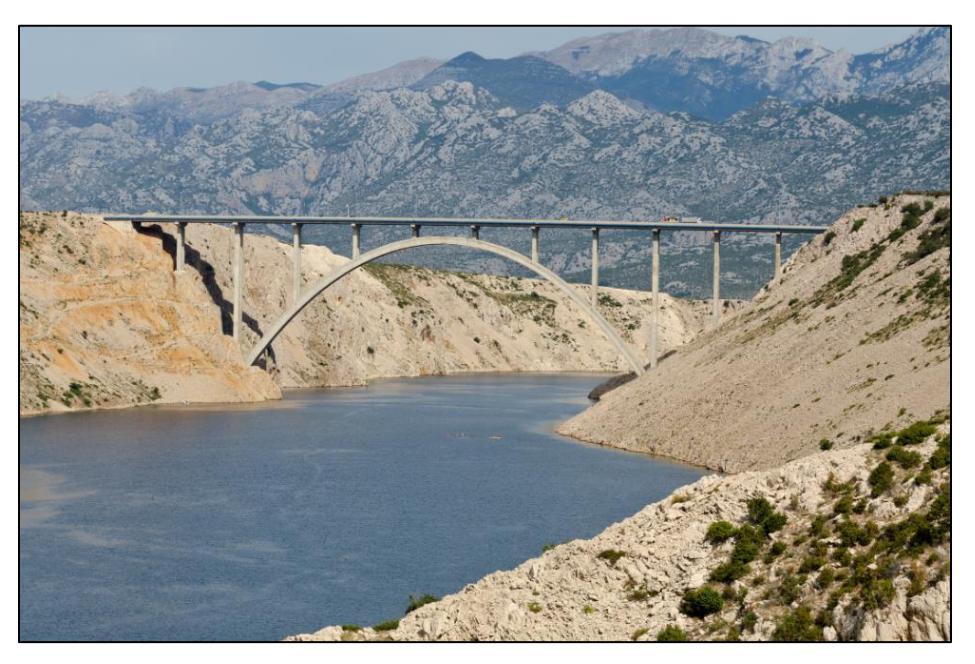
The Maslenica Bridge in Croatia is one of the largest bridges of its type with an arc of 200 meters (218.7 yd) in diameter. Because of the aggressive environment of changing temperatures, constantly fluctuating humidity, and strong wind containing salt from seawater, reinforcing steel had started to corrode, causing concrete spalling. To restore the bridge and prevent future corrosion from happening,

all spalling concrete was water-blasted off, along with dirt and corrosion on the rebar. CorrVerter<sup>®</sup> MCI<sup>®</sup> Rust Primer was brushed on exposed rebar to passivate the metal from further corrosion, and MCI<sup>®</sup>-2020 was applied to the entire concrete structure using an airless sprayer to prevent any potential corrosion that was not apparent.
