MIGRATORY CORROSION INHIBITOR (MCI®) PRODUCTS FOR CONCRETE

CASE HISTORY SPOTLIGHT

Case History #102: Concrete Cooling Tower Repair

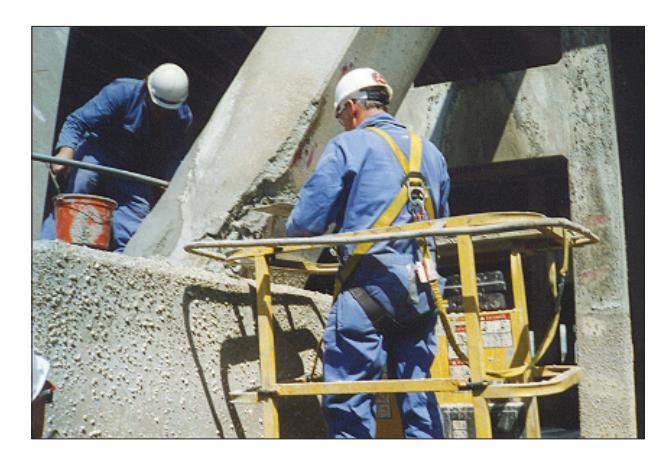
A major power supplier needed high quality repair materials to fix cooling towers that had been damaged by corrosion and contaminated by chlorides and carbonation. Prior to placing repair mortars, MCI®-2020 was sprayed into the area where concrete had spalled. The cavity was then filled in using MCI®-2038 and MCI®-2039. Surrounding areas were treated with MCI®-2020 to fight the ring-anode effect that can accelerate corrosion in concrete adjacent to repairs. In this way, the immediate repair was completed using a proven technology that would have ongoing effects to mitigate future corrosion and concrete damage.
