# MIGRATORY CORROSION INHIBITOR (MCI®) PRODUCTS FOR CONCRETE

## CASE HISTORY

### Repair of San Agustin Church

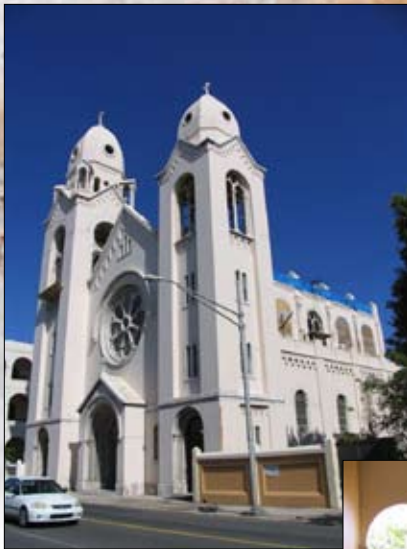
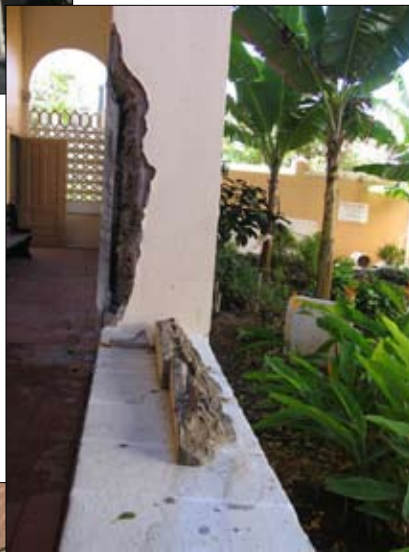
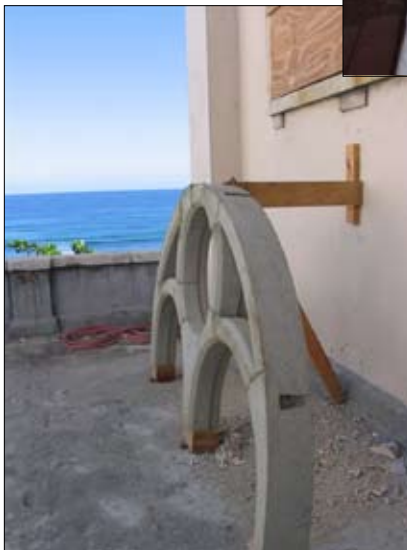
A 100 year old church standing less than 300 feet from the ocean was exposed to the daily sea breezes and started showing signs of deterioration due to corroded rebar. The structure was in urgent need of repair before the damage became irreversible.

First, MCI®-2020 was applied on the precasts and the walls to allow the inhibitors to migrate through the concrete to treat the steel reinforcement bars. The second step was to repair the damage by applying MCI®-2311, a single component, cement-based mortar. This was followed by a saturation of MCI®-2022, a water-based, water-repelling sealer.
