CASE HISTORY

Brune Bridge Repair

SANRAL
(South African National Roads Agency Limited)

Nkangala Region of Mpumalanga Province

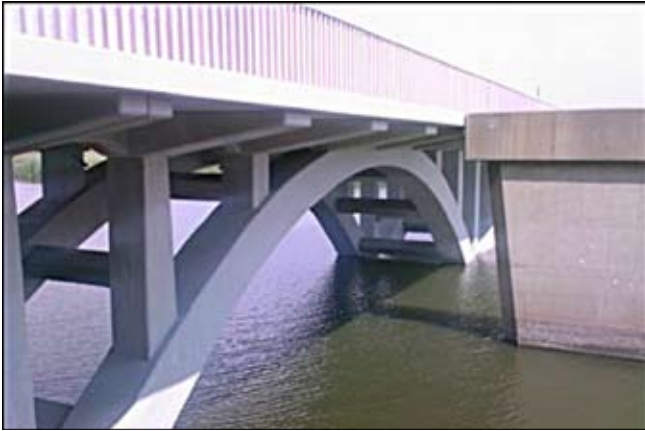
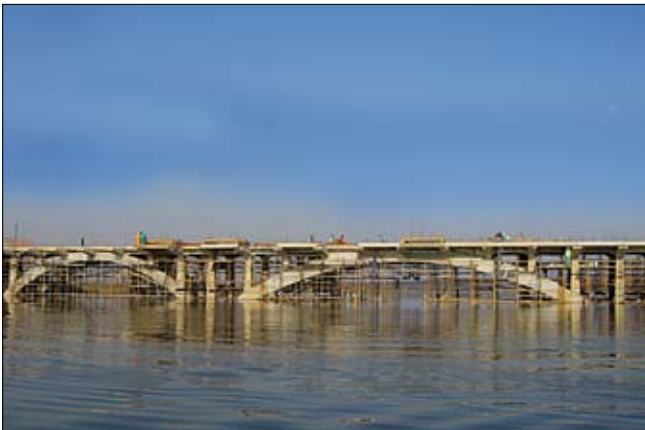
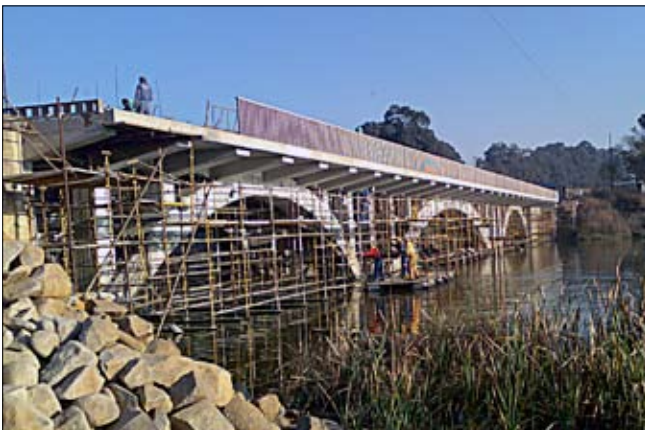
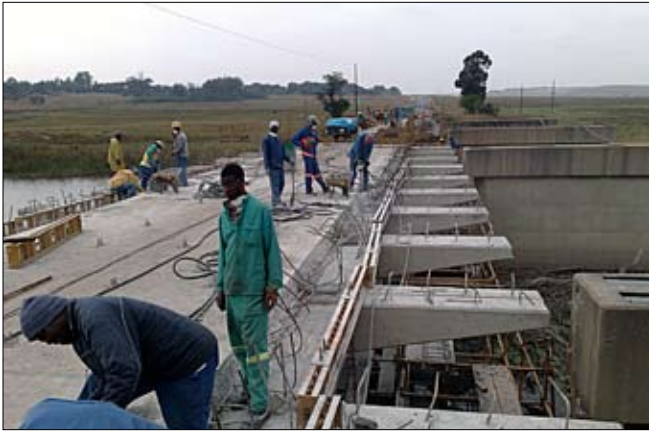
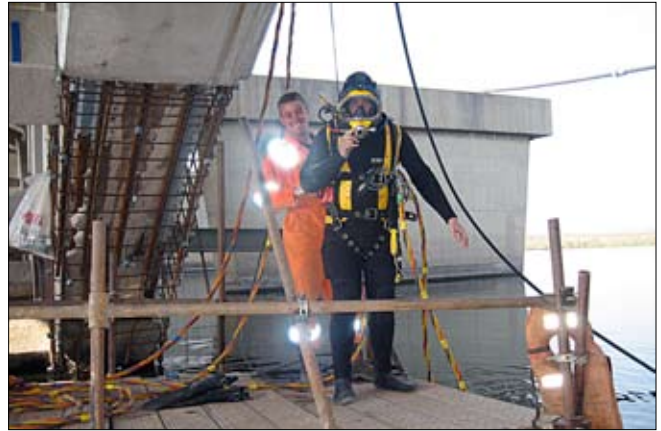
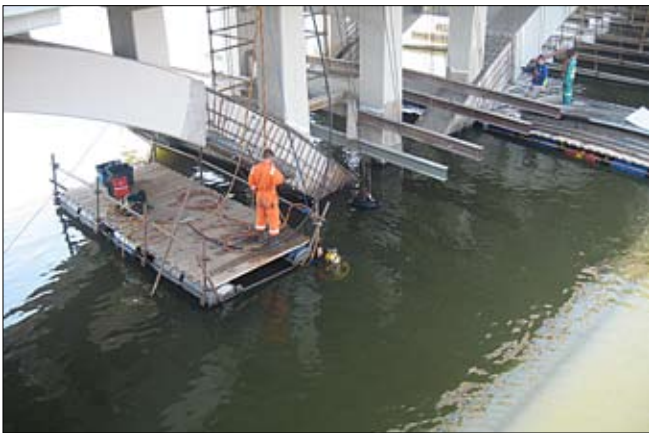
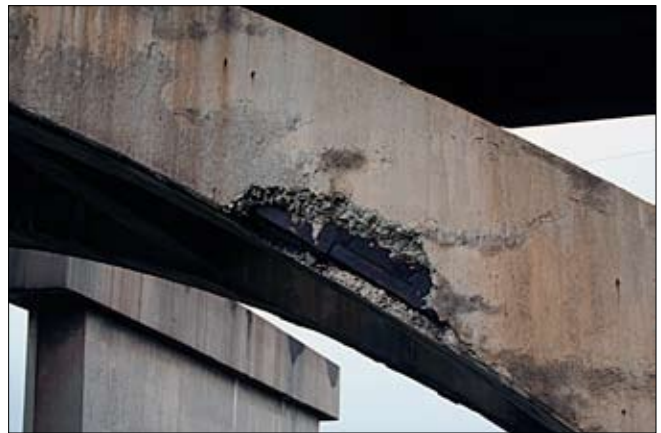
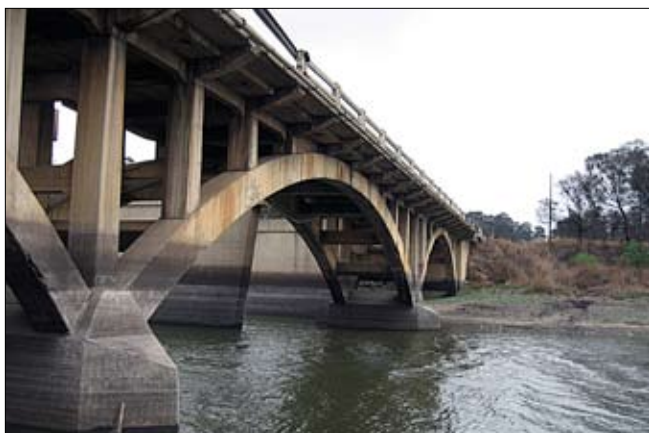
Corrosion had caused cracking and spalling of the concrete on the Brune Bridge, requiring extensive repairs and alterations.

The Pro-Struct 531 M-GP was extended with 12.5 kg of 6.2 mm stone and used for repairs above water. The same was done with Pro-Struct 531 MCI®, below water. The entire bridge was then coated with Pro-Struct MCI®-2020 to prevent corrosion, and then Pro-Struct 684/4 kitty wake grey.
