HIGH PERFORMANCE VpCI® COATINGS

CASE HISTORY

Corrosion Protection System for Electrical Power Plant

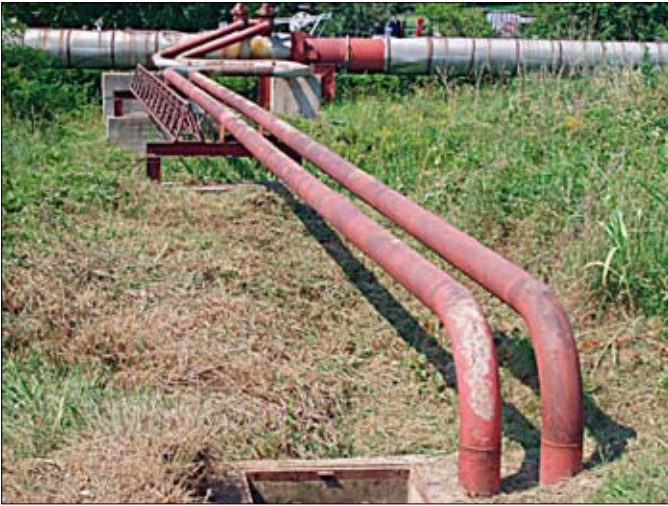
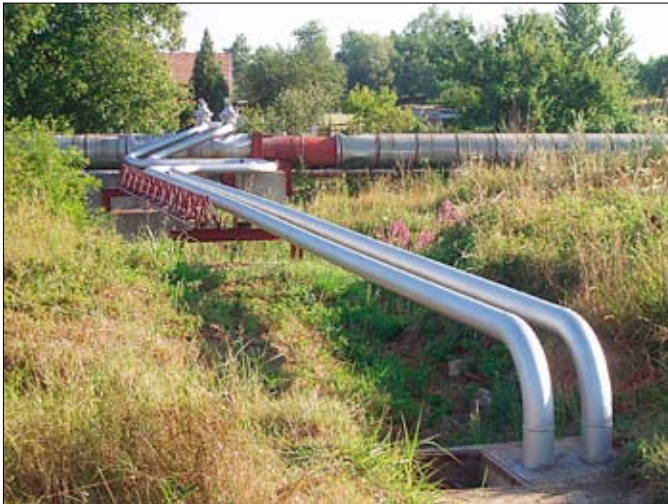
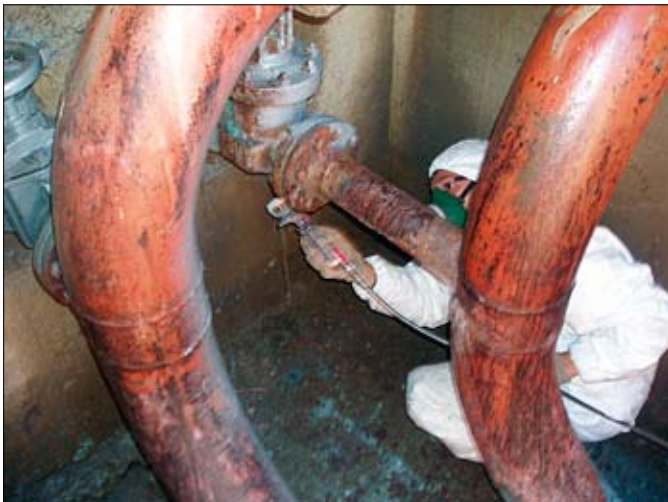
Corseto Co. Ltd. needed to repaint all of their pipe lines and valves due to extreme corrosion. The customer required a system that did not include sand or water blasting as a surface preparation, and was looking for a corrosion protection solution that was easy to apply, cost effective, and environmentally friendly.

The temperatures during function process of the hitting pipes line is 80°C (176°F). First, all the metal surfaces were cleaned by hand to remove mud and loose rust. VpCI Corverter Rust Primer was brushed on and a top coat of VpCI-396 at 80-100 microns was sprayed on the pipes and the valves.
