CASE HISTORY

Rehabilitation of the Cooling Tower for Repsol YPF-Tarragona Refinery

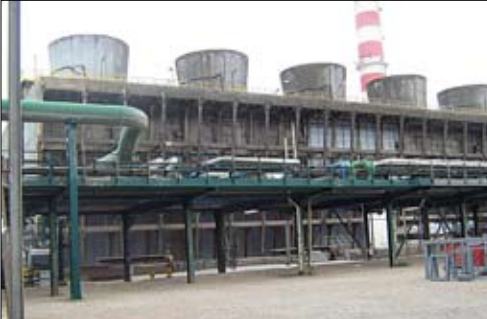
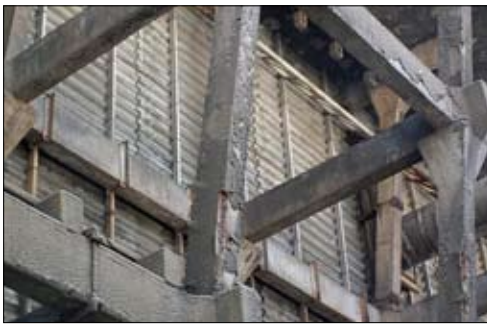
The deterioration of a concrete cooling tower at the Repsol YPF Refinery had occurred from the aggressive environment; which included heavy thermal gradients and constant humidity changes. Spalling of the concrete occurred due to generalized corrosion on the reinforcing steel. The corrosion also affected the strength of the rebar and caused a decrease in the tower's structural integrity. In addition to the evident damage, the goal was to passivate any potential corrosion that was not yet visible.

- Using a very high pressure sprayer (35,000 psi), the spalling concrete and corrosion were removed.
- Q-2023 grout (equivalent to MCI®-2023) was applied to passivate corrosion on the rebar.
- Q-2039 T, a polymeric mortar similar to MCI®-2039, was used to return the concrete structure to its original shape.
- MCI®-2020 was applied to the entire structure using an airless sprayer at the recommended dosage rate.
- Carbon fiber reinforcement, followed by an acrylic, anti-carbonation coating (similar to MCI® Architectural Coating) was applied to restore the structural integrity of the main support beams for the ventilation chimneys.

Cortec's MCI®-2020 was applied to over 2,000 linear meters of concrete pillars along with over 5,000 linear meters of concrete beams in the building. About 1,500 m² of concrete slab was repaired using Quimilock's mortar followed by Cortec's MCI®-2020.
