CASE HISTORY

Kriel Power Station Repair

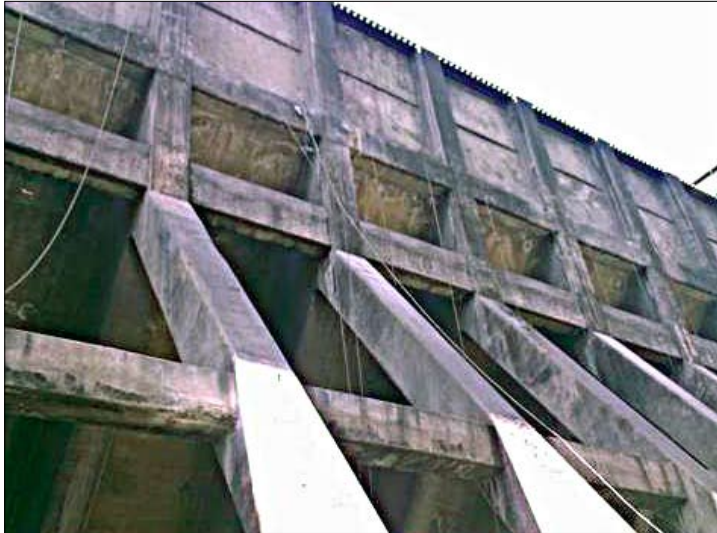
The Coal Staiths at Kriel Power Station needed to be repaired and then coated in order to prolong the lifespan of the structures.

Defective concrete was removed and replaced with repair mortars containing MCI-2006 NS. The corrosion inhibitor was added to the repair mortar mixes prior to application to add corrosion protection to the reinforcement within, and surrounding the patch. After all patchwork was completed, both of the structures were then coated with MCI-2020 to ensure corrosion rate reduction on the rest of the embedded reinforcement.
