HIGH PERFORMANCE VpCI® COATINGS

CASE HISTORY

Corrosion Protection for Steel Tank Farm

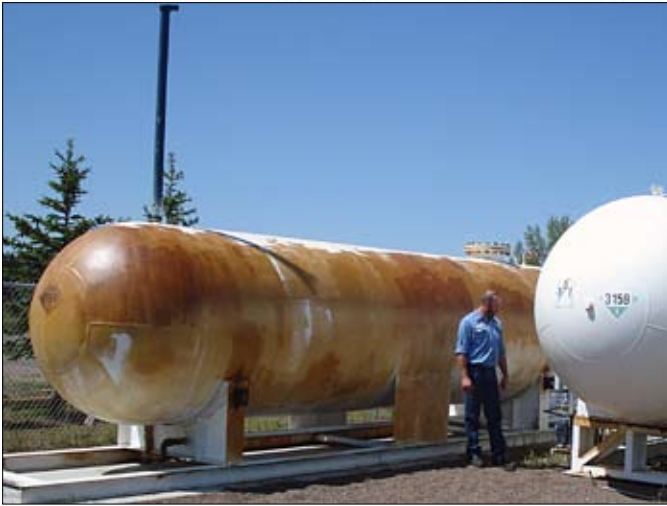
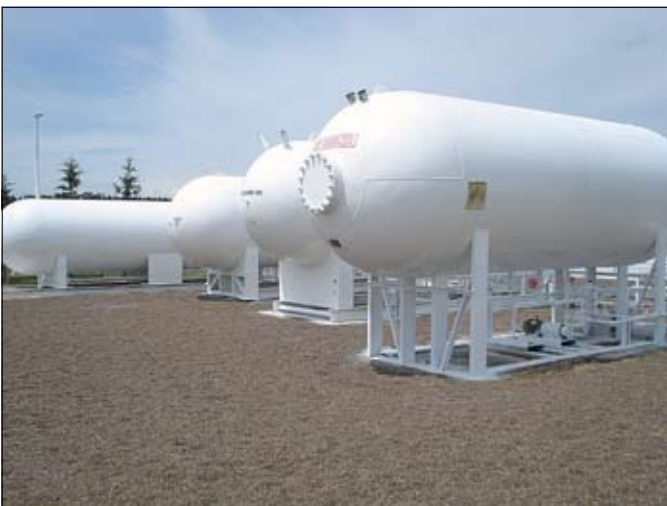
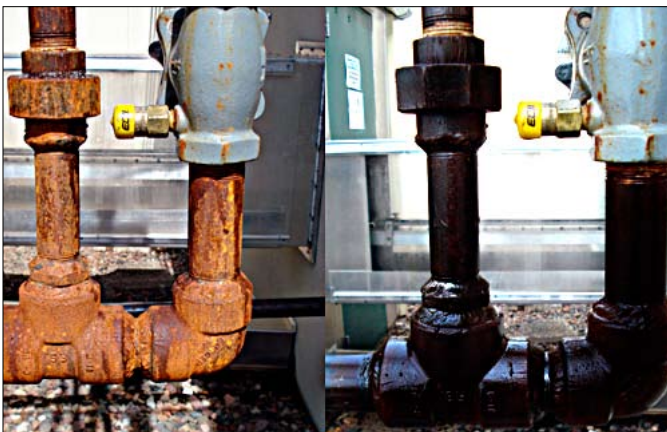
The steel tanks and piping supplying aerosol operations to a contract filling and private labeling plant were exhibiting corrosion. According to the 2011 National Fire Protection Association regulations, all tank farms are required to be protected from corrosion. The customer was looking for an easy, long lasting, cost effective solution to their corrosion problem.

The tanks and piping were pretreated with VpCI® -415 cleaner/degreaser, pressure washed, then rinsed with fresh water. Once dry, the corroded areas were coated with CorrVerter®, then VpCI® -386 White was sprayed on as a topcoat. The application process took approximately 3 days to treat 4 tanks and 200 feet of piping.

The tanks and piping have lasting corrosion protection and will continue to be regulation compliant. Cortec® products have provided an easy, cost effect solution to help maintain this customer's needs. The physical appearance of the tanks and piping is superior to previous painting attempts; and an extended service life is expected.
