# CASE HISTORY

## Iceland Residential Concrete Repair and Renovation

March - June 2010

Reykjavik

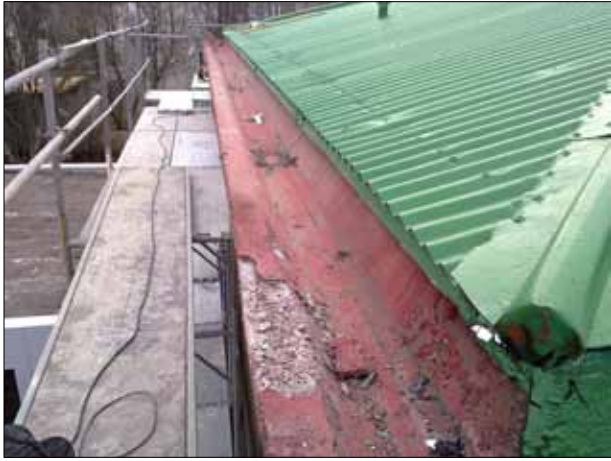
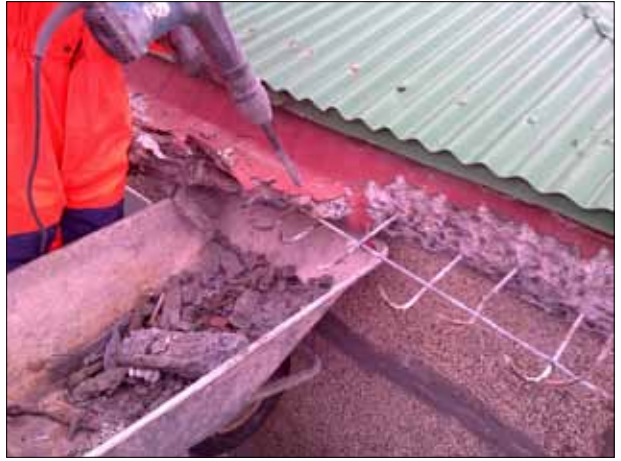
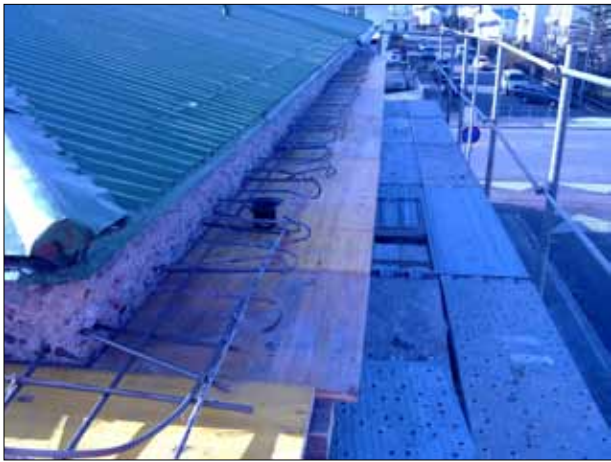
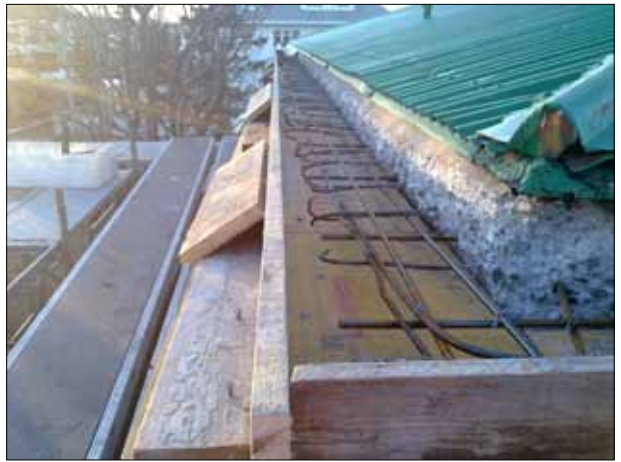
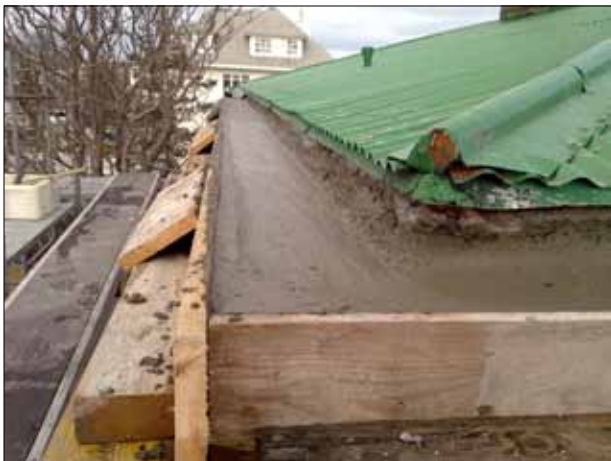
Being built before World War II, the house had various structural problems. No repairs had been completed for over 70 years. Due to the age and years of freeze-thaw cycles, the concrete had become extremely deteriorated and began to leak, crack, and spall. In some areas, extreme spalling exposed steel reinforcement that was heavily corroded.

MCI® -2006 NS and MCI® Mini Grenades were added to repair mortars in order to rehabilitate the spalling concrete. MCI® Fiber Grenades were used along with Xypex Waterproofing Admixture in the replacement of the concrete gutters around the entire house. MCI® -2241 was applied to the cured concrete gutters to ensure waterproofing. All of the concrete repairs totaled over 50% of the house.
