CASE HISTORY

Longboat Key Florida Roof Protection

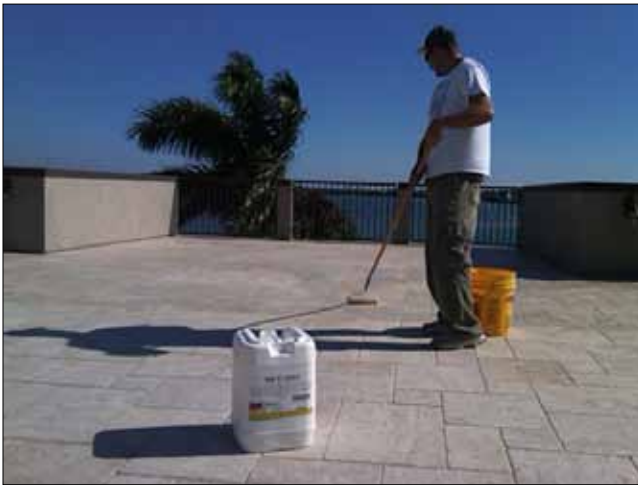
The marble roof deck had been exposed to Florida sun and aging since 2004 when the home was constructed. It needed to be sealed to protect it from water ingress and to extend its life.

MCI®-2022, a silane/siloxane based water repellent containing migrating corrosion inhibitors was applied to the marble at the recommended coverage rate of 150 square feet/gallon (3.68 m²/liter)

Cortec's MCI®-2022 is providing the much needed water repellency to the roof, allowing it to remain in service for years to come.
