CASE HISTORY

BOP Equipment Preservation

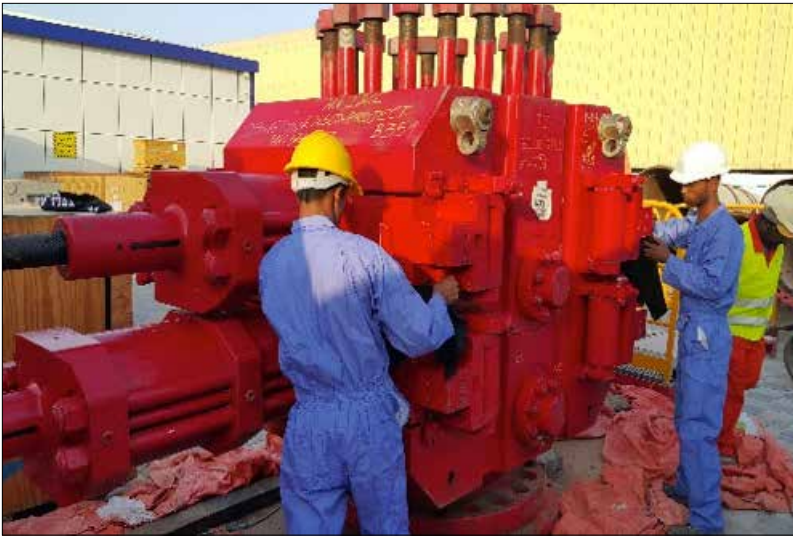
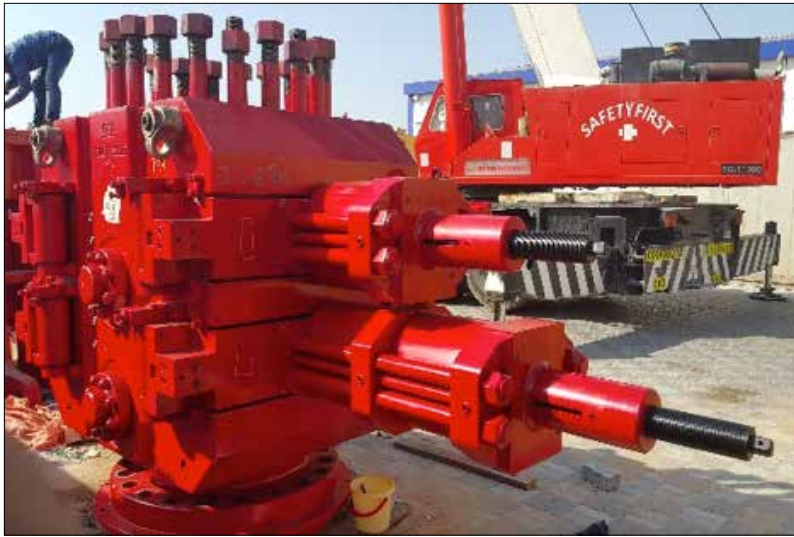
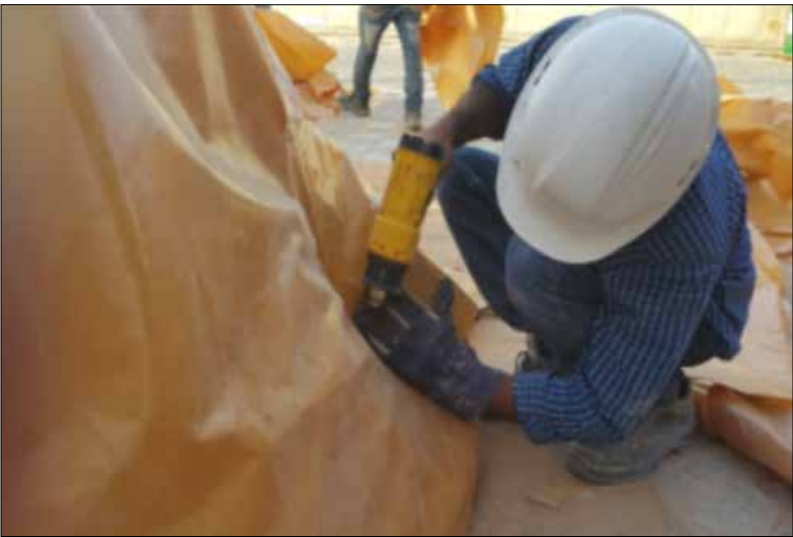
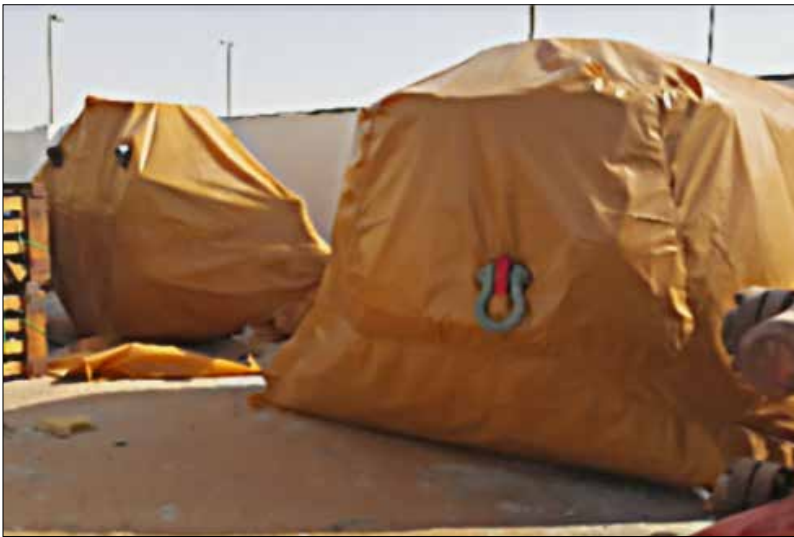
- Equipment was hand cleaned and then VpCI®-414 was brushed on to prepare the surface for the new coating.
- VpCI®-386 was applied to all painted surfaces and VpCI®-368 to all bare surfaces.
- Internal void spaces were protected by placing VpCI®-308 Pouches inside the cavity.
- Equipment was then wrapped with MilCorr® VpCI® Shrink Film to prevent the ingress of dust to the unit and provide additional corrosion protection.

The equipment was effectively and efficiently preserved with Cortec® products at the yard where they were stored. Following which they were moved to a new storage location, access to lifting lugs was maintained and the MilCorr® wrap was durable enough that it did not tear or rip during transit, pleasing the client.
