# CASE HISTORY

## Port Container Handling Cranes Preservation

December 2012

Andaman Lakshadweep Harbour Works (ALHW)

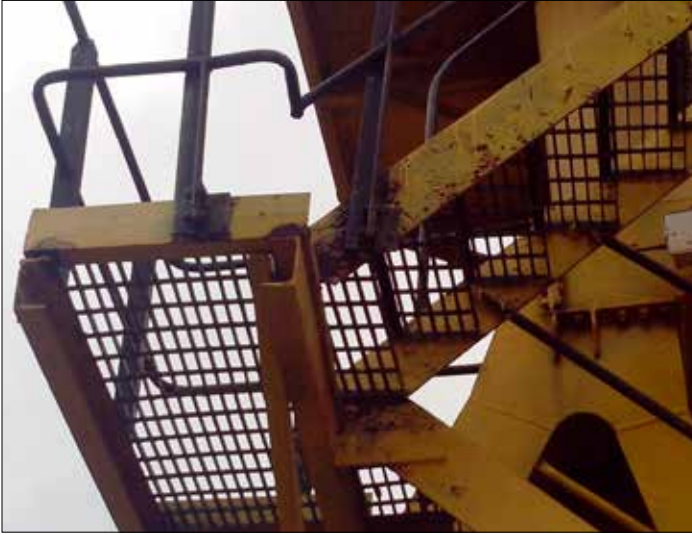
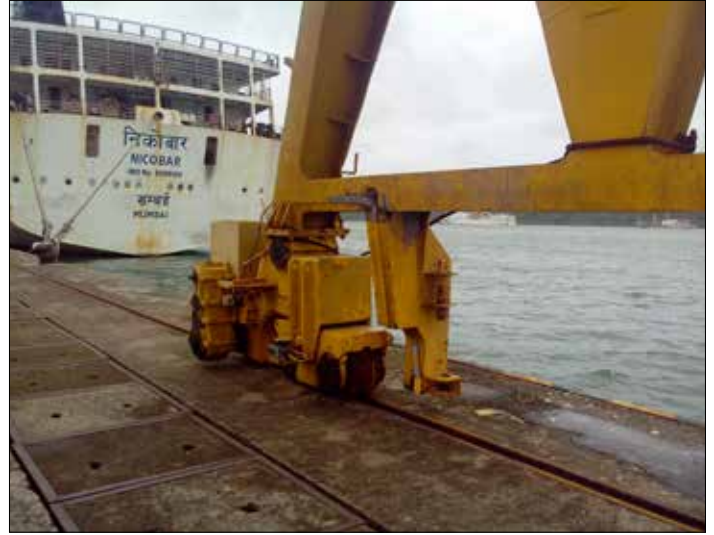
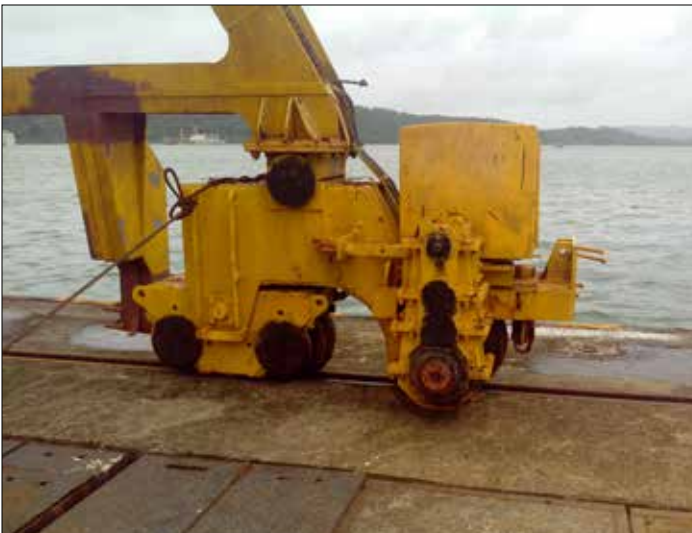
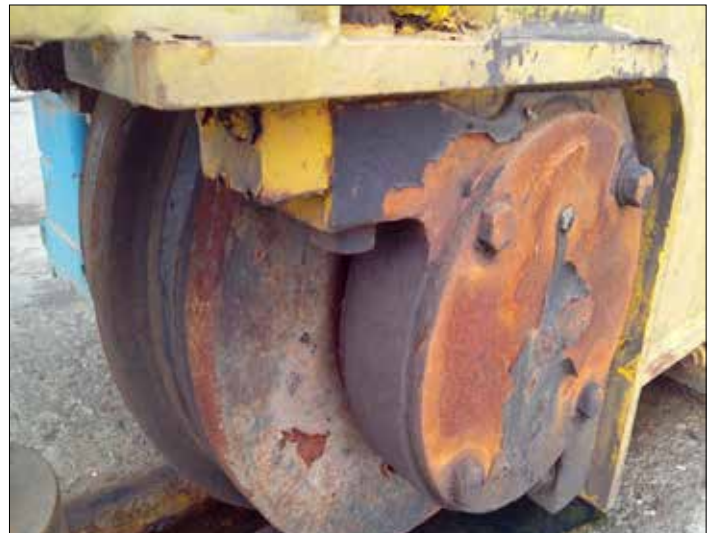
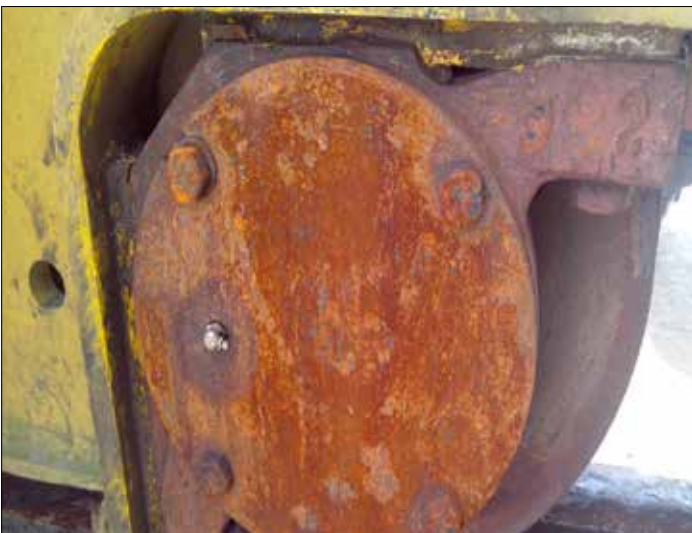
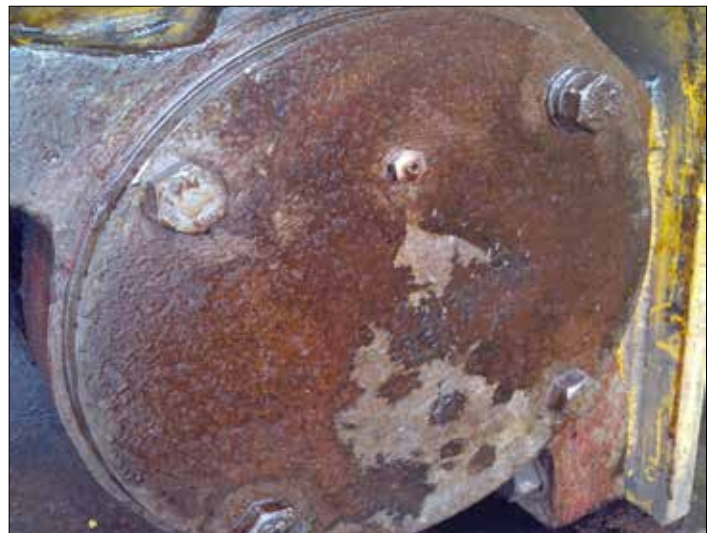
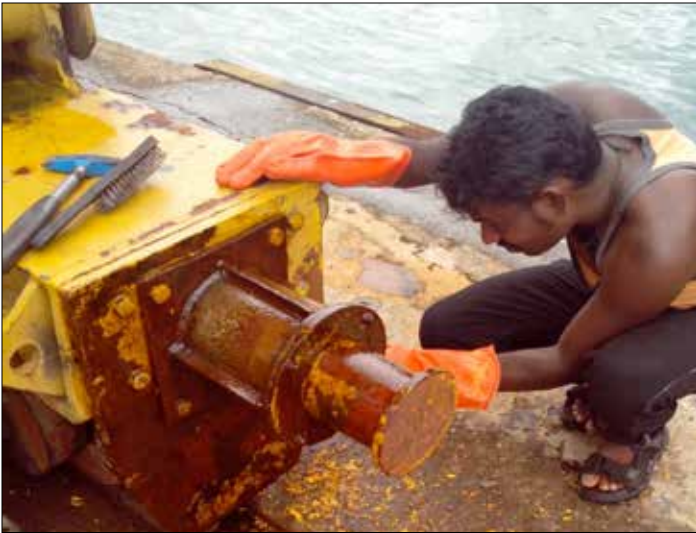
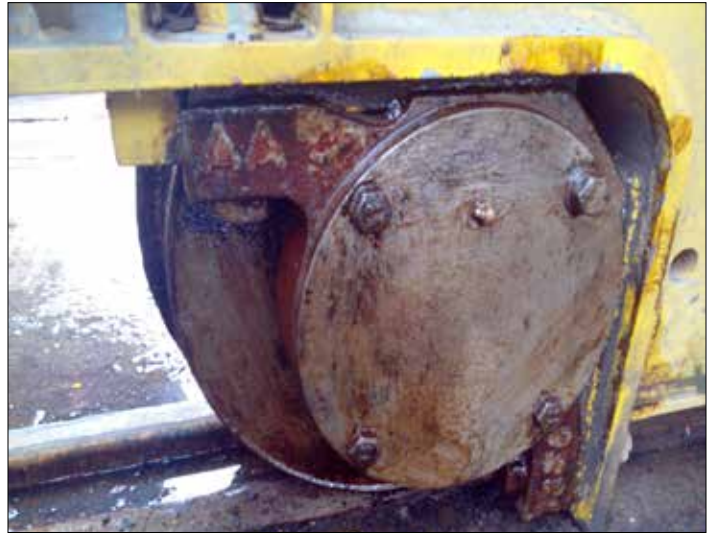
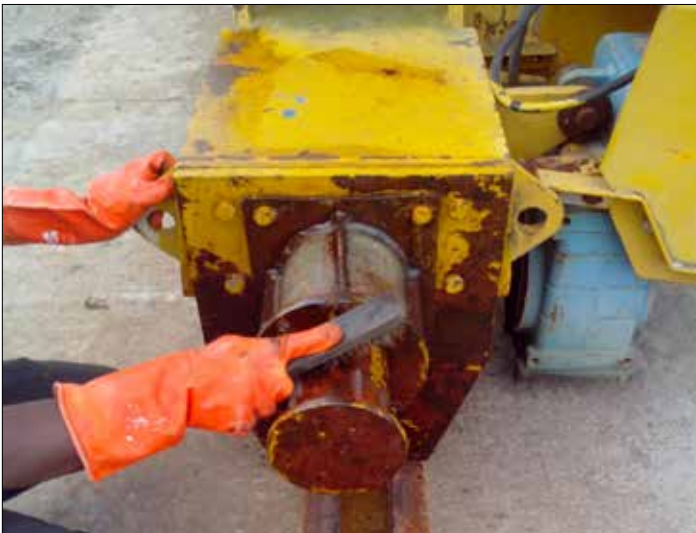
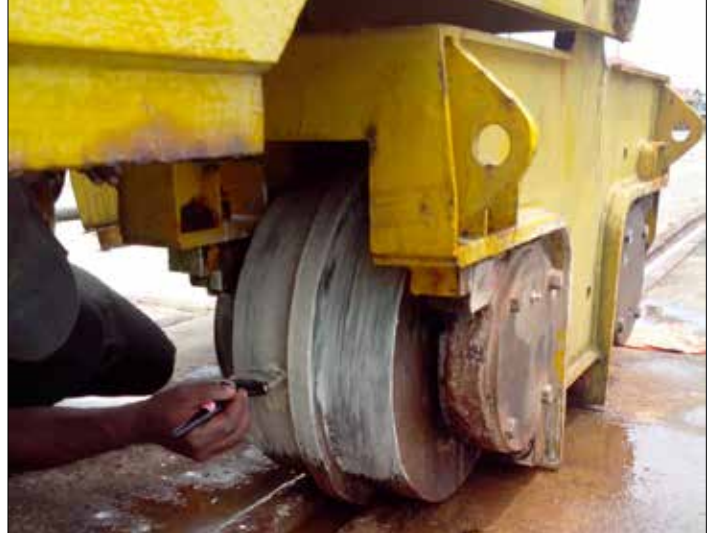
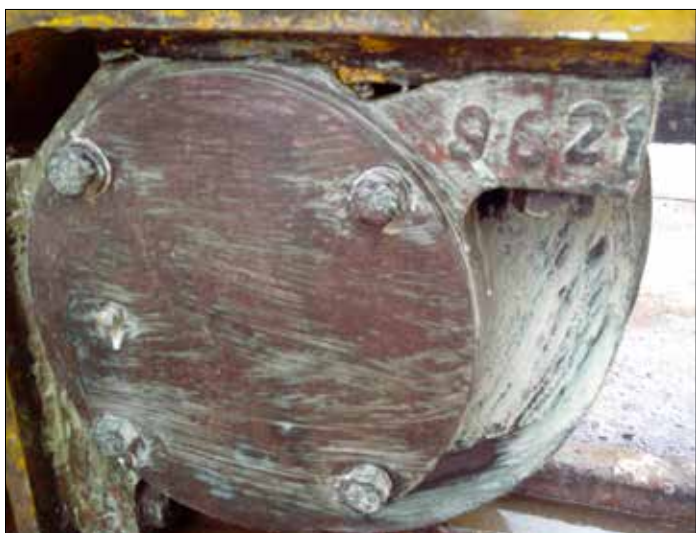
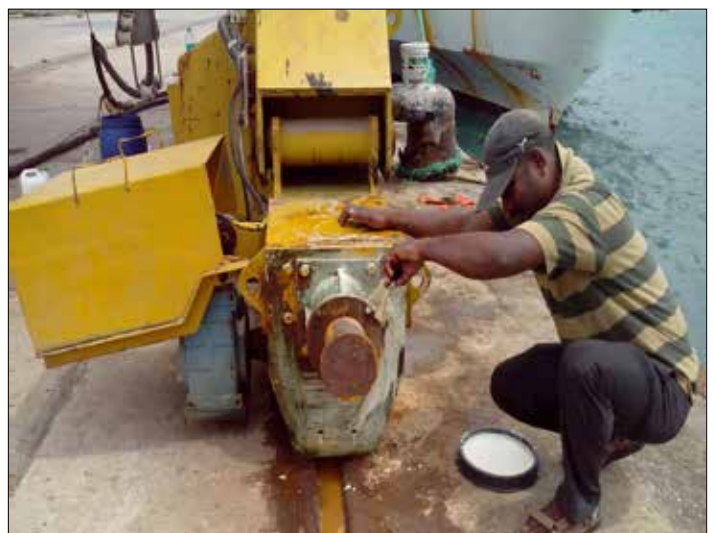
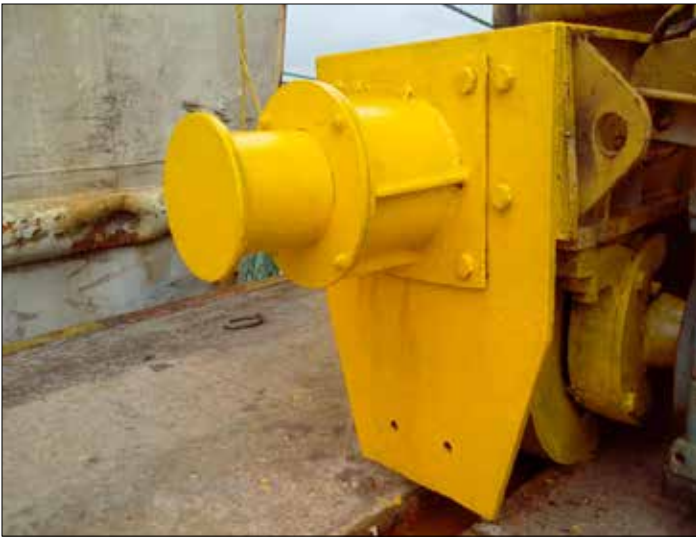
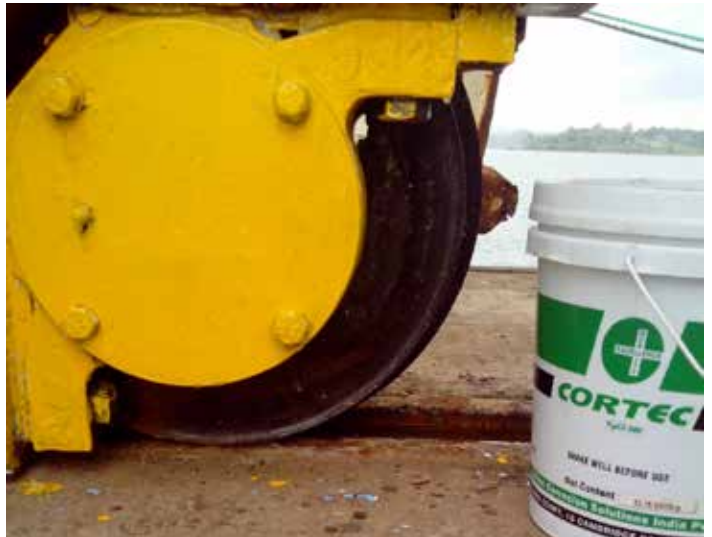
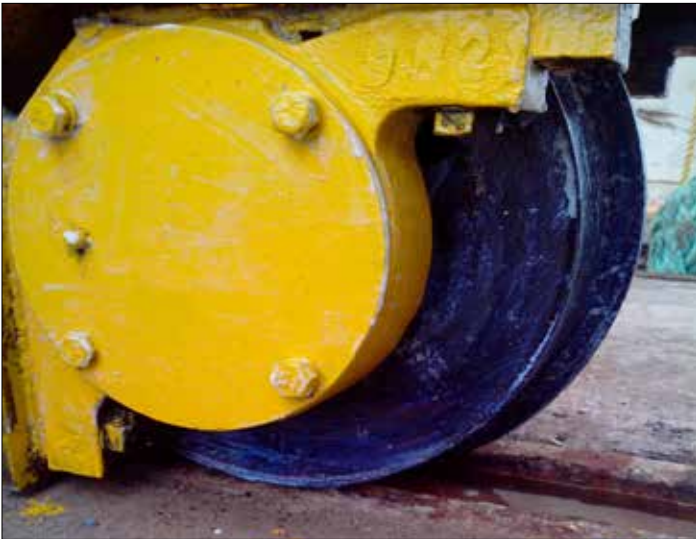
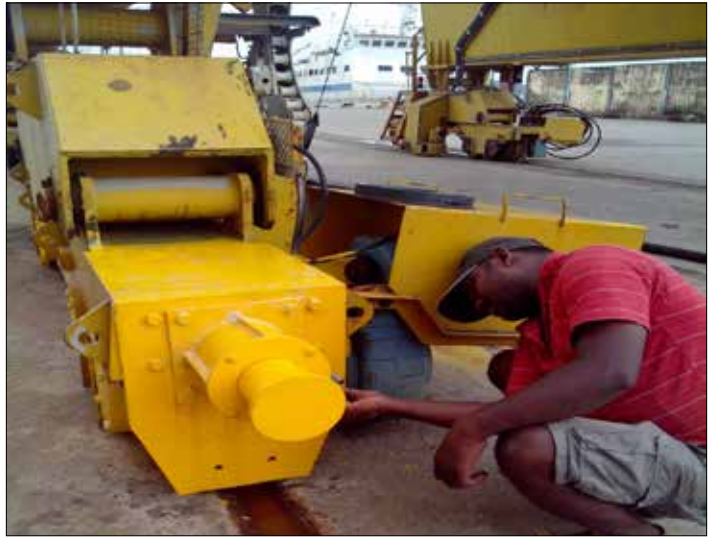
SIASCO Associates was entrusted with the job of protecting the ALHW cranes. SIASCO cleaned the rusted areas with a wire brush and then applied Cortec's VpCI®-423 Gel on the cranes, leaving it to soak for one hour. They then washed the surfaces with VpCI®-418 L and after cleaning, CorrVerter® was applied as a primer followed by two coats of VpCI®-386. The customer's yellow-colored paint was then applied as a final top-coat.

After one month, there was no corrosion. The customer was satisfied and planned to have the rest of the cranes refurbished soon in a similar fashion. Since then, the customer has been releasing cranes or crane components for refurbishment of corroded areas as their budget permits.
