# CASE HISTORY

## Valve Bonnet Spares Preservation

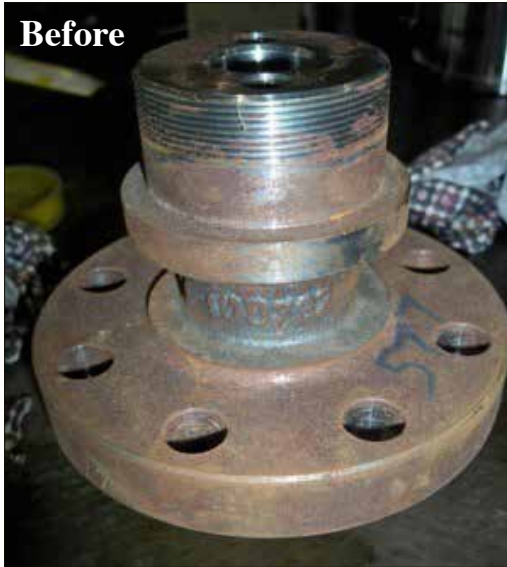
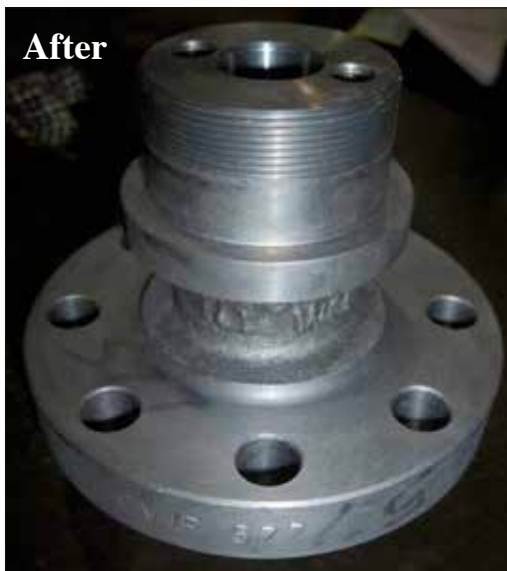
GE wanted to use valve bonnet spares that had been stored for more than five years and were in a rusted condition. GE's policy did not permit phosphating or any other harmful chemical process, so an environmentally friendly rust removal product was needed.

Cortec® VpCI®-422, an organic and biodegradable rust remover, was applied to the valve bonnets and neutralized with VpCI®-419 cleaner/degreaser. It only took 45 minutes to remove the rust, and the bonnets were soon restored to a ready to use condition.
