CASE HISTORY

Assembly Part Preservation

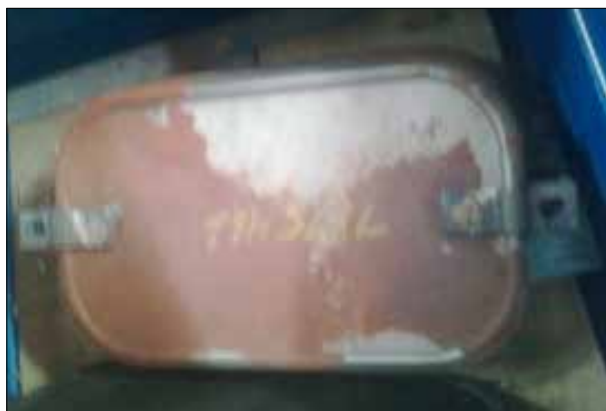
Before

The customer was facing corrosion issues on assembly parts. They wanted a cost-effective, eco-friendly rust preventive product that would not affect painting.

Rust was removed from parts with VpCI®-422, an organic rust remover. Parts were then washed with VpCI®-418 L cleaner/degreaser. Finally, VpCI®-377 was applied at 5% dilution as a rust preventive. This leaves a clear, hydrophobic film that can be coated over with conventional paint systems.

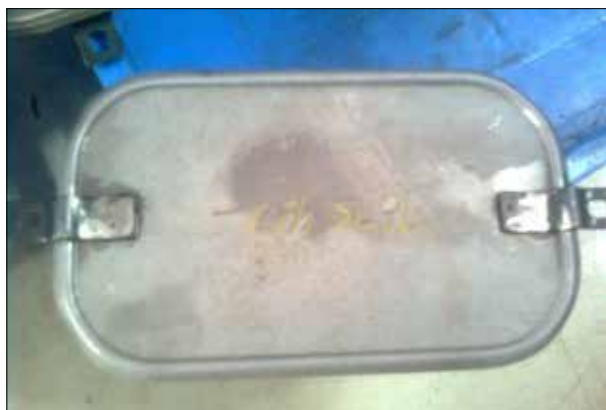
After

The rust remover was eco- and user-friendly, and the customer was satisfied with the rust prevention of VpCI®-377, which has a good surface finish. By using this system, the customer's effective cost was significantly reduced.
