# Protecting the Historic ZAGREB CATHEDRAL

The famous Zagreb Cathedral is the tallest and one of the most beautiful buildings in Croatia. It attracts thousands of tourists from around the world, and it was left to Cortec to provide a solution to help with its restoration.

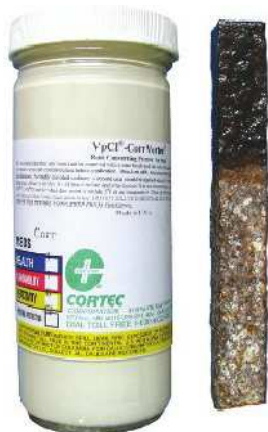
The famous neo-gothic towers of the Zagreb Cathedral were restored using Cortec's CorrVerter

During reconstruction work on the south tower, the steel bands which were surrounding the tower at approximately every 3m were found to be damaged. Most of the bands were covered in rust, and in the drainage areas visual damage to the thickness of the bands could be seen.

CorrVerter® is a water-based primer that quickly converts rust into a protective layer and is capable of penetrating into the depths of corroded surfaces. It contains a novel chemical chelating agent that modifies surface rust into a hydrophobic passive layer. Two-layers of the CorrVerter® coating were applied directly onto the metal bands; brushed onto the smaller surfaces and sprayed onto larger areas. Steel fishplates were then welded onto the bands for reinforcement and also protected with CorrVerter®.
