## MCI<sup>®</sup> Polyfilm Continued

## Salt Storage Facility Case History

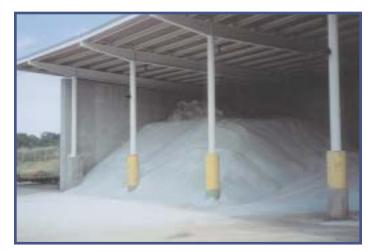
In early August, employees from Cortec Corporation and American Engineering Testing (AET) updated corrosion rate readings and chloride levels on the Hennepin County Salt Storage Facility in Medina, Minnesota. This facility was built in 1997, using MCI 2000 in the mix design, and stores road salt for county trucks. The majority of the facility is filled with salt 10 months out of the year, and the walls are damp, creating a very corrosive environment.

Hennepin County Salt Storage Facility in Medina, Minnesota

AET performed chloride analyses on core samples taken from the lower portion of the wall where the most salt exposure had occurred. This analysis showed that chloride levels at the bar had already exceeded the level upon which active corrosion will begin. However, corrosion rate and copper/copper sulfate half-cell potential readings taken with the Gecor 6 device indicated that there was actually very little corrosion occurring. This was confirmed with a visual inspection of the bar in the location where the chloride levels and corrosion rate readings were taken. This is another excellent example of how MCI 2000 is effective in mitigating chlorideinduced corrosion.
