PROTECTION AND REPAIR OF REINFORCED CONCRETE STRUCTURES BY MEANS OF MCI-INHIBITORS AND CORROSION PROTECTIVE MATERIALS

It is also described the procedure of the restoration with the MCI-inhibitors and materials contained this inhibitors of the reinforced concrete structures of the module no. 3 on the wharf mo. 5 in the harbour Ploče.

4. PROCEDURE OF THE RESTORATION OF THE REINFORCED CONCRETE STRUCTURE OF THE MODULE NO.3 ON THE WHARF NO.5 IN THE PORT PLOČE CARRIED OUT DURING THE YEAR 2005

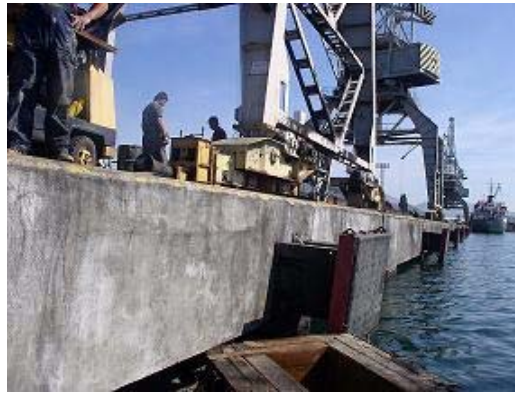
Figure 1: The module No. 3 in port Ploče

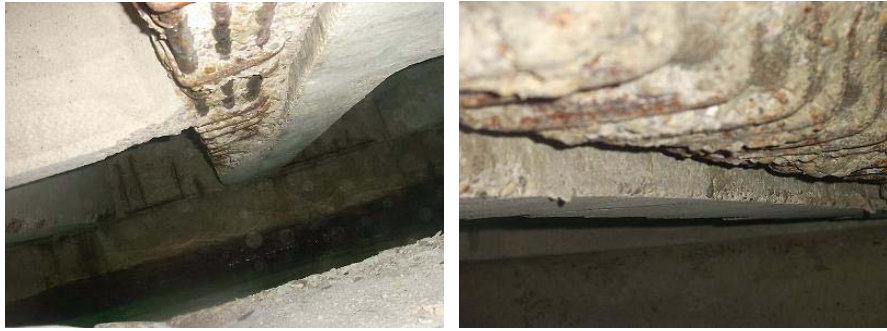
Figure 2.: Impregnation concrete surface

Impregnation of the entire concrete surface was with the water solution (1:4) of the corrosion inhibitor MCI – in powder. Application was with the brush or roller in 2 layer of the total yield cca 25 m²/kg.

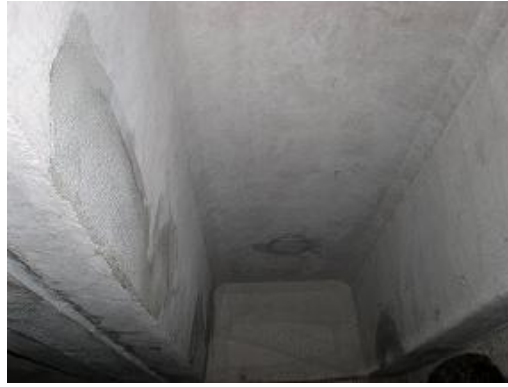
Figure 3.: Reprofiling concrete surface

Reprofilation of the concrete surface and the covering of the exposed reinforcing steel was performed with the repair mortar containing MCI-inhibitor, with the manual application in 1-3 layers depending on the total thickness of the mortar layer (on some areas mortar thickness even to 8 cm). Freshly applied repair mortar needed “curing”/protection against to fast drying and loss of technological moisture. On the concrete surfaces of the faces of the wharf, exposed to the insolation and to the air circulation, freshly applied repair mortar was protected from the to fast drying by means of the curing on the basis soya oil containing MCI inhibitor, applied with the brush or roller in one layer, yield ca 5 m²/l.

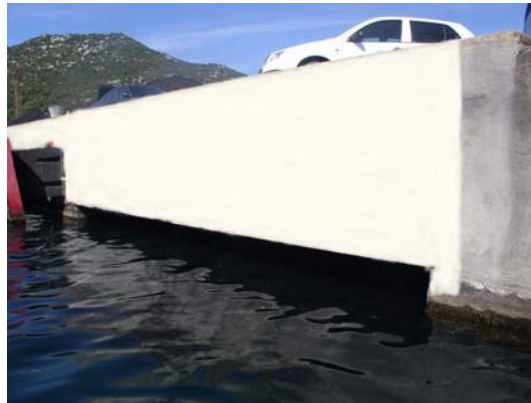
Figure 4.: MCI coating on the concrete surface

Protection of the entire surface, i.e. concrete and reprofiled with the repair mortar, from the impact of the moisture and atmospheric agents was performed with the protective-decorative coat, or hydrophobic impregnation:

- *Wharf face* was treated with the protective-decorative coat (colour light gray) on the basis of 1-k acrylate binder containing MCI-inhibitor, applied with the brush or roller in two layers of the total yield ca 8 m²/l and,

- *Concrete surfaces on the soffit and in the interior of the structure* were protected with treatment with the hydrophobic impregnation on the basis of silane-syloxane in the water medium containing MCI-inhibitor, application with the brush or roller in 1-2 layers, treated surface does not change appearance or colour, yield, ca 3,5m²/l.
