Paper No.  
**09488**

## **NOVEL APPROACH TO TANK LINING COATINGS**

**Angel Green**  
**Cortec Corporation**  
**4119 White Bear Parkway**  
**White Bear Lake, MN 55110**  
[agreen@cortecvci.com](mailto:agreen@cortecvci.com)

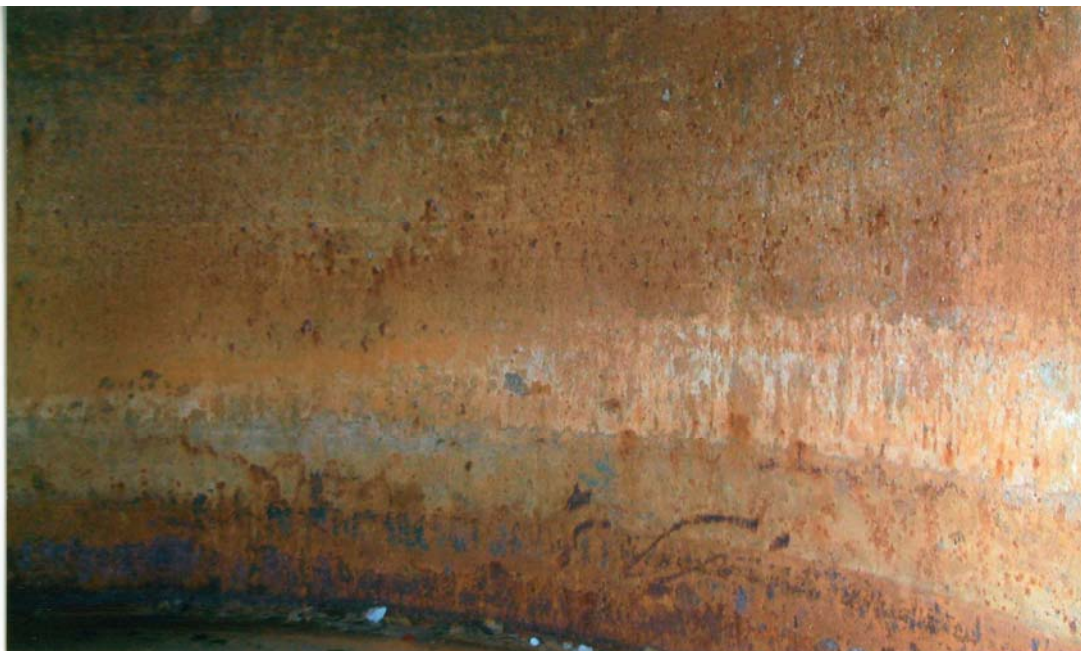
FIGURE 6 - Inside of Uncoated Holding Tank

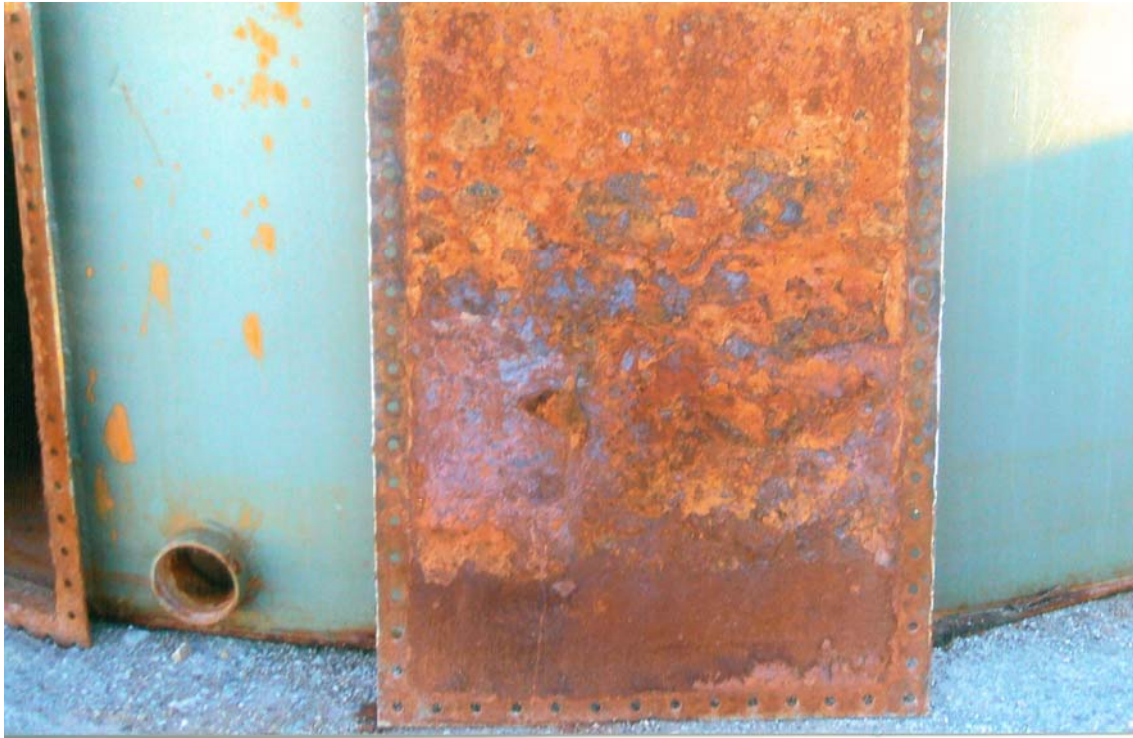
FIGURE 7 – Uncoated Holding Tank Hatch

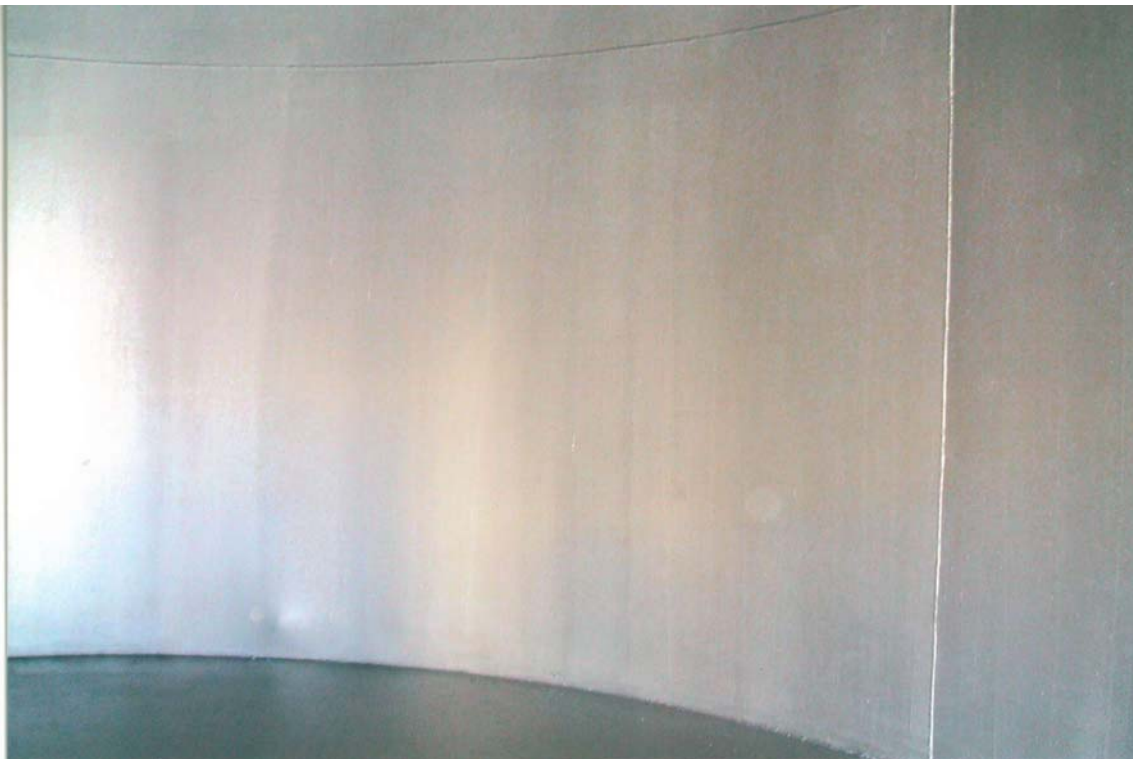
FIGURE 8 - Inside of Coated Tank

1. Laboratory and field measurements show that the coating system of a low VOC rust - converting water-based primer and a high solids moisture-cure urethane coating conforms to the performance criteria for tank lining systems containing hydrocarbon and/or high salinity solutions.
2. The observations made of the field applications have shown that the coating system is protecting the tanks from corrosion for the last 2 years. There were minimal signs of corrosion observed at the 2 year point.
