MMP MATERIALS PERFORMANCE

Method developed to protect 'insurance spares'

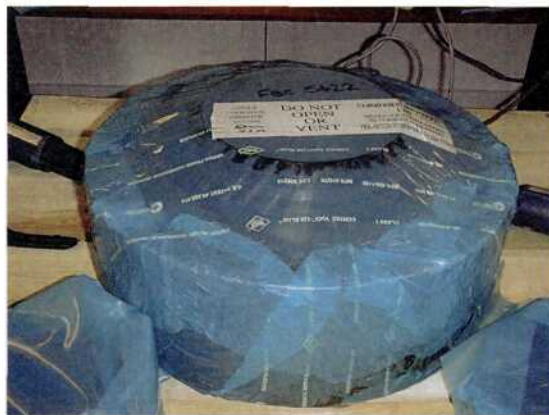
A spare flange receives protection from a thin film of inhibited grease in a VpCI polyethylene film. Photo courtesy of CSL.

and primers, but these obviously do not last." Durham's company has developed and managed a preservation maintenance program for insurance spares that entails blowing a powder vapor phase corrosion inhibitor (VpCI) manufactured by Cortec Corp. (St. Paul, Minnesota) through pipe and then capping and sealing them. "This gives protection to the entire internals of the pipe via a chemically adsorbed film, which provides a molecular film," explains Durham, noting that flanges and clamps are protected by a thin film of inhibited grease in a VpCI polyethylene film. "This form of protection will protect bare steel and will prolong the life of any coating that may have been applied." External surfaces are protected using a VpCI wax coating, says Durham, who adds that
