## **Corrosion Protection of Steel Rebar in Concrete with Optimal Application of Migrating Corrosion Inhibitors, MCI 2022**

(Report #1137)

**Behzad Bavarian, PhD**

**March 2003**

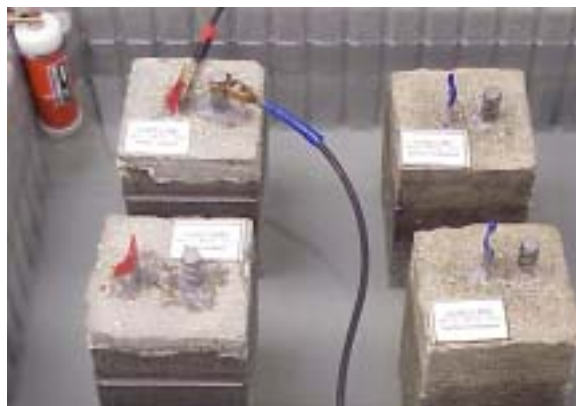
**Figure 1.** This photo shows four of the concrete samples partially immersed in a 3.5% NaCl solution.

Two of the concrete blocks were surface impregnated with several coats of MCI 2022 and set to dry. The inhibitor was applied to the surface of the concrete with a paint brush while partially immersed in a shallow container of inhibitor. Mortar samples were prepared using a 10 lb (4.5 kg) bag of Quikrete mortar mix, 100 ml MCI 2022 and 800 ml water. The remaining two samples were left untreated and used as standards for comparison. Clear silicon was applied to the concrete/metal interface to prevent easy access for ions. Figure 1 shows the samples partially immersed in a solution of 3.5% NaCl and water; roughly 7 inches of each sample was

continuously immersed in the solution for the entire testing period. A Cu/CuSO<sub>4</sub> electrode was used as the reference and each sample was tested approximately every two weeks. The results were compared with previous investigations conducted on several admixtures and stainless steel rebar.

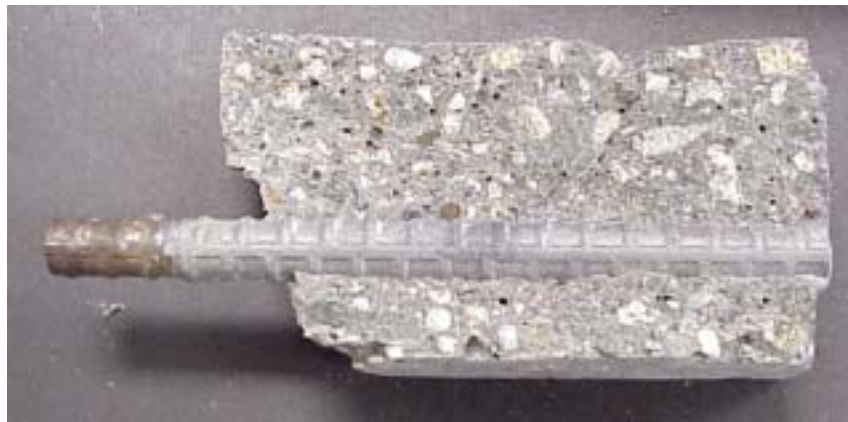
**Figure 8. This photo shows the treated rebar still embedded in the concrete and the portion of the rebar that was exposed to the corrosive environment.**

After 415 days of immersion in a NaCl solution, several samples were removed from testing for XPS analysis and depth profiling. The rebar was removed from the concrete (Figures 8 & 9) and its surface chemistry was assessed. Figure 10 shows the XPS spectrum from untreated rebar sample after 450 days. It is similar to the spectrum shown in Figure 11 for the rebar removed from an MCI treated sample after 415 days.
