Evaluating Various Protection Methods for Copper Tubing from Erico International

Project #: 07-271-1125

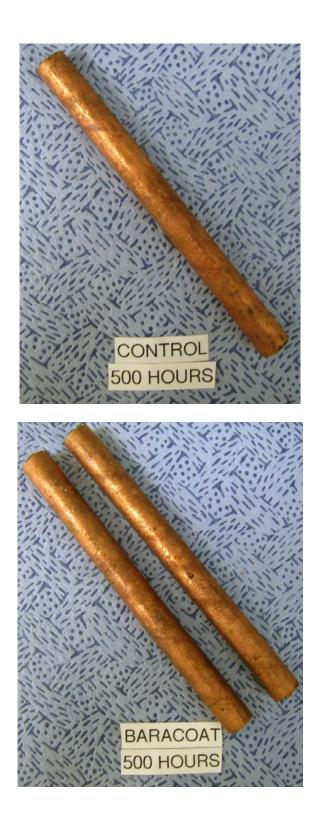
Treatment	Time to Failure (Hours)
Control	<24
Light Blue Film	72
Armor Film	72
Baracoat Liquid	<24
VpCI-316	168
VpCI-126	DNF*
