Evaluating SRPO Product and Comparing
to Similar Cortec Products

Project #: 07-293-1325

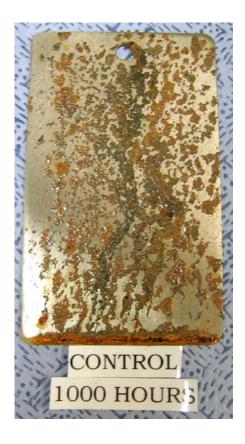
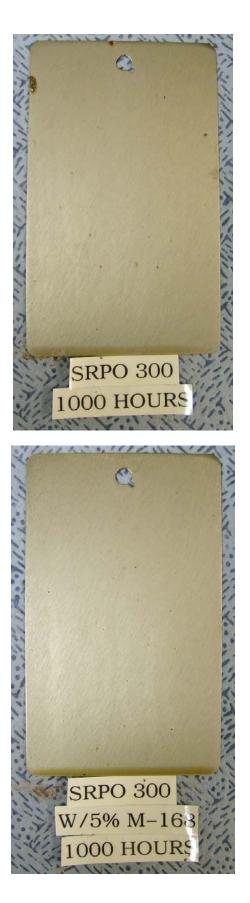
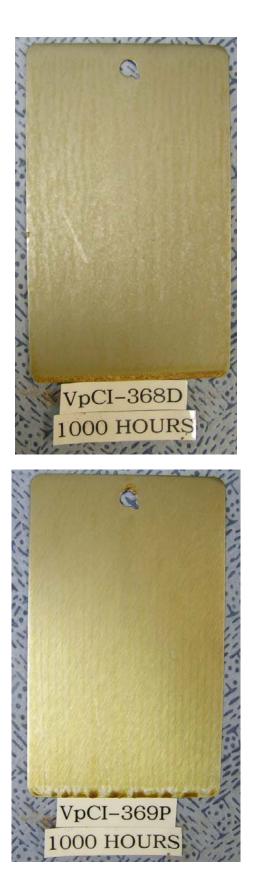
Panel	Time to Failure (Hours)
A1	192
B1	DNF*
C1	DNF*
D1	DNF*
E1	<24

Conclusion: The two VpCI products greatly outperformed the SRPO product currently being used by Red Man Pipe. Both of these products provided excellent corrosion protection for the 1000 hour test period. Although the corrosion on the SRPO panel was light (~5%), corrosion first appeared after only 192. The addition of Cortec M-168 lead to greatly increased protection, with no corrosion present during the 1000 hour test period.
