Evaluating Ferrocote 118 and BioCorr for Customer

Purpose: To compare the corrosion protection of Ferrocote 118, VPCI-418LM and BioCorr on cast

Project #: 10-079-1625(bis)

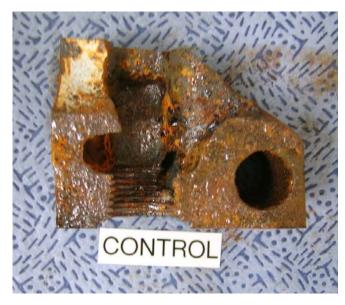
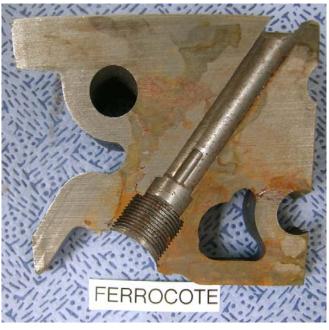
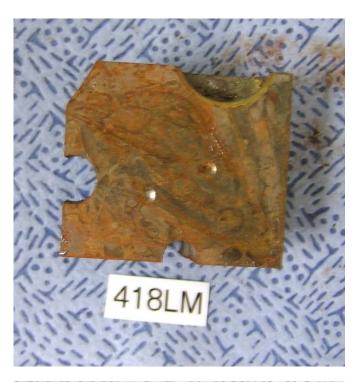
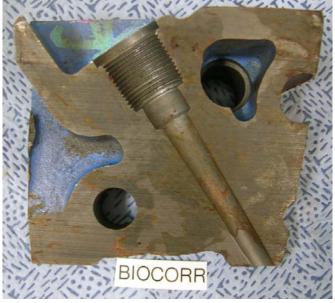
- 3) After dipping, all parts were allowed to air dry overnight.
- 4) After drying, all parts were packaged in non-VCI PE bags.
- 5) All parts were then placed in ASTM D-1735 water fog cabinet.
- 6) All parts were visually inspected periodically.
- 7) After 384 hours, all parts were removed from ASTM D-1735 water fog testing.
- 8) All parts were visually inspected and photographed.

Product Used	Time to Failure (Hours)
None (Control)	<8
Ferrocote + Non-VCI PE	216
VpCI-418LM + Non-VCI PE	120
BioCorr + Non-VCI PE	360

Based on the cast iron composition of these parts, a secondary rust preventive step (after cleaning) will be necessary for corrosion protection. BioCorr provided superior corrosion protection to the Ferrocote product currently used by customer.
