Evaluating Rust Preventive Systems for Mursix

Project #: 11-147-1825 (supplemental)

Date: August 31, 2011

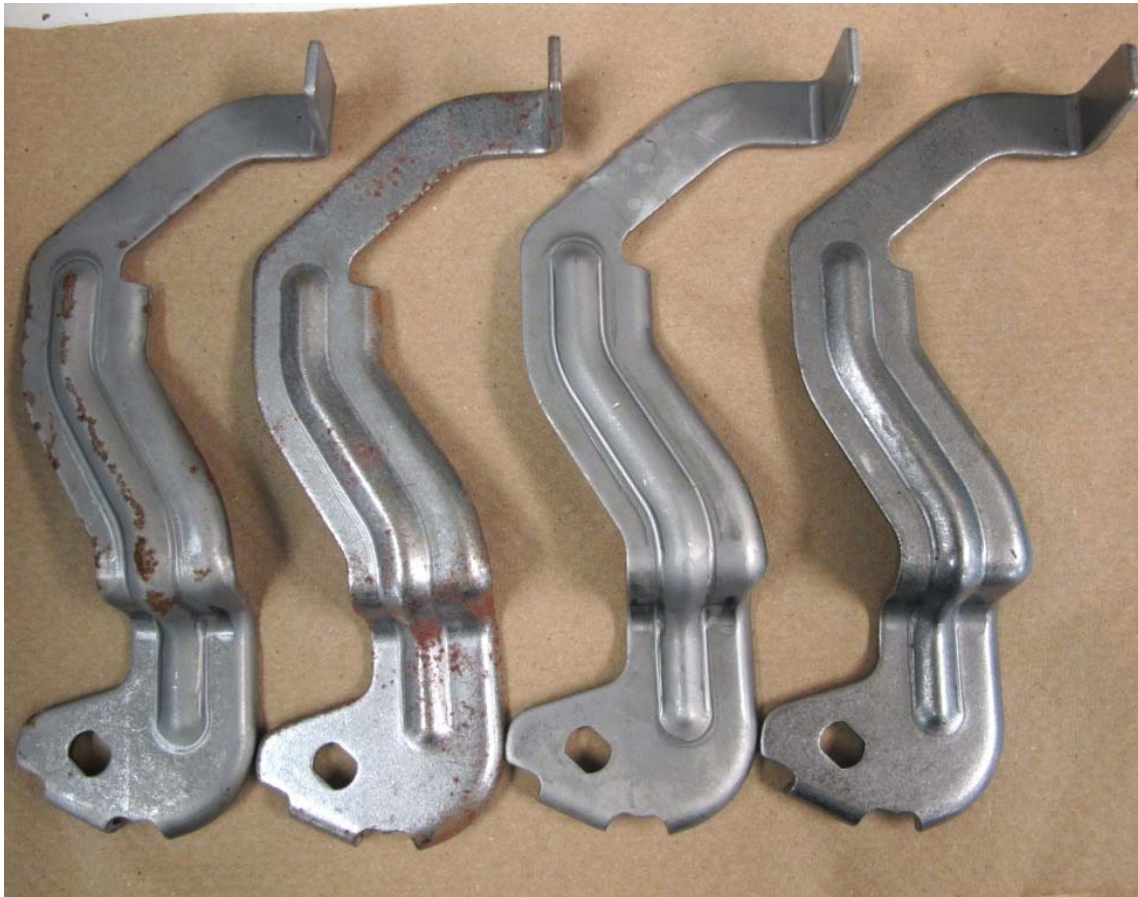
Figure 1: Group A parts, after 696 hours of ASTM D-1735 testing. From L-R: Amor/Current RP, Armor/BioCorr, VpCI-126/Current RP, VpCI-126/BioCorr

Part ID	Time to Corrosion (Hours)
A – Armor/Current RP	600
A – Armor/BioCorr	600
A – VpCI-126/Current RP	DNF
A – VpCI-126/BioCorr	DNF
B – Current RP only	312
B – BioCorr only	504
B – Current RP/Armor	DNF
B – BioCorr/VpCI-126	DNF

Interpretations: After 696 hours of testing, corrosion was minimal in all packaged parts. The biggest difference in corrosion protection was between the liquid products; BioCorr provided better protection than the rust preventive currently being utilized by Mursix.

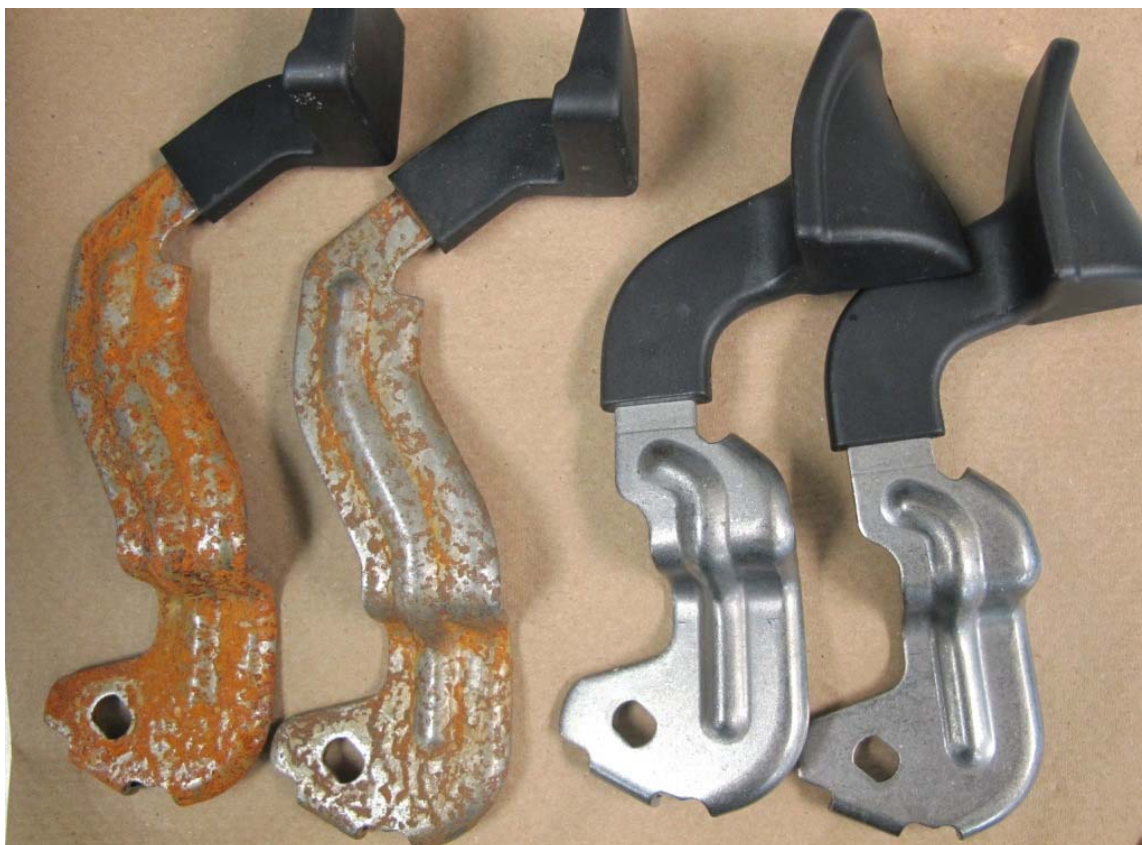
Figure 2: Group B parts after 696 hours of ASTM D-1735 testing. From L-R: Current RP only, BioCorr only, Current RP/Armor, VpCI-126/BioCorr
