Comparison of VpCI-389D and Rilco RP-184

Project #: 16-108-1125.supplemental.bis

Background:

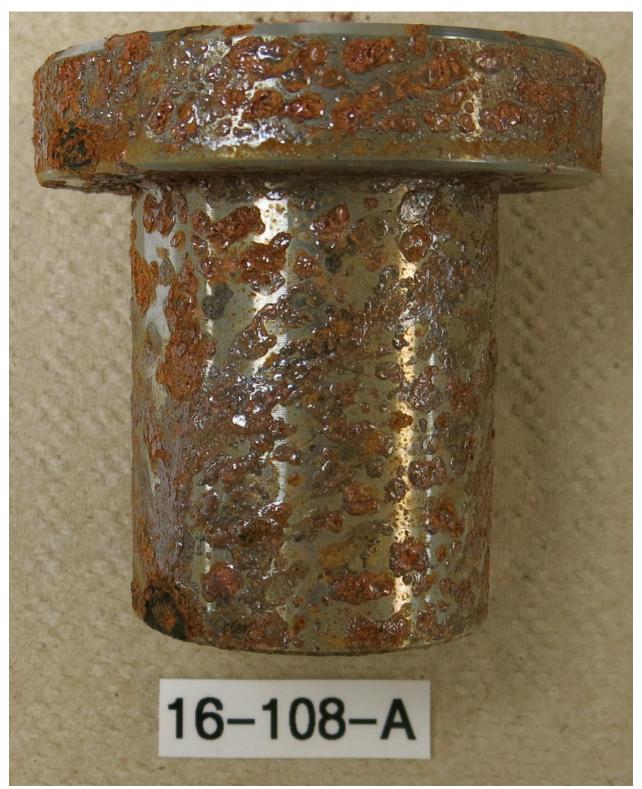
Figure 1: Part 16-108-A (control), after 336 hours in ASTM D1748 testing.

Part Treatment	Time to Failure (Hours)
None (control)	<16
Rilco RP-184	40
VpCI-389D	336

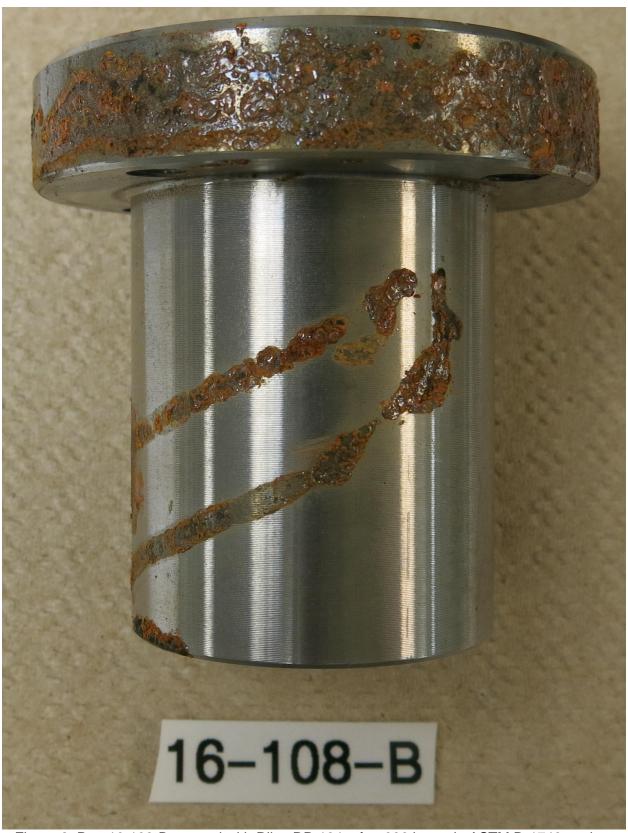
Figure 2: Part 16-108-B, treated with Rilco RP-184, after 336 hours in ASTM D-1748 testing.

Interpretations: After 336 hours in ASTM D-1748 humidity testing, VpCI-389D provided superior corrosion protection, when compared to the Rilco solution currently used by the customer.

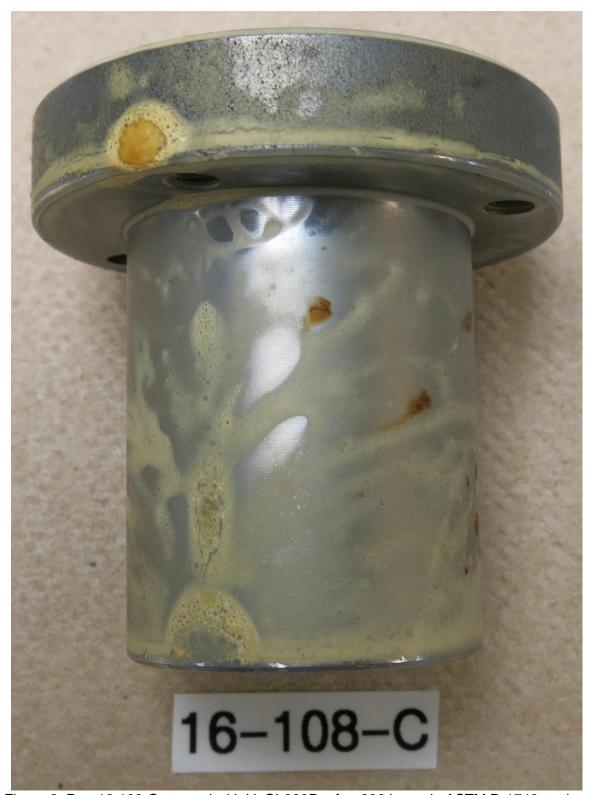
Figure 3: Part 16-108-C, treated with VpCI-389D, after 336 hours in ASTM D-1748 testing.
